Seismic assessment of masonry churches in Matera landscape

Michelangelo Laterza^a, Michele D'Amato^a, Daniela Díaz^a

^a Department of European and Mediterranean Cultures, University of Basilicata, Via Lazzizzera, Matera, Italy

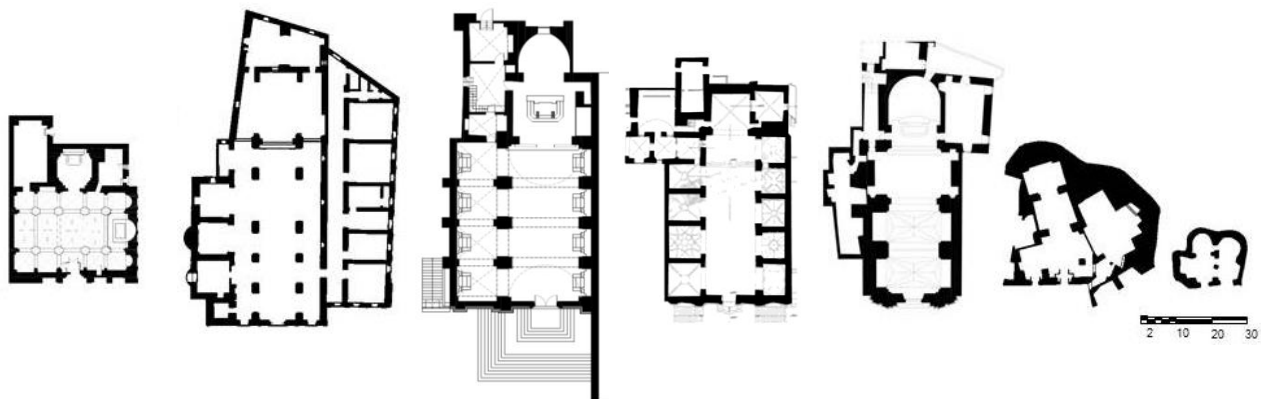
Figure 1. Churches floor plan (from left to right): San Giovanni Battista, San Pietro Caveoso, San Rocco, San Francesco d’Assisi, Sant’Agostino, Santa Maria de Armenis and San Nicola dei Greci. Reference: Superintendence for the Architectural and Landscape Assets in Italy, 2016; La Scaletta (1960); and Marcella Chietera, 2017.

Five churches are in calcarenite (limestone) masonry. Of these the churches of Sant’Agostino, San Rocco and San Francesco d’Assisi have an one-nave basilica floor plan configuration, while the churches of San Pietro Caveoso and San Giovanni Battista have a three-naves configuration. Regarding the roof structure, Sant’Agostino, San Rocco and San Giovanni Battista have limestone vault systems, while San Francesco d’Assisi and San Pietro Caveoso have wooden structures and limestone vaults. The church of Santa Maria de Armenis is excavated with a three-leaf masonry façade, while San Nicola dei Greci is completely excavated.
