A multidisciplinary diagnostic approach for the restoration of the inside surfaces decorative plaster of the vault of the late seventeenth-century Sant'Angelo Church in Monopoli (Bari, Italy)

Abstract

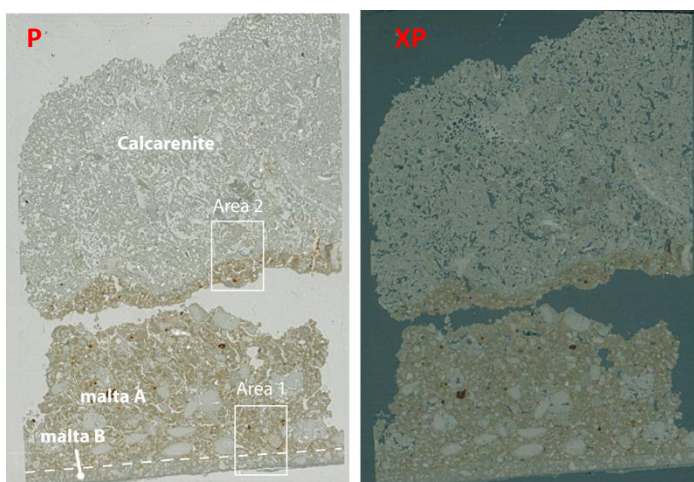
CSA1: POM of the thin section shows a layered plaster adhering to the calcarenite blocks of the vault (Fig. 1). Layer A is homogeneous and approximately 1 cm thick. The aggregate texture is seriated, with a predominant grain size in the medium sand class (0.25-0.5 mm). The aggregate consists almost entirely of calcareous sand and modest amounts of quartz and feldspars. The texture of the binder varies from micro- to cryptocrystalline. EDS microanalysis of the binder-enriched portion shows the use of lime putty. The primary pores (Figure 1) are less frequent than the shrinkage cracks developed during the setting of the lime plaster.

Layer B is approximately 1 mm thick and has the same composition and microstructures as layer A. On layer B, two paint layers with a total thickness of approx. 0.3 mm can be observed, which were partially damaged by sampling and preparation. Both are lime-based, but in the former case the presence of siliceous clasts is detected, with a maximum size of and around 50 μ m (Figure 1). Microanalysis shows that some of these are quartz, while the largest part consists of minute glassy fragments (SiO₂ = 66.5 wt%; K₂O = 15 wt%; BaO = 7.5 wt%; Al₂O₃ = 2 wt%; CoO = 1 wt%; FeO_{tot} = 1.5 wt%; As₂O₃ = 1.5 wt%). This composition can be referred to as *azzurro di smalto* or *smaltino* (Borgia and Seccaroni, 2005; Casoli et al., 2007). Sulphur was detected along the outer surface and at some points in the open porosity of the plaster, as an indicator of the presence of gypsum.

Figure 1 – CSA1, Thin section scans at polarizer only (P) and cross-polarizers (XP) and position of the analysed areas at SEM-EDS

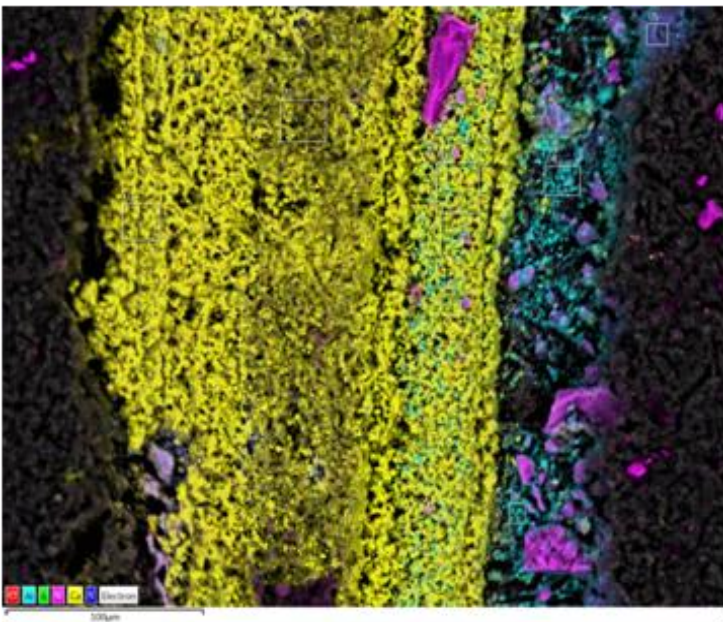
CSA5: The three analysed fragments are layered, with a total thickness of approximately 0.3 mm. The two innermost layers show a laminated structure and are based on lime and gypsum. In layer B, rare quartz inclusions and clay minerals can be recognised. Layer C, on the other hand, is potassium alum (aluminum potassium sulfate dodecahydrate), with very fine quartz sand and iron oxides. On the outer surface there is gypsum as an alteration of the underlying alum.

In fragment 2 the layers are not always adherent each other. EDS analyses shows compositions comparable to those of fragment 1, although gypsum is present in A and B. The stratigraphic sequence of fragment 3 is enriched by a layer of gypsum and a layer of lime before the alum layer.

Figure 2 – CSA5, fragment 1: chemical map and portions analysed by EDS microanalysis. In the legend the elements considered in the map.

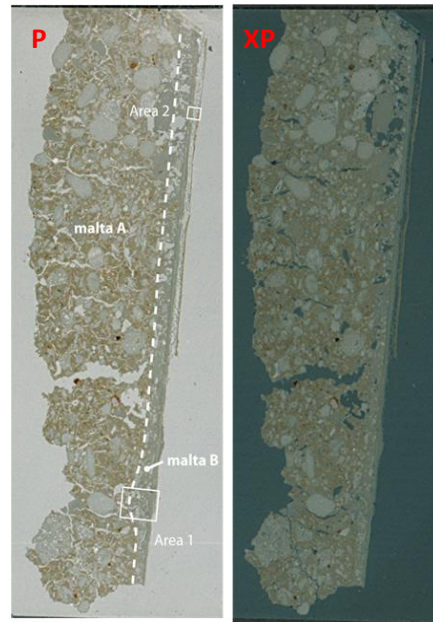
Figure 3 – CSA6, Thin section scans at plane polarized (P) and cross polarized (XP) light and location of the analysed areas at SEM-EDS.

CS6: The sample is stratified, with a sequence of paint layers reconstructed between areas 1 and 2 (Figure 2). Layer A shows similar composition and texture to those recognised in sample CSA1 and CSA4. Layer B is approximately 1 mm thick and reflects the characteristics of layer A. In the innermost layer, EDS microanalysis shows that the pigments are minute fragments of *azzurro di smalto*, as in sample CSA1. A lime wash coloured with copper sulphide overlays the blue layer and is followed by three other white lime washes (Figure 3). The outermost layer is alum, with non-negligible concentrations of copper and iron ($\text{FeO}_{\text{tot}} = 0.7 \div 12.9 \text{ wt\%}$; $\text{CuO} = 0.6 \div 1.8 \text{ wt\%}$).

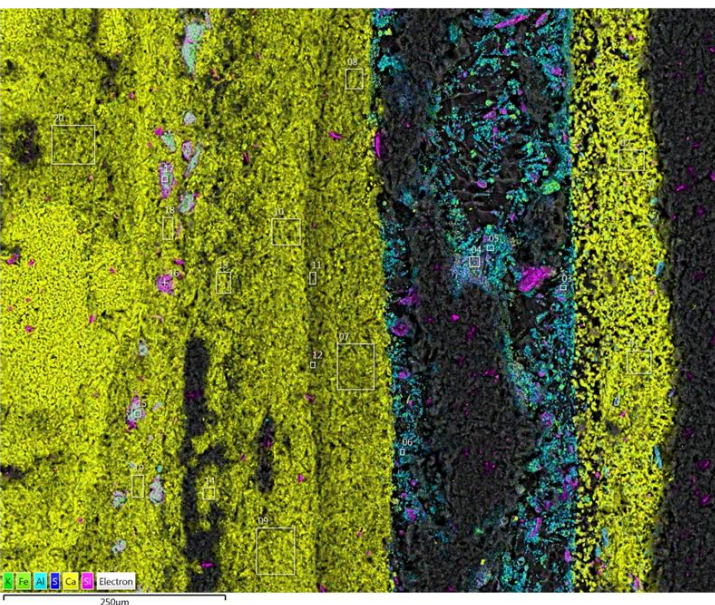
Figure 4 – CSA6, area 2: Chemical map and portions analyzed by EDS microanalysis (see Fig. 1). In legend the elements considered in the map.

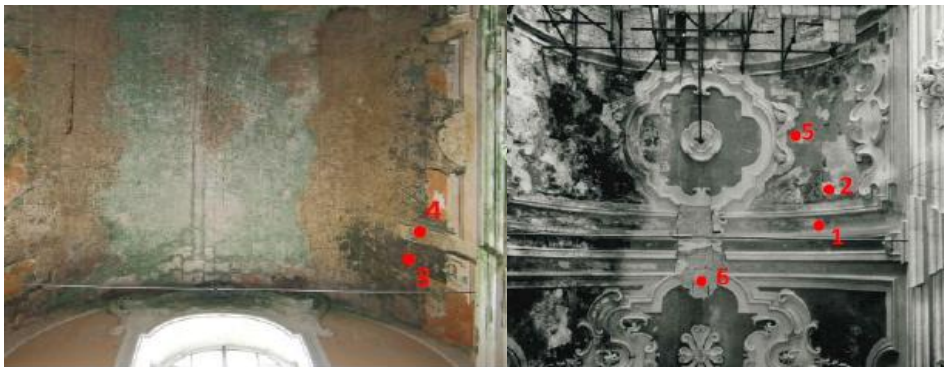
The degradation state of the church was showy noticeable, and the attention was focused on the biodeterioration of the internal surfaces. Figure 5 highlights the state of decay and the sampling areas.

Figure 5 – State of decay and the sampling areas

From the sampling zones #1 - #4 the presence of fungal colonies emerged while the samplings #5- #6 showed the presence of bacterial colonies. Table 1 reports the biological identification while figures 6 and 7 show the SEM images. Notably, all isolated bacteria strains were gram-positive.

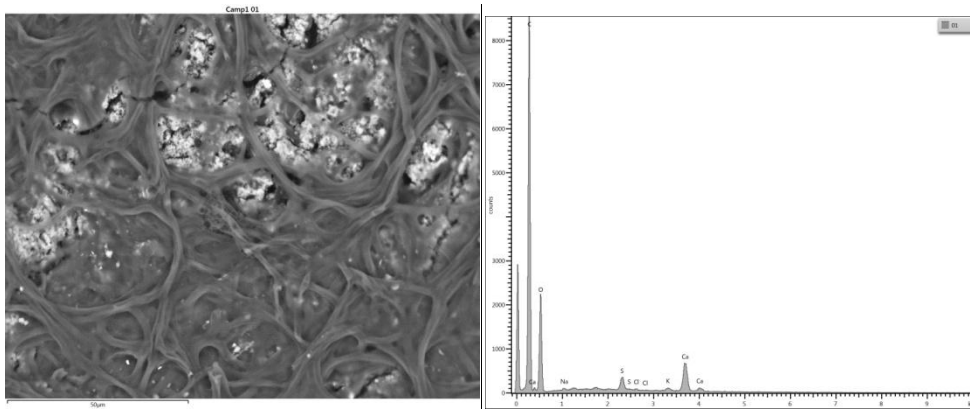
Figure 6 – Fungal colonies and relative EDS analysis

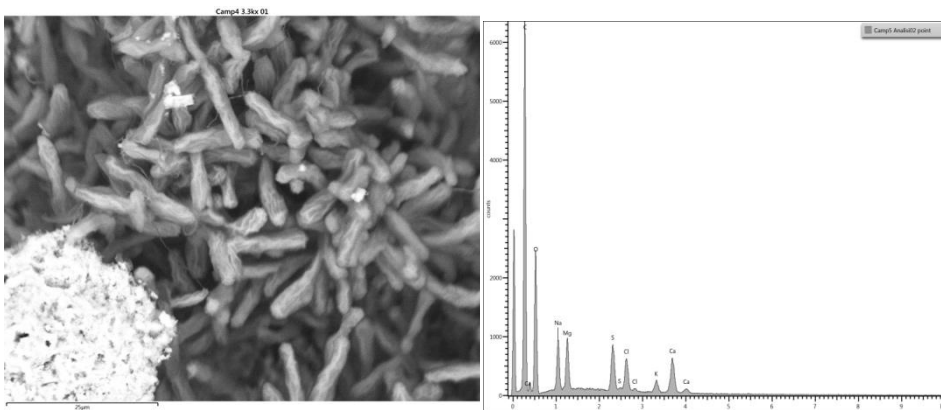
Figure 7 – Bacterial colonies and relative EDS analysis

The prevalence of *Bacillus* species may be due to the specific environmental conditions, very similar in all sampling sites of the church, and their ability to produce endospores, dormant forms allowing bacteria to survive unfavourable conditions e.g., low nutrition, as the carbonate stone constituting the church walls is favourable for bacterial settlement (Li et al., 2018, Nicholson et al. 2000). The diffusion of microorganisms is linked to air movement (Mulec t al, 2008; Northup et al. 1994) but also it is related to presence of organic matter produced by the pigeons that had settled in the abandoned building. Organic matter, indeed, is as source of carbon for heterotrophic organisms. The identification of bacterial and fungal colonies on the stone material is a problem not limited to the prevention and restoration of aesthetic damages, but it can also be important from a sanitary point of view. Sporigenic bacterial and fungal species can be of health concern for visitors. In particular, the genus *Bacillus* produces toxins in self-defence, but if produced in excess in an area with poor ventilation, it can cause problems for the most fragile subjects (From et al., 2005).
