Building Pathology and Rehabilitation

João M.P.Q. Delgado *Editor*

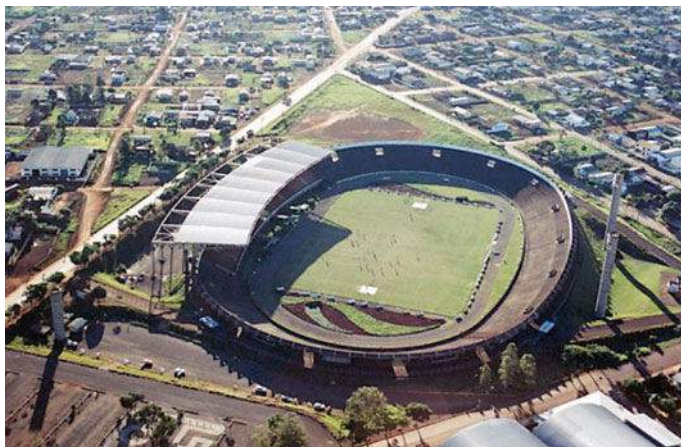
Fig. 1 Olympic stadium Arnaldo Busatto

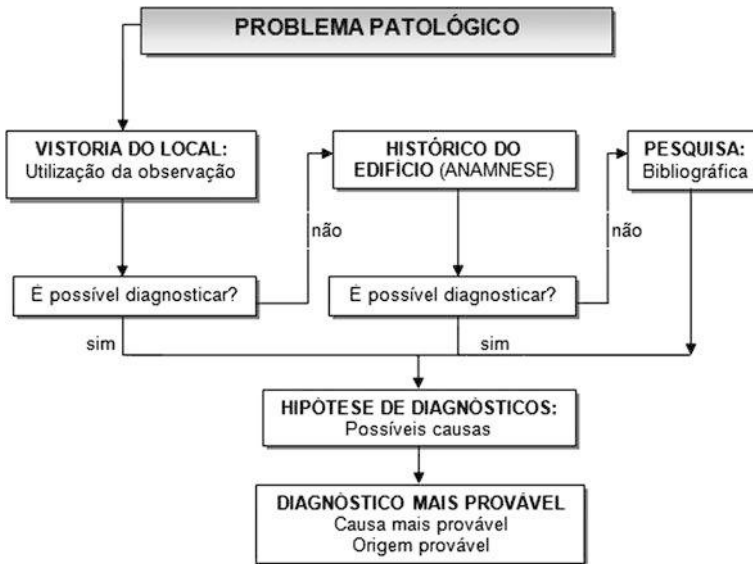
Fig. 2 Schema of method used

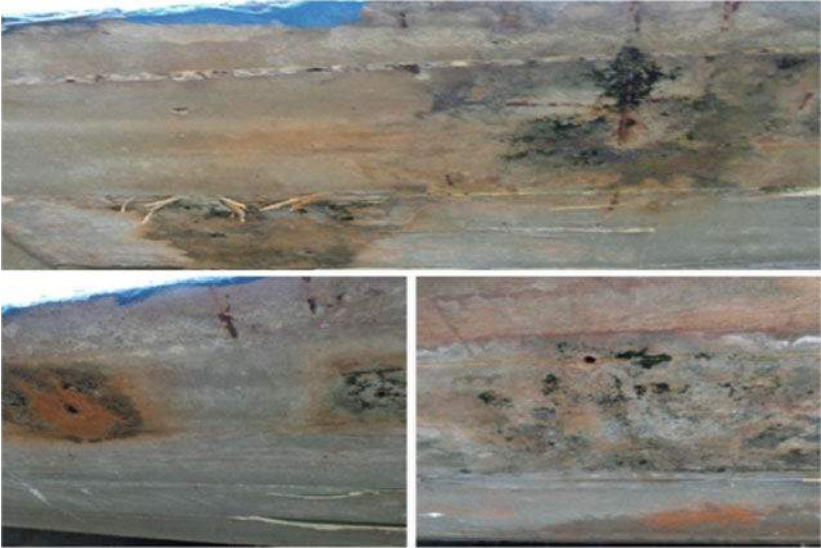
TECHNICAL DATA		
SOURCE: FIELD RESEARCH PERFORMED BY THE AUTHOR		Location - Circulation 04
		jan/14
Pathology type	Mold	
Symptom data	There are holes in the slab. At some points it is possible to note the coating detachment, oxidation of the slab reinforcement and deployment of pieces of wood.	
Probable causes	Ineffective waterproofing of the slab	
	Infiltration of rainwater	
Degree of risk	Regular

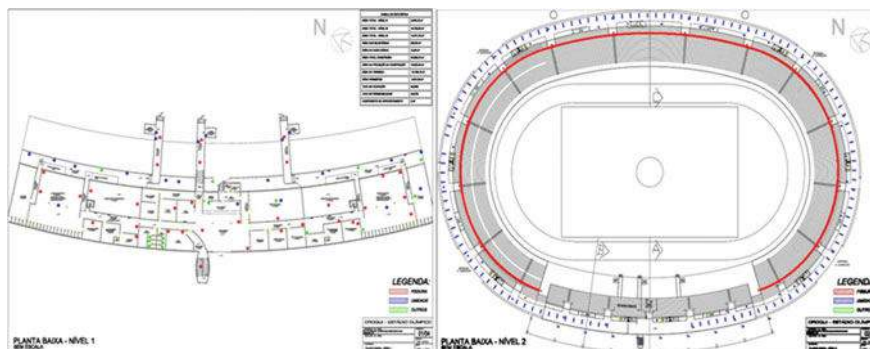
Fig. 5 Mapping of pathologies in the different levels of the stadium

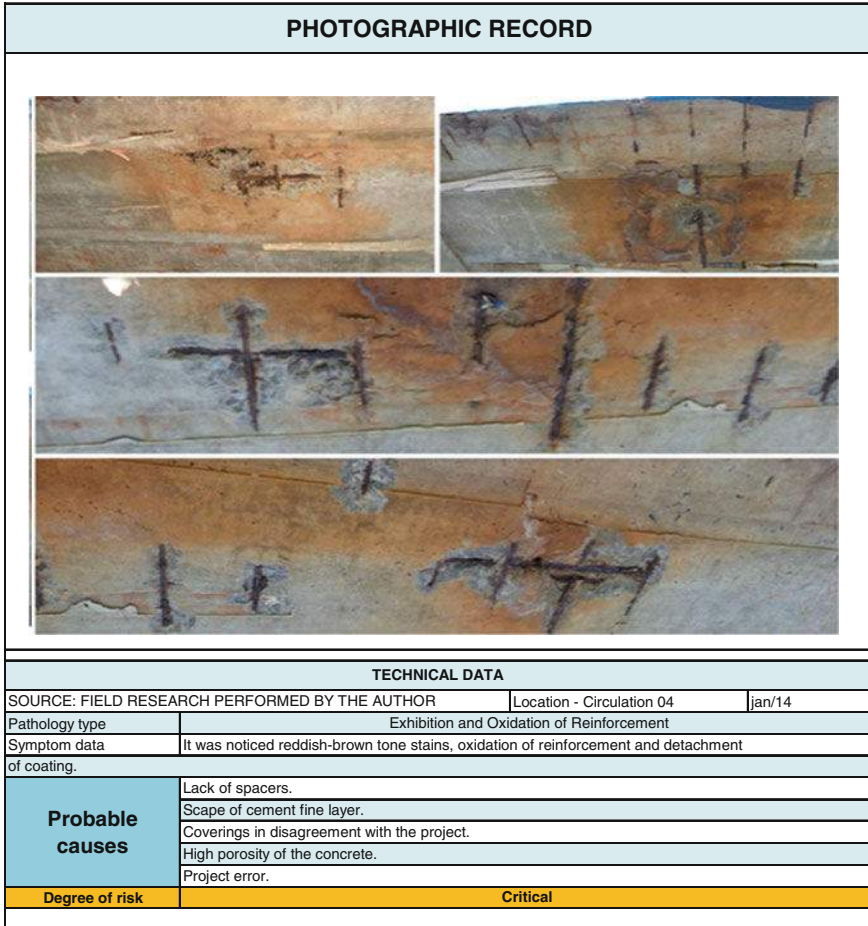
Fig. 6 Oxidation of slabs

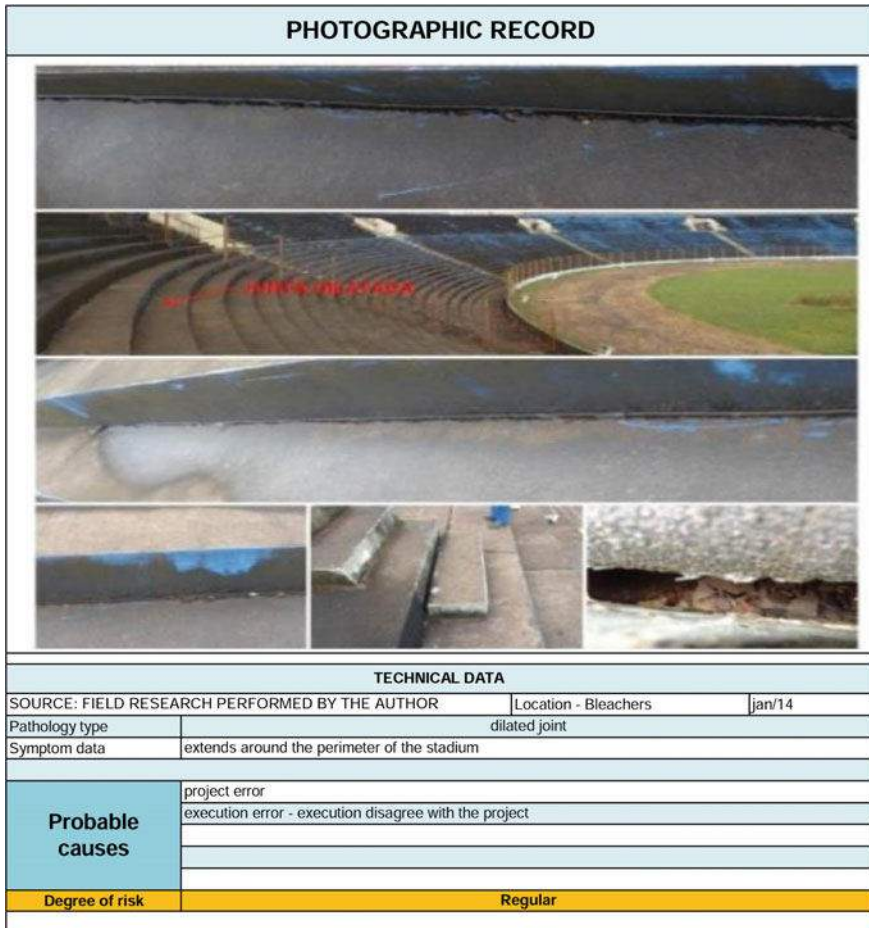
Fig. 8 Dilation of horizontal joint

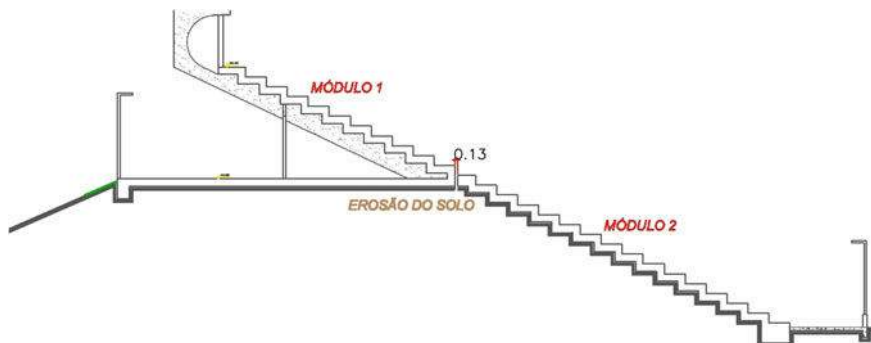
Fig. 9 Cross section of the bleachers slab

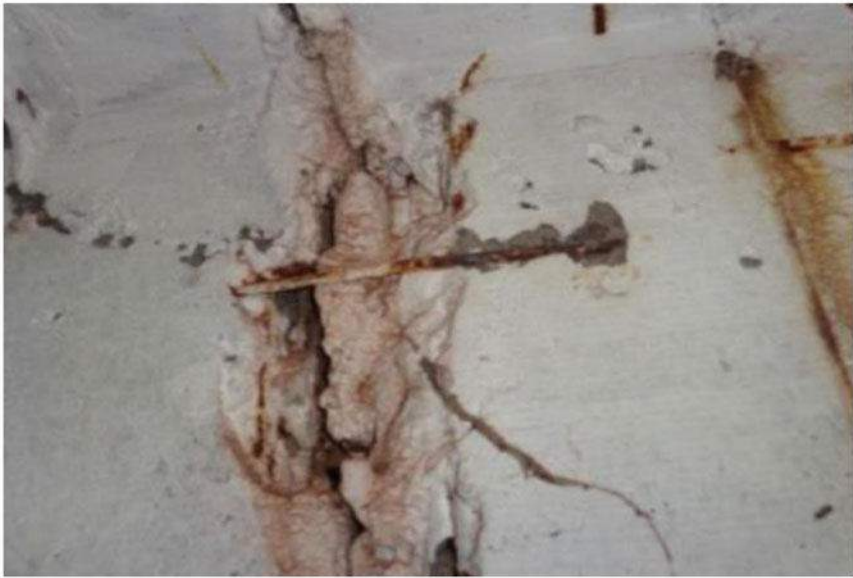
TECHNICAL DATA		
SOURCE: FIELD RESEARCH PERFORMED BY THE AUTHOR		Location - Cabin jan/14
Pathology type	crack, detachment, armor exhibition	
Symptom data	detachment of coating and oxidation armor in the dilatation joint	
Probable causes	oxidation due to insufficient coverings - project or execution error	
	moving of the joint caused detachment	
Degree of risk	Regular

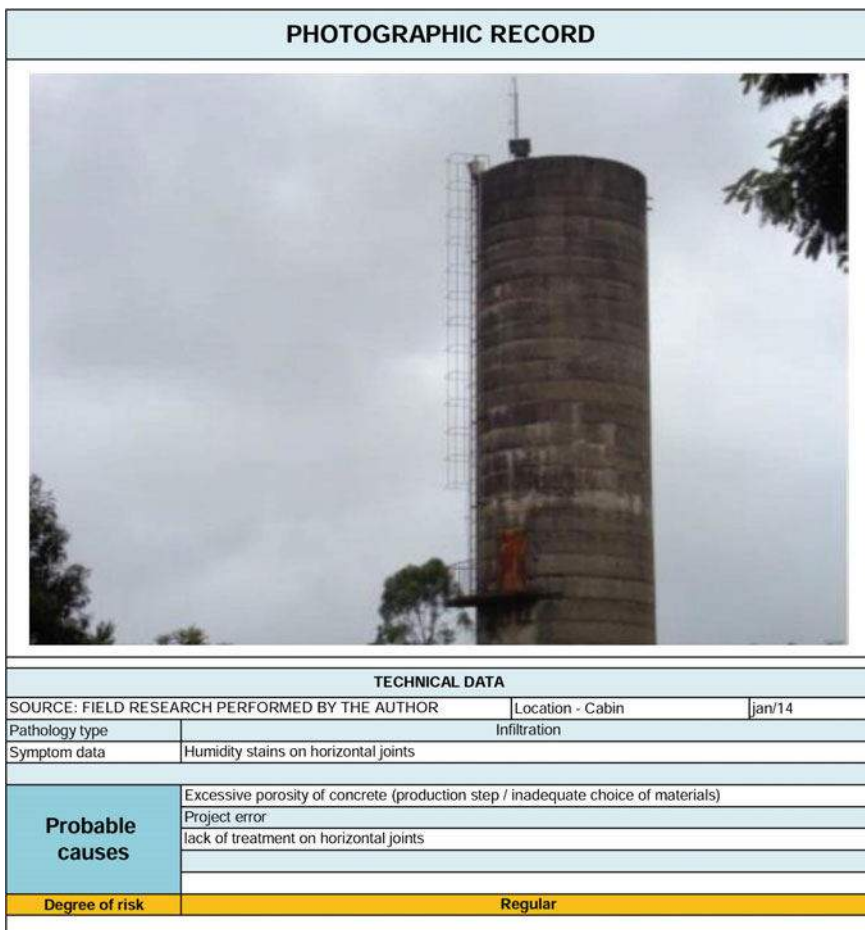
Fig. 11 Infiltration and carbonation

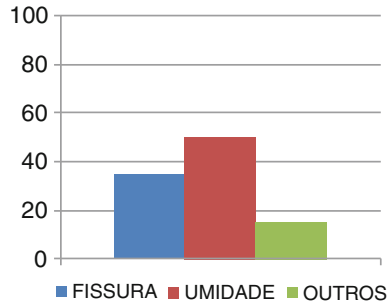
Fig. 13 Pathologies by degree of risk

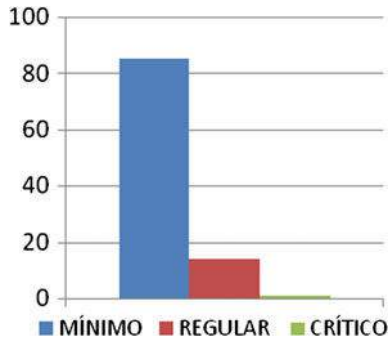
coatings, breaking of ceramic coatings, and detachment of paintings. Such amounts may be related to the exposure of the elements present on the second level to the weather and correlated to possible insufficient waterproofing processes or lack of maintenance of these. In contrast, the third level is where the constructive elements are in lower exposure to weathering external agents causing constructive diseases and, unlike the level 1, does not maintain contact with the ground and possible rise episodes of humidity from this material body.

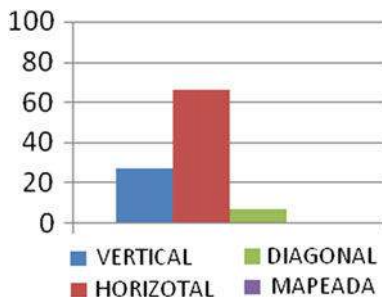
Fig. 15 Origin of pathological manifestations

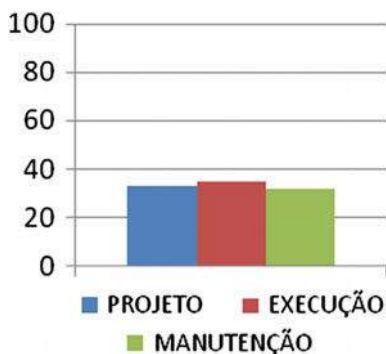
Fig. 14, which in all four evaluated levels stand out the horizontally directed pathologies that may represent inharmonious movement, either by shrinkage and thermal expansion between the ceramic material components walls and concrete structures, or by humidity; as well as the possibility of failure or prematurity of the wedge-shaping procedures perceived in some environments inspected at the first level.

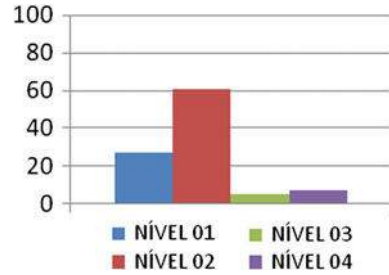
weathering agents and possibly related to insufficient waterproofing processes or lack of maintenance of these. In contrast, the third level is where the building elements have a lower exposure to external agents of weathering causing constructive diseases and, contrary to the level 1, does not maintain direct contact with the ground and possible episodes of moisture ascending from this material body.

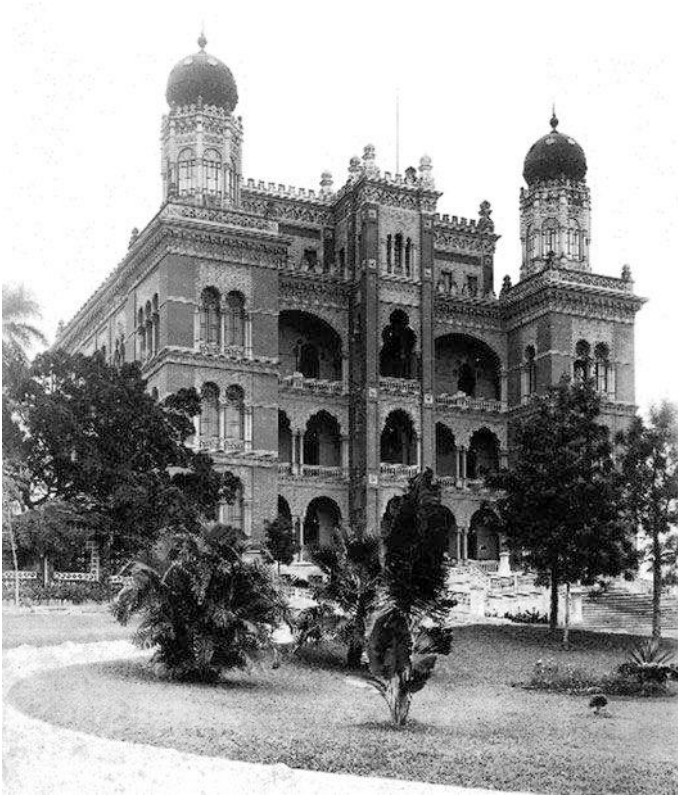
Fig. 5 Pavilhão Mourisco in 1911

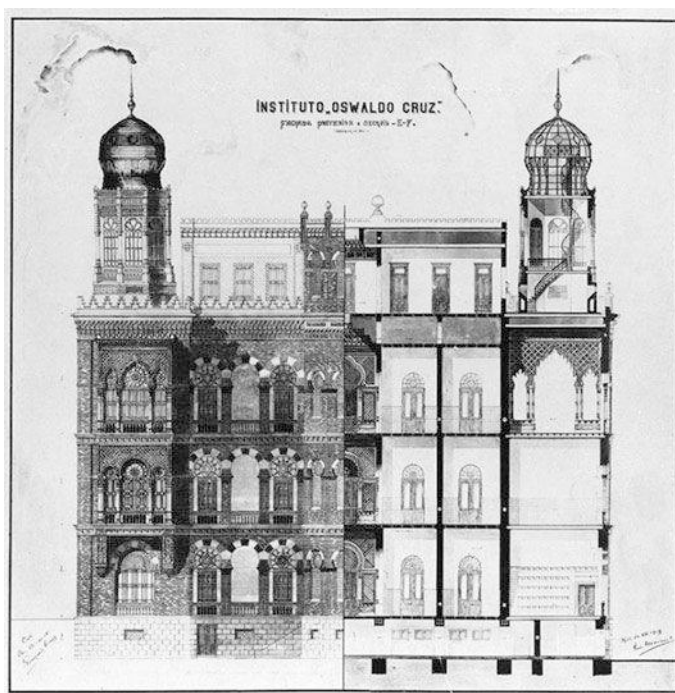
Fig. 6 Final design for the Pavilhão Mourisco—Elevation and cross section, by Luiz Moraes Jr., made while the pavilion was already being built (1908)

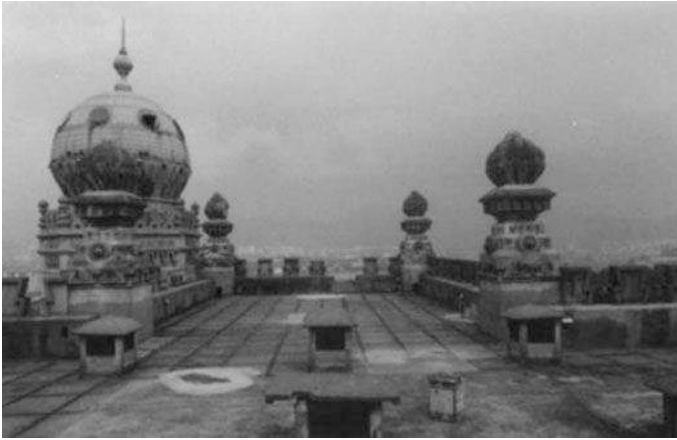
Fig. 7 View from the seventh-floor terrace, with the old cement tiles (1989)

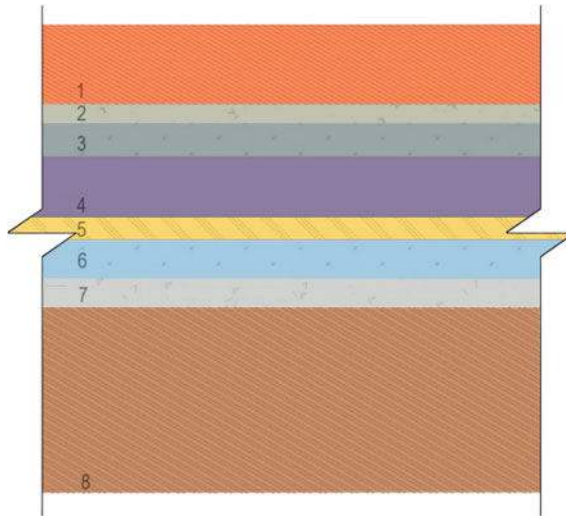
Fig. 9 Layers scheme on the butyl blanket waterproofing system, where: 1 Ceramic tile laid with cement–sand mortar (1:3 ratio) with waterproofing additive. 2 Cement–sand mortar (1:2 ratio, and 1.5 cm thick) reinforced with steel screen. 3 Bituminous felt sheets 250/15. 4 Butyl rubber blanket (8 mm thick) set with vulcanising adhesive. 5 “Cradle” composed of bitumen emulsion and rubber flakes at a 1:2 ratio. 6 Dihydric bitumen emulsion diluted in 50 % water. 7 Settlement mortar, at a 1:3 cement–sand ratio. 8 Slab (steel beam and brick stuck)

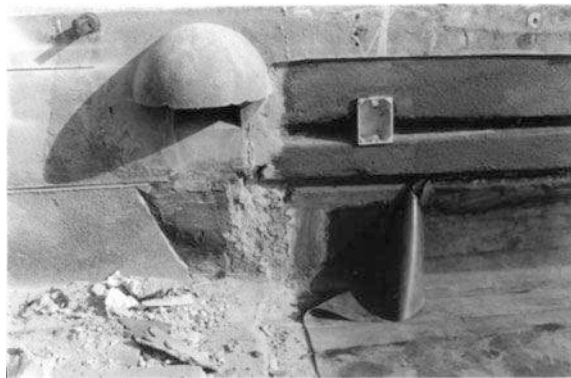
uncoated and do not show any kind of stress or leakage points (Figs. 14, 15, and 16).

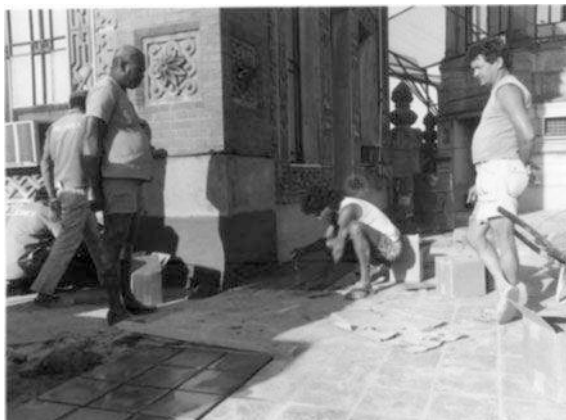
Fig. 12 North wing terrace on the seventh floor (1990)

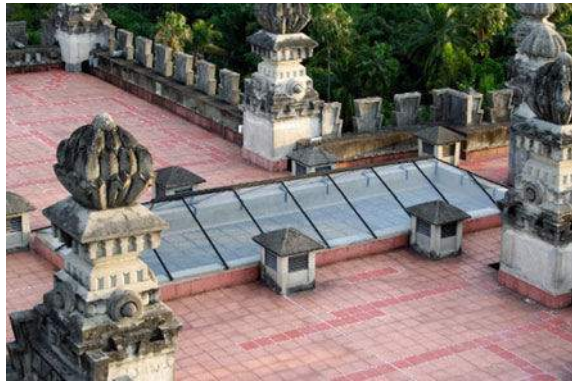
The report states that the cracks on the fifth floor result from thermal variation due to extreme temperatures in Rio de Janeiro and do not represent structural damage to the building. The report also shows that, on the seventh floor, the damage was related to the poor quality of the ceramic tiles used in the 1990s intervention (Cerne Engenharia e Projetos 2006) (Figs. 17 and 18).

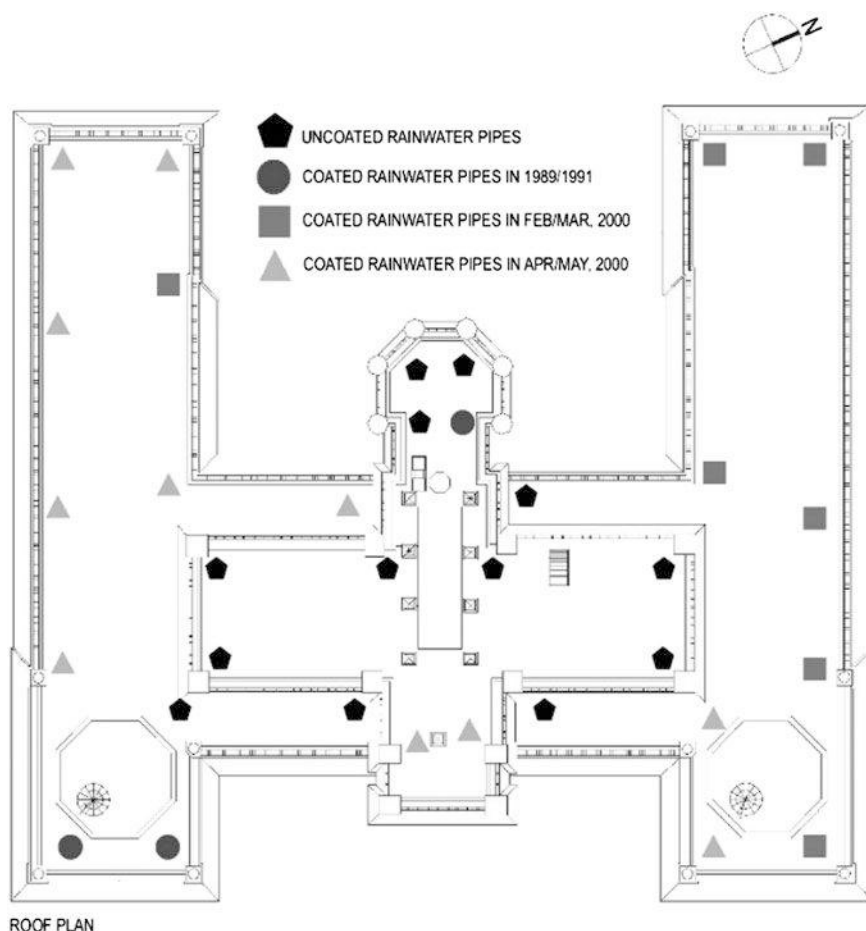
Fig. 16 Roof plan (seventh floor on the central area and fifth floor on the rest of the plan) indicating the location of the drain pipes and their interventions

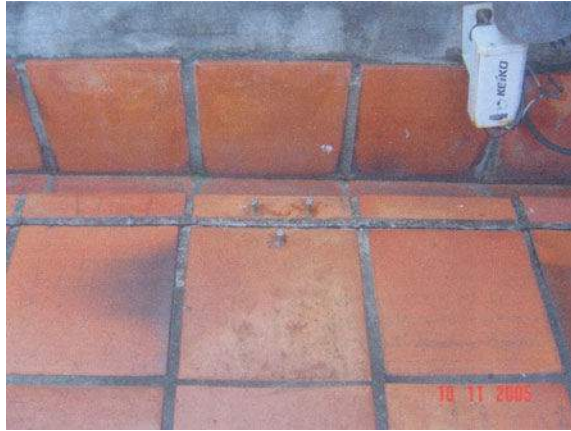
Fig. 18 Monitoring station placed by a turret on the seventh-floor terrace (Nov 2005—Cerme Engenharia)

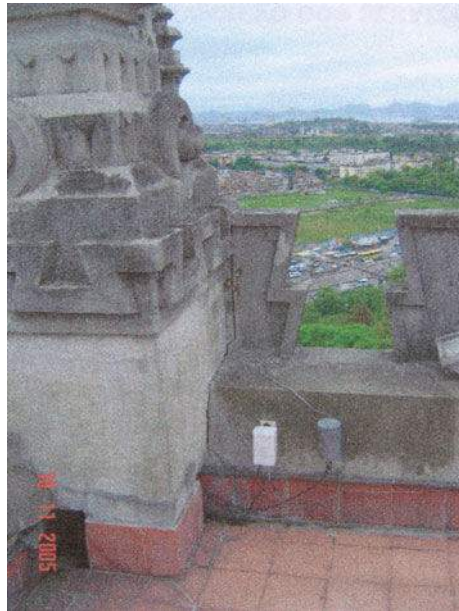
4 Intervention at the Eaves and Parapets from the Terraces

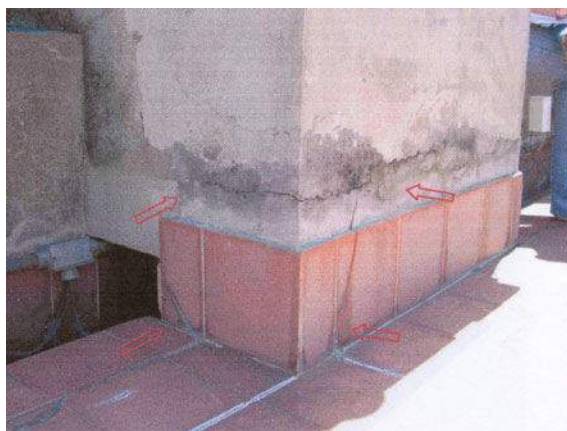
Fig. 19 Cracks on the mortar indicating the displacement of the waterproofing blanket (Nov 2005 —Cerme Engenharia)

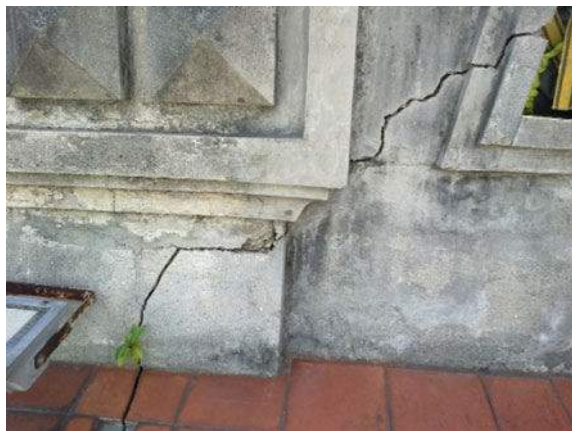
Fig. 22 Black crust on the external ceramic tiles (May 2014)

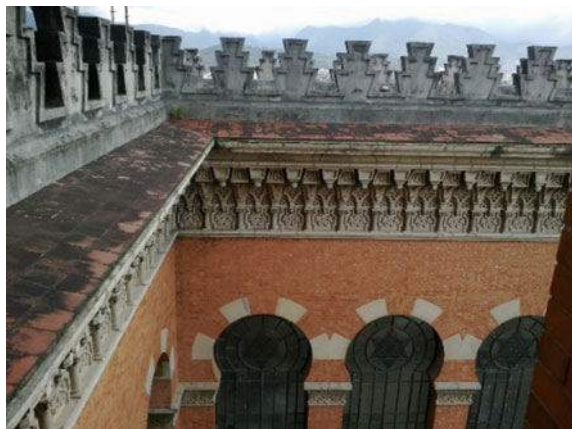
the second one, the western part of it. The two pictures below show the scaffolds installed for the first phase of the work.

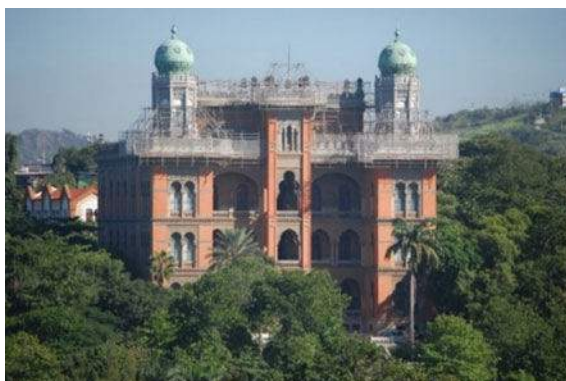
Fig. 24 Scaffolds on the seventh-floor terrace (May 2014)

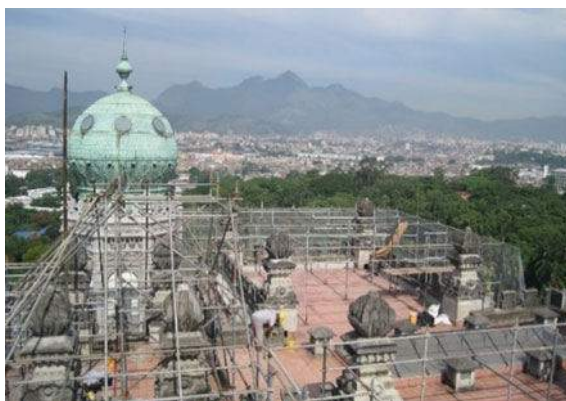
A new cement mortar was laid over the waterproofing system, the paint formula to cover the new surface was determined through the analysis of the demolished mortar. The plastic membrane was also applied to every surface that could accumulate water (gutters, ornaments, etc.), and near the fissures and cracks. Some places were reinforced with a thin net below the new cement layer (Figs. 25 and 26).

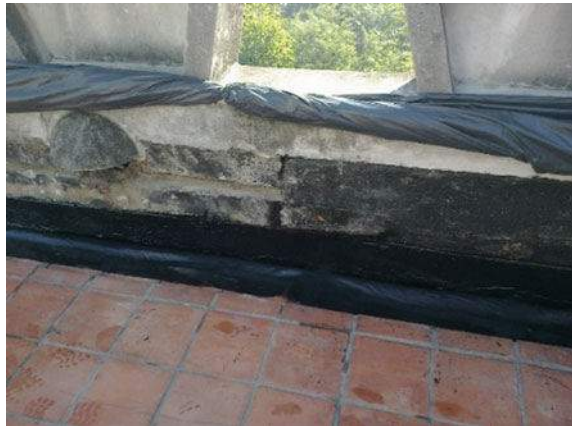
Fig. 26 Plastic membrane applied on top of the butyl rubber blanket in order to improve waterproofing in the lower part of the parapet (Apr 2014)

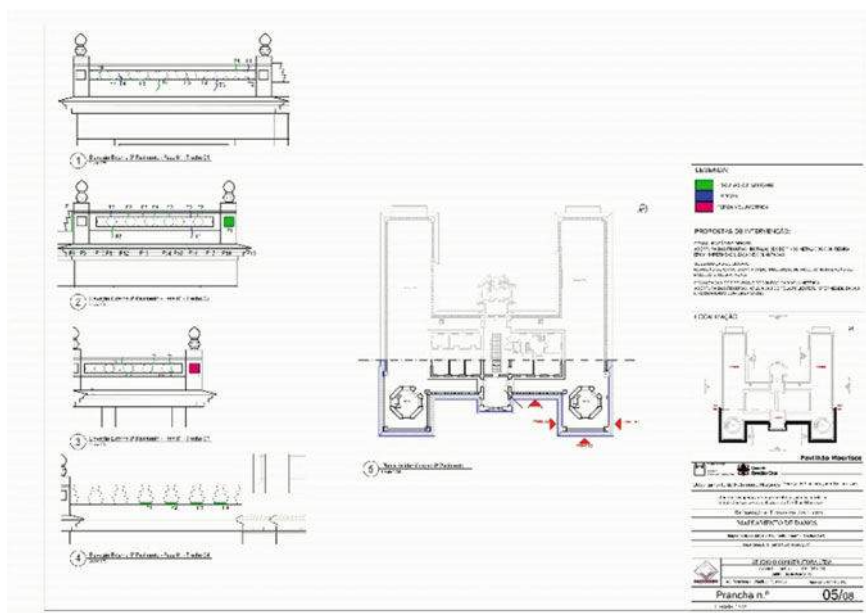
Fig. 27 Pathology and damage mapping survey—elements on the fifth-floor terrace, north wing

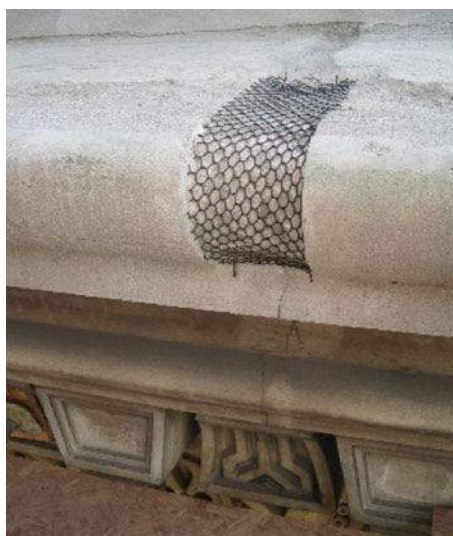
The copper plaques located below the ceramic tiles on the eaves work as a drip edge for the building and were subject to physical intervention. The copper drip edges were removed, received anticorrosion treatment, and were finally put back in

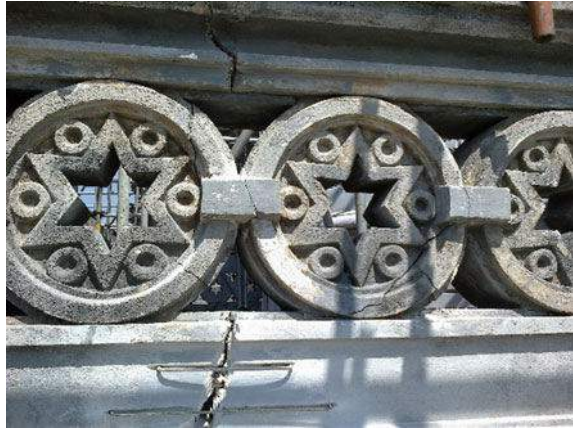
Fig. 30 Structural damage seen at the seventh floor, north wing, eave: crack opening, affecting also the copper plaque (Feb 2014)

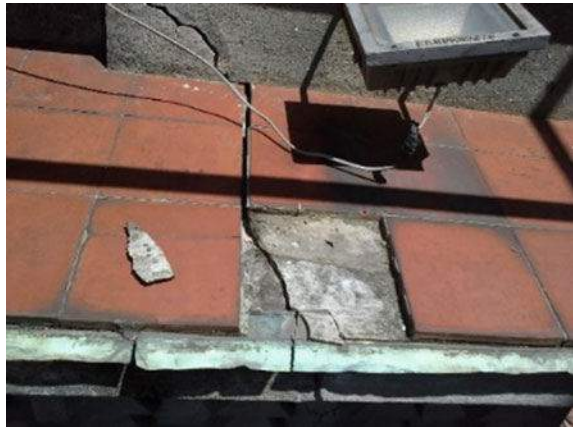
place before being welded back together and coated with automotive varnish (Figs. 30, 31, and 32).

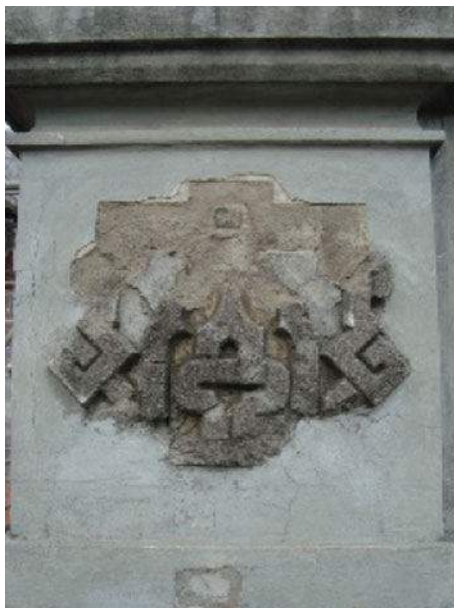
Fig. 34 Ornament on the fifth-floor terrace, north wing, external wall—the damage goes deep into its metallic structure (Mar 2014)

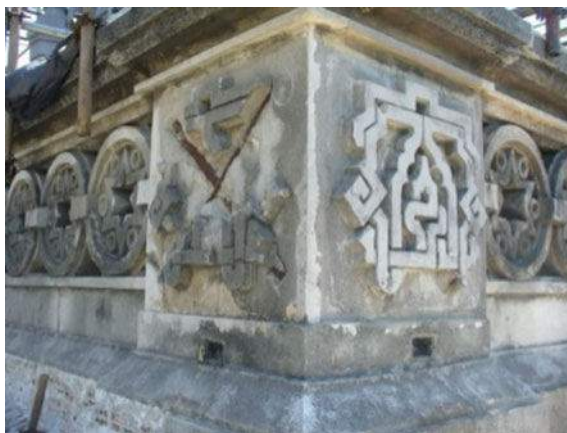
and worked alongside the DPH personnel and construction staff, in order to better perform the restoration of the mortars of this historic building (Fig. 38).

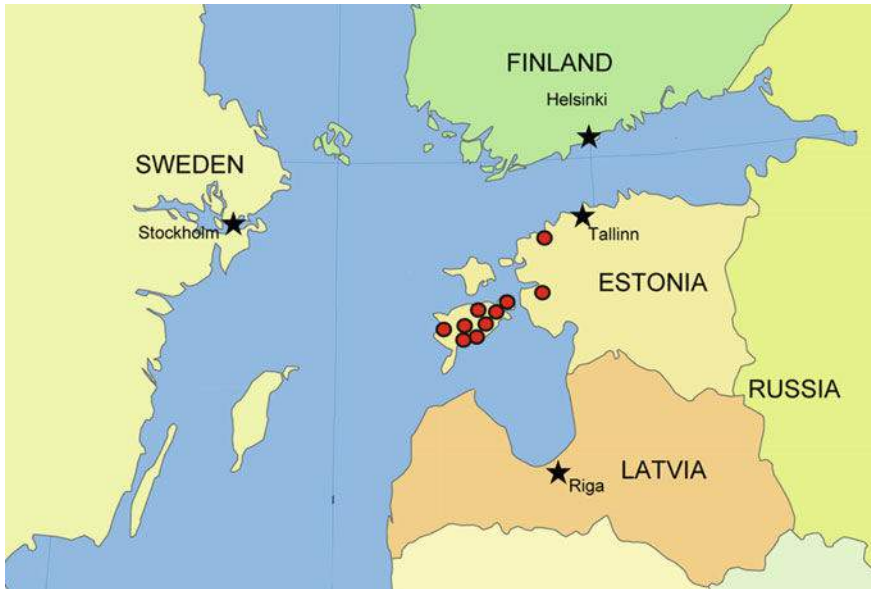
Fig. 1 Locations of studied medieval churches on the island of Saaremaa and in Western Estonia are marked with a *red* dot

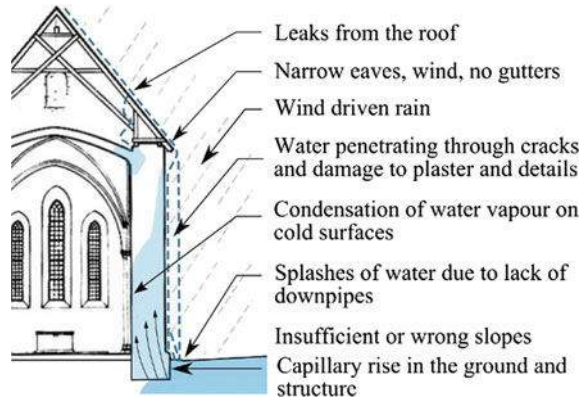
structure of the churches. The performance of the buildings and their deficiencies are highly dependent on the building management.

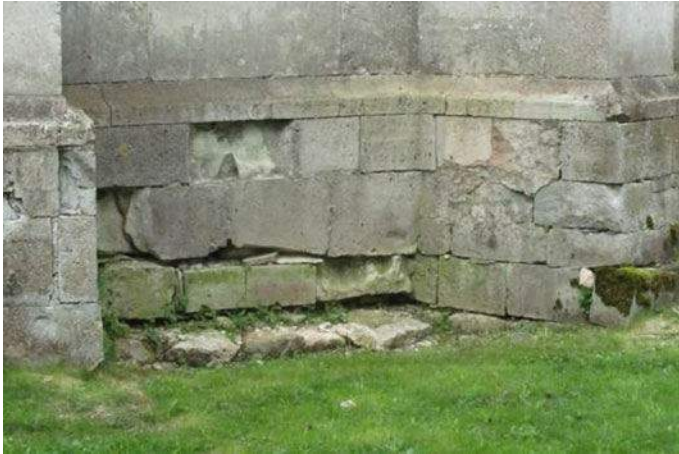
Fig. 3 Ground around the church is sloped towards the building and leads water to the structure, frost damage caused by excess moisture is also visible

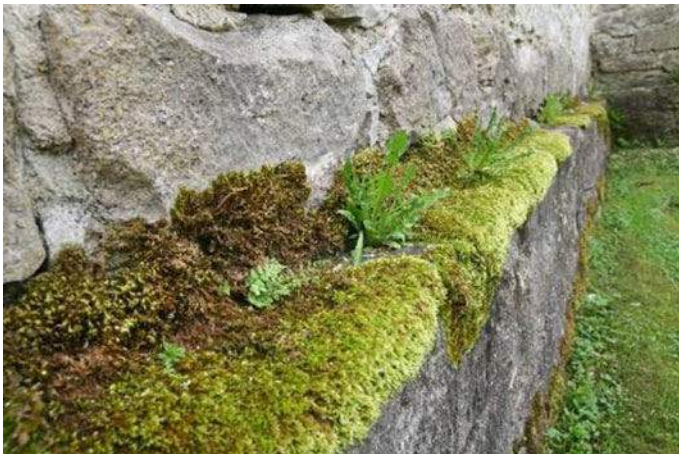
Fig. 4 Protruding foundation wall ought to have sufficient slopes and a cornice to lead the water away safely. Foundation wall has been wet enough to facilitate the growth of moss

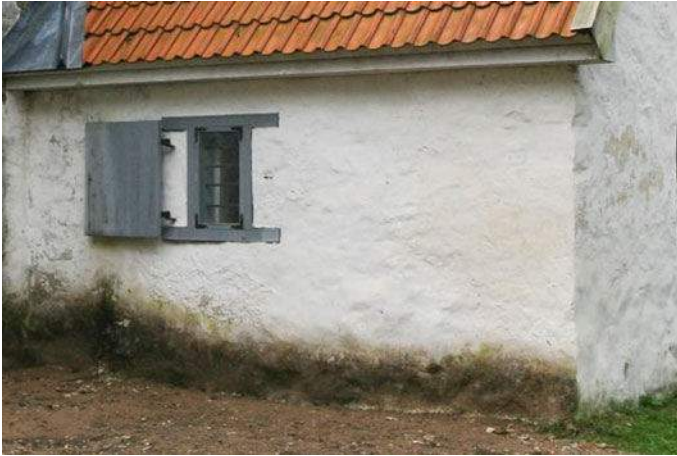
Fig. 5 Water falling from the gutterless eaves moistens the façade while exhausting the frost resistance of the plaster, splashing water also carries soil—the foundation wall is dirty and suitable habitat for algal growth

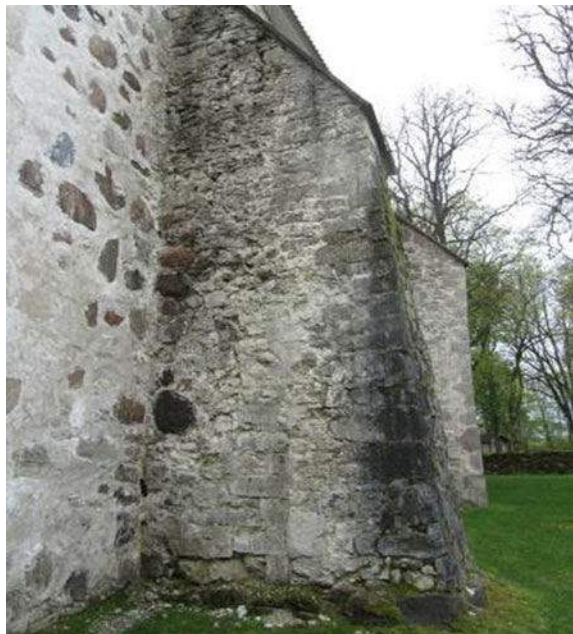
Fig. 6 Roof covers only part of the buttress resulting in discoloration, frost damage, and wetting of the wall

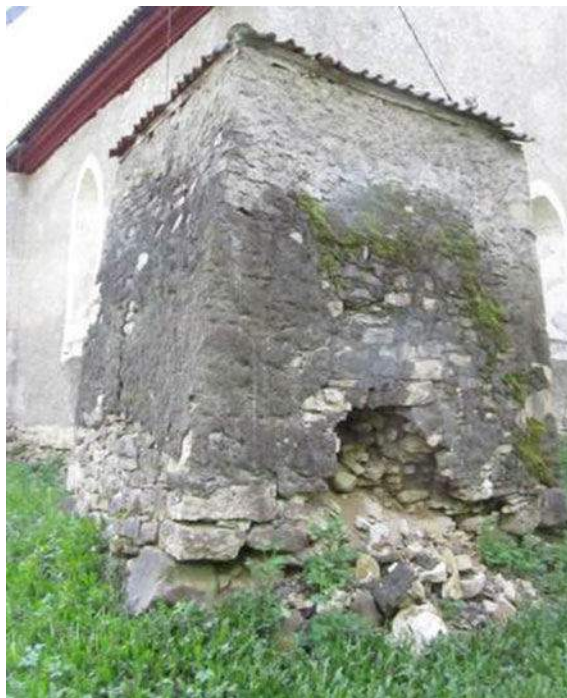
Fig. 7 Only surface layers of the masonry wall were built using binder, damage to these layers can cause collapse

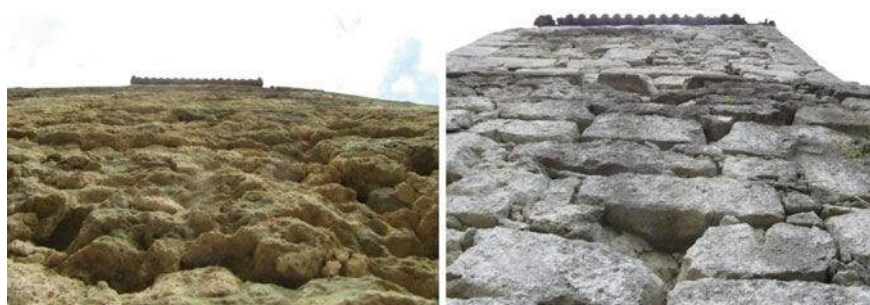
Fig. 8 Parts of the façade uncovered by eaves are exposed to high water loads, frost damage to mortar and stone is visible

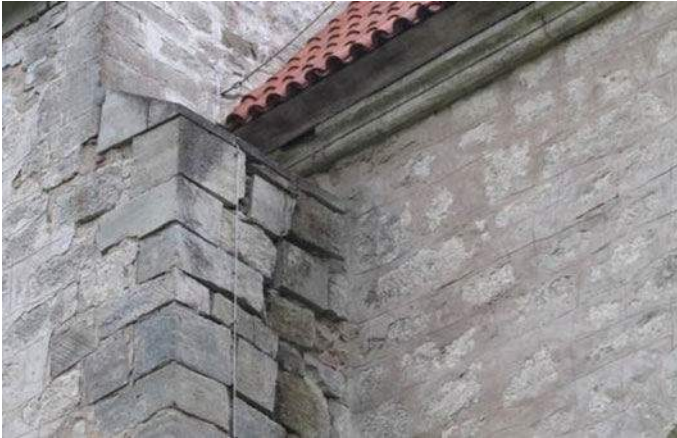
Fig. 9 Due to incorrectly designed details, concentrated amounts of rainwater are able to penetrate the wall

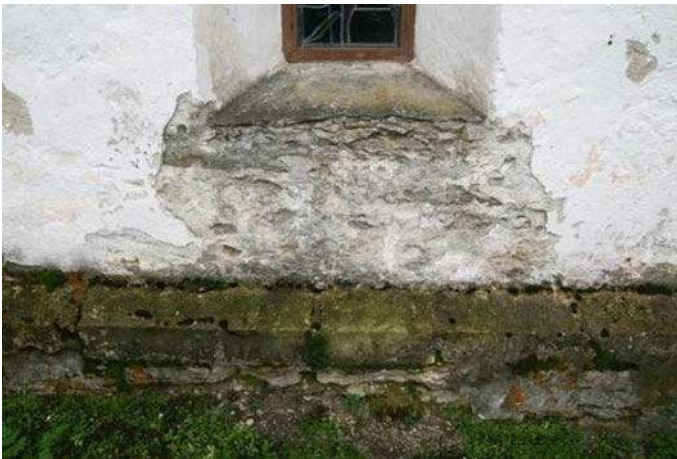
Fig. 10 Proper detailing of façade elements has an important role in the service life of the whole wall. Window flashing made of mortar has failed to lead the water away safely

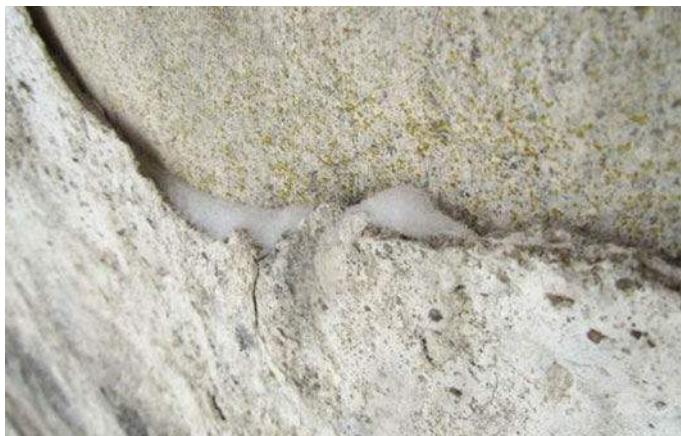
Fig. 11 Damaged plaster contributes to wetting of the wall and accelerated corrosion of the building components

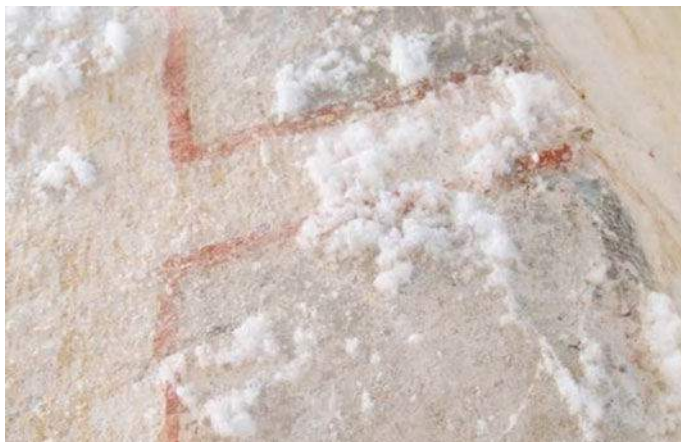
Fig. 12 Efflorescence of salts can disfigure and ruin historic paintings

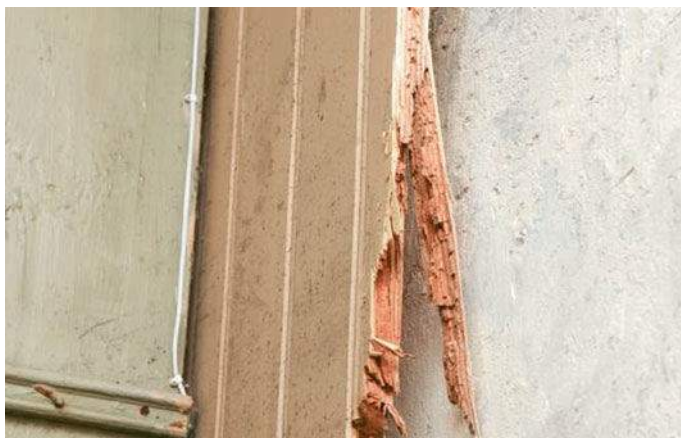
Fig. 13 Rotten wooden cladding on the interior surface of the wall—covering up wet masonry wall causes high levels of relative humidity in the space between—suitable for mould and rot growth

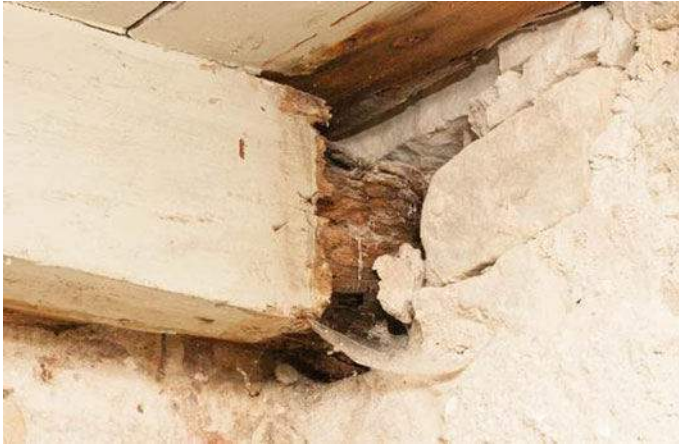
Fig. 14 Wooden beam has become a suitable habitat for rot. Wooden cladding on the interior surface has speeded up the process

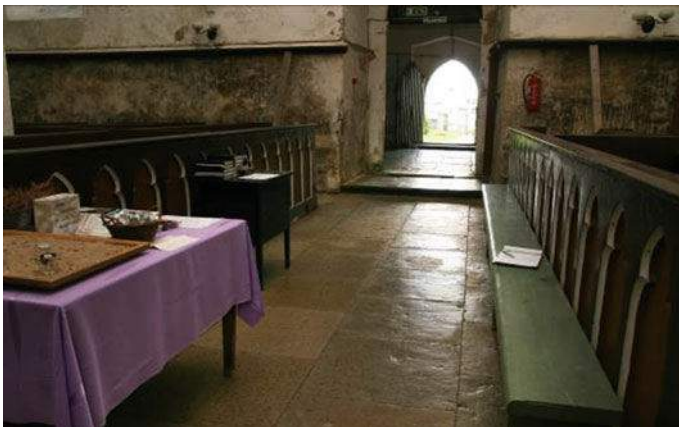
Fig. 15 Condensation on cold surfaces due to ventilation with moist air is an important factor in wetting of the structures (note the reflection from the moist floor)

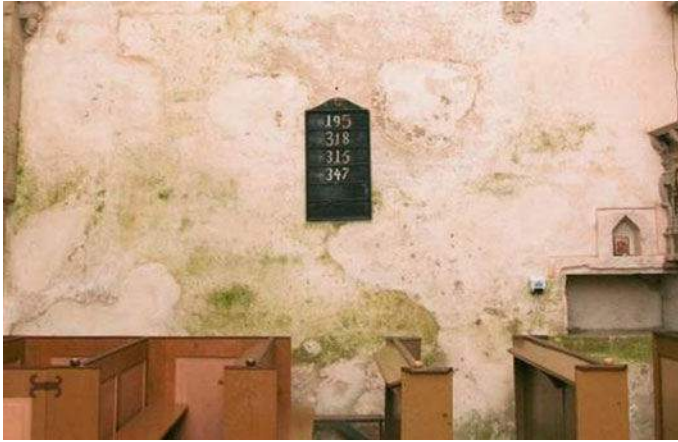
Fig. 16 Flaking due to crystallization of salts and growth of pink bacteria and algae is also visible

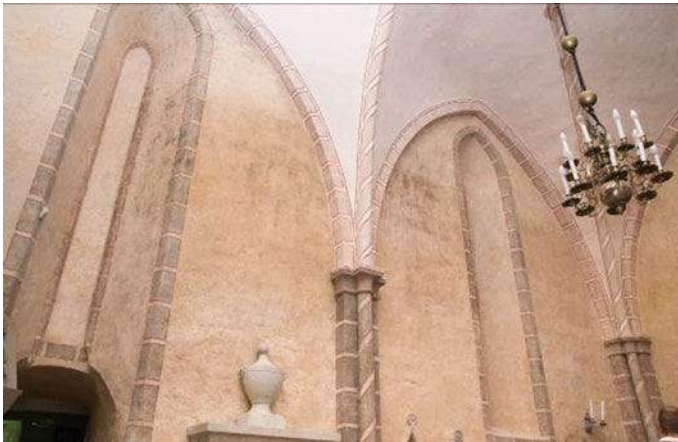
Fig. 17 Growth of mould and pink bacteria can indicate moist surfaces and cause discoloration.

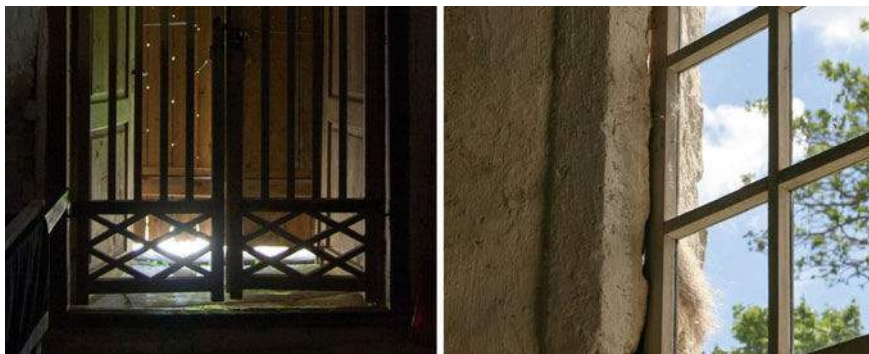
Fig. 18 Airtightness of the openings was visibly low

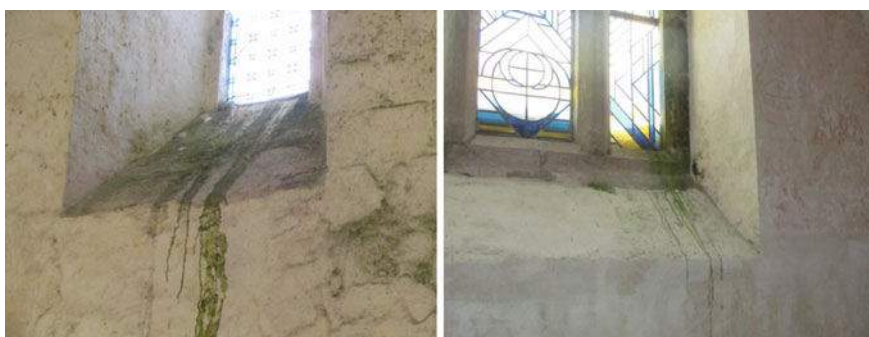
Fig. 20 Results of surface condensation and leaks on the interior surfaces of window sills: growth of algae, salt efflorescence

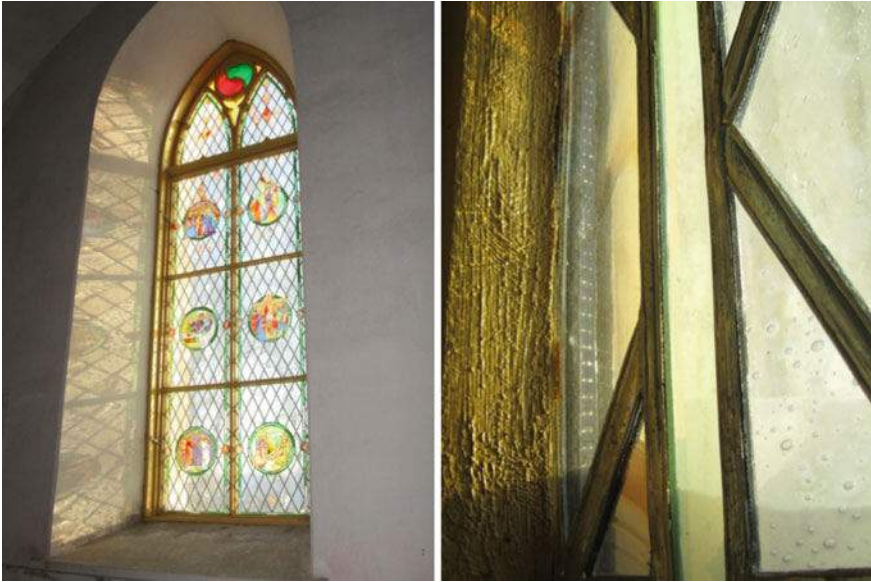
Fig. 21 A modern glazing unit on the exterior side of the historic window preserves the original appearance while reducing thermal conductivity and air leakages

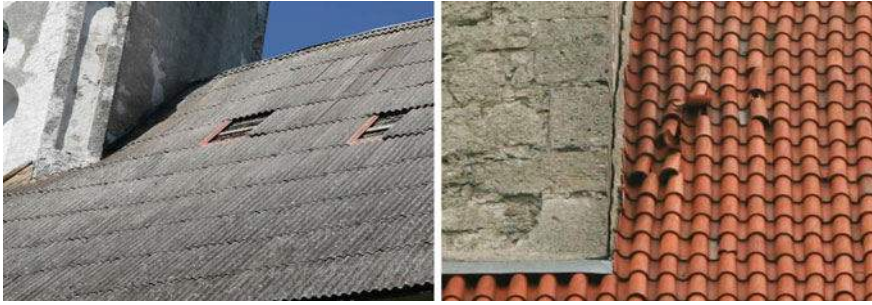
Fig. 24 *Left* Loss of already one sheet of cement fibreboard roofing causes a serious problem—large area of the roof is exposed to the elements. *Right* Displaced monk and nun type of tiles cannot be refitted from the inside and due to the lack of specialized equipment, the leaks in rural areas might be exist for a long time

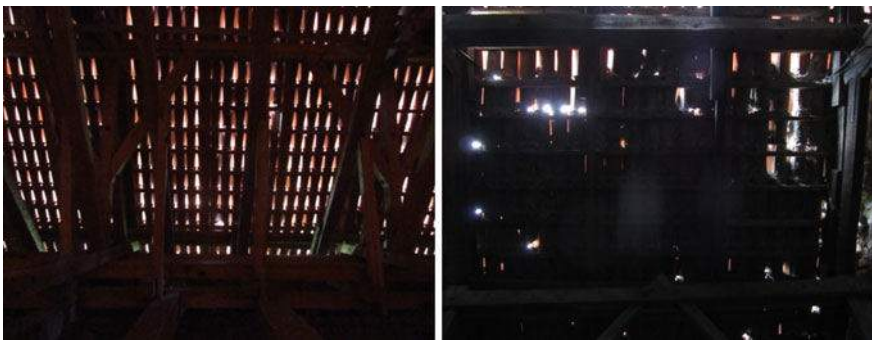
Fig. 25 Tile roofs require underlayment—driving rain and snow cause additional moisture load on the building, underlayment also provides additional protection in case of loss of tiles

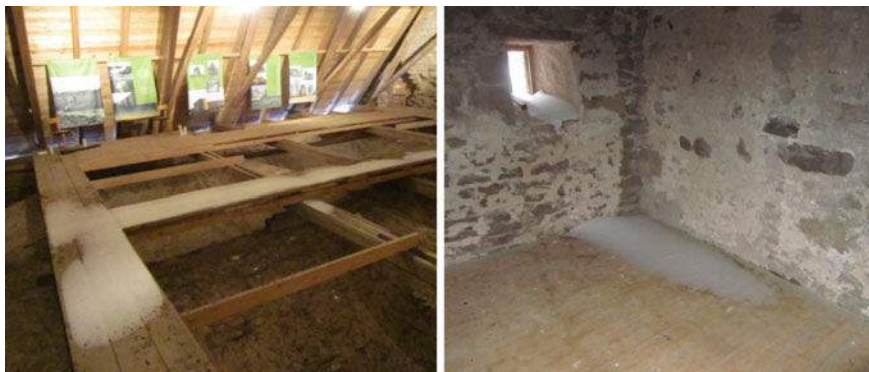
Fig. 26 *Left* Snow has penetrated the roofing and will cause an additional moisture load on the structure once it melts. *Right* Snow has penetrated a window

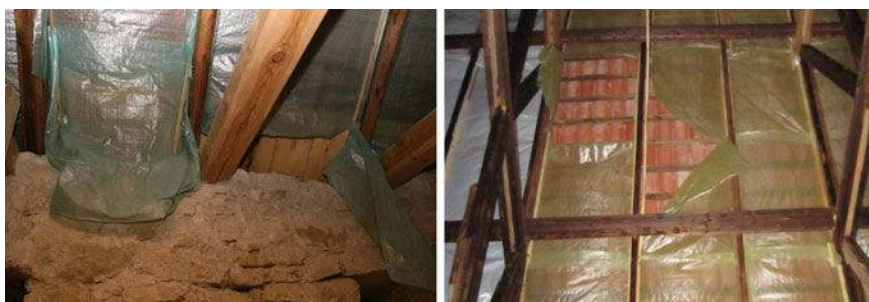
Fig. 27 Underlayment added after the main roofing has lower reliability, safe drainage of water may also be difficult to accomplish

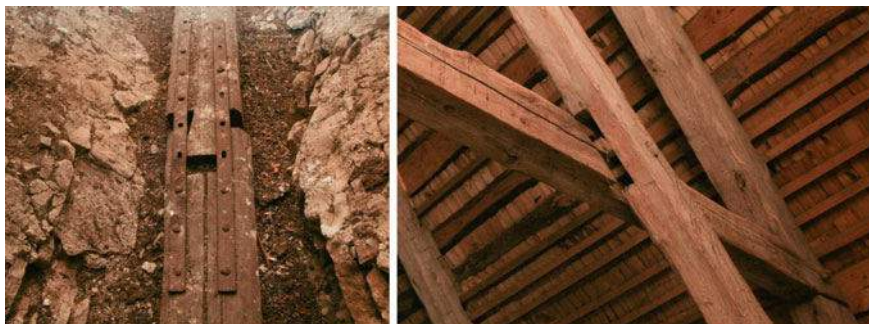
Fig. 28 *Left* Deformed bottom splice causes a change in the truss geometry and possibly an additional lateral load on the walls. *Right* Connection with wooden pin needs urgent intervention

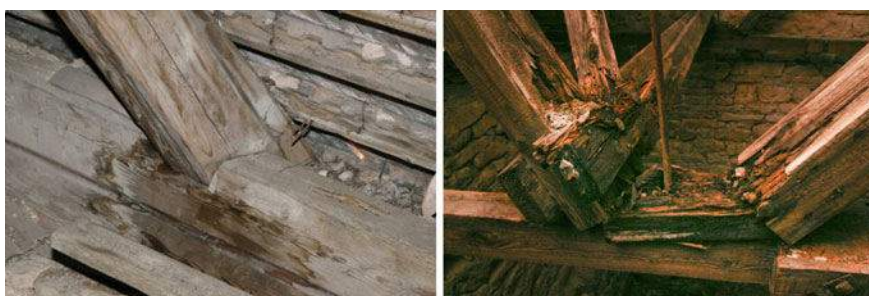
Fig. 29 *Left* Leaks and contact with a moist wall cause wood decay. *Right* Almost fully decayed connection needs prompt repairs
