Building Pathology and Rehabilitation

João M.P.Q. Delgado *Editor*

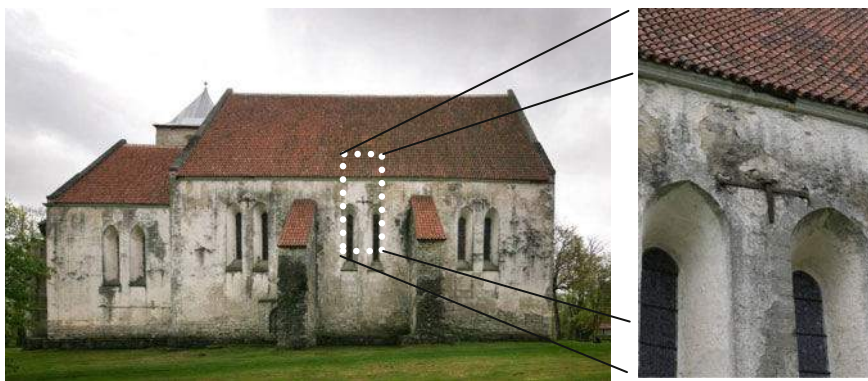
Fig. 30 Narrow eaves without rainwater disposal systems offer no protection against driving rain while being a contributing factor to the wetting of the structure and also to the damage on the interior surface

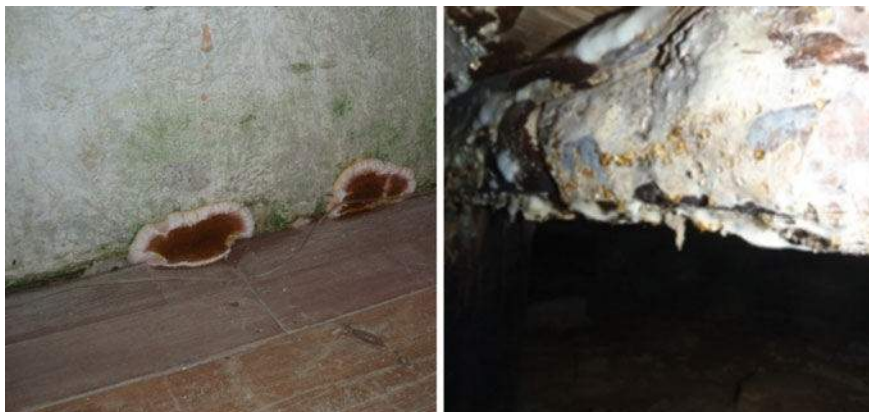
Fig. 31 Wooden floor infected with rot causing fungi from the top (*left*) and below (*right*)

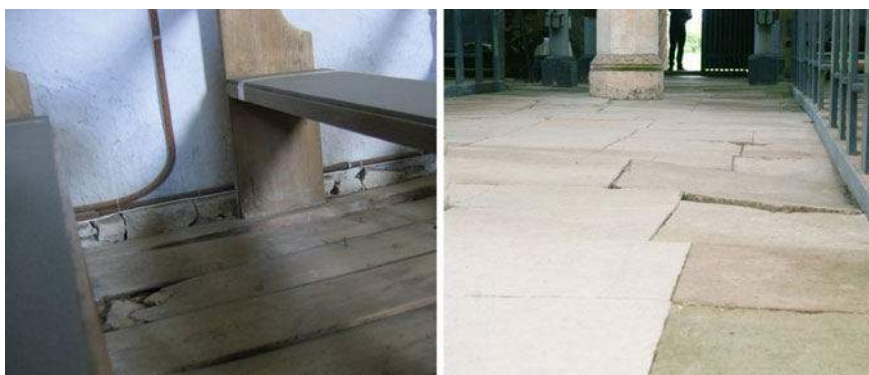
Fig. 32 *Left* Wooden floor with fungal infection. *Right* Uneven stone floor

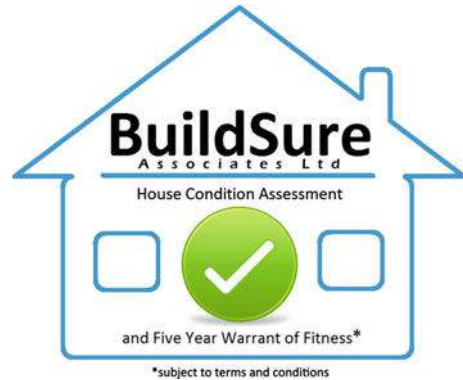
Fig. 1 House condition assessment logo

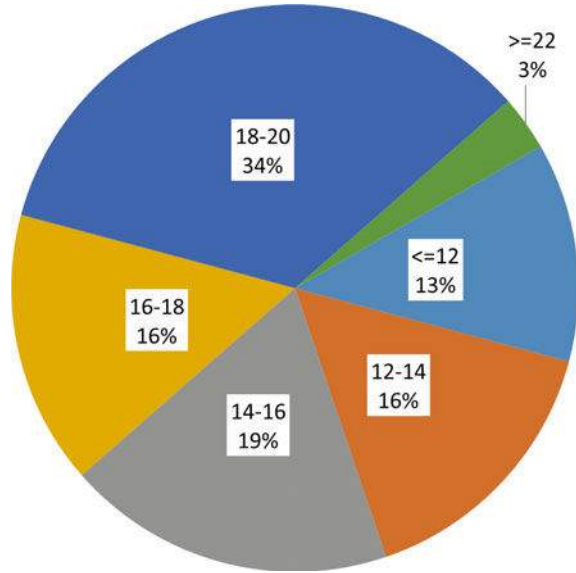
Fig. 4 Debris resulting from a nearby stream flooding

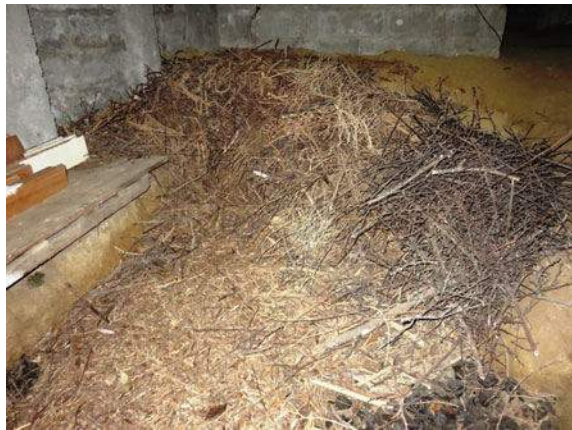
Although perhaps an extreme example, Fig. 4 shows the collection of debris found underneath a house. These had been deposited as a result of heavy rainfall leading to the nearby stream overflowing its banks, flooding neighboring properties. The flood waters carried the debris into the subfloor area, leaving behind the potential for decay or fire.

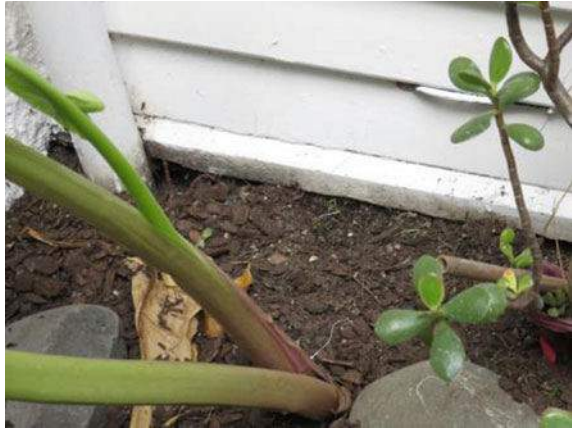
continuous high levels of dampness can delaminate, while timber (even when treated) will rot.

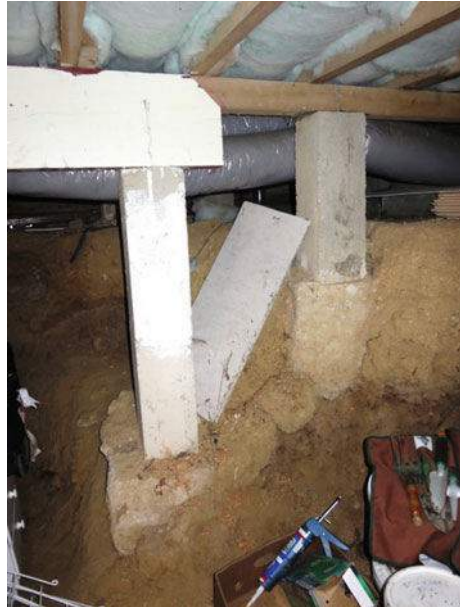
Fig. 7 Untreated floor bearer rests on treated pile

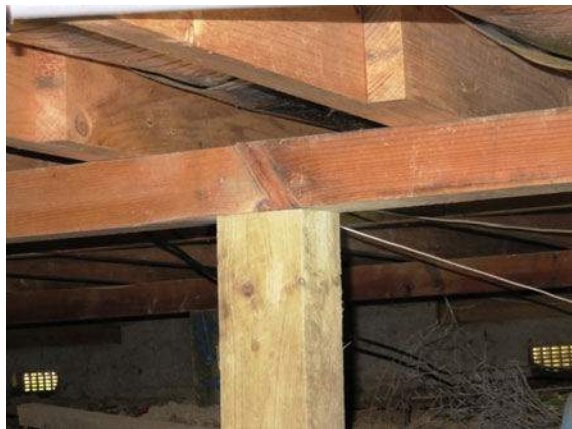
moisture levels as low as 20–25 %. Several fungi, including certain species of *Aspergillus* and *Penicillium*, grow at water activities as low as 0.70–0.80, which correspond to wood moisture contents of approximately 16 %.

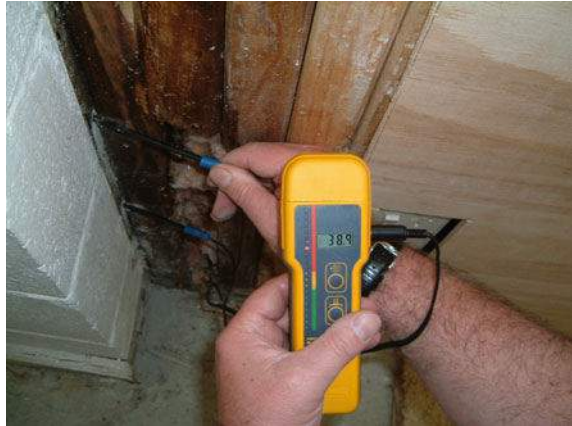
on the inside wall of all external openings, heads, jambs, and sills. Where any other areas visually indicate moisture ingress, then readings are also taken.

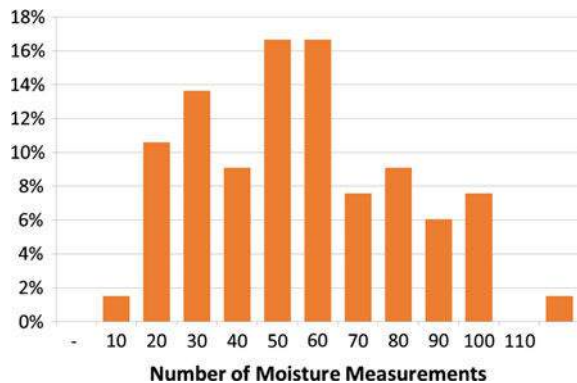
Fig. 10 Houses with mean interior wall moisture level

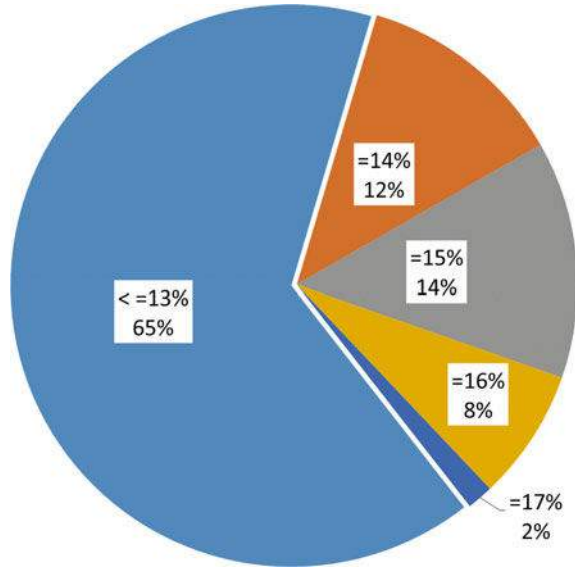
Fig. 11 Houses with given maximum interior wall moisture level

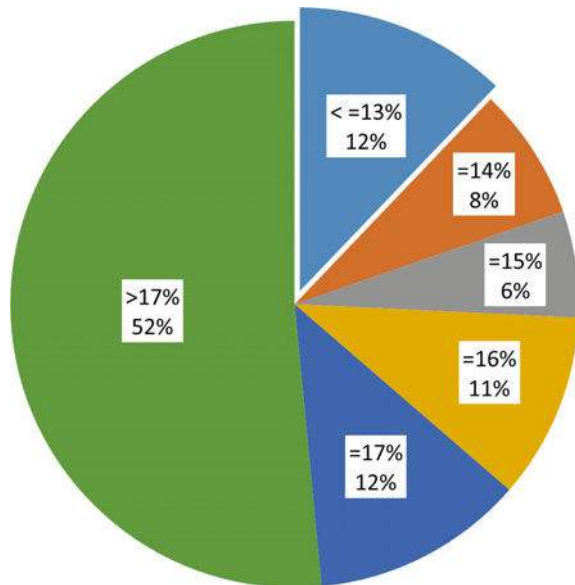
moisture level of below 13 %. In 88 % of the houses, the moisture level was so high in one or more locations as to give concern.

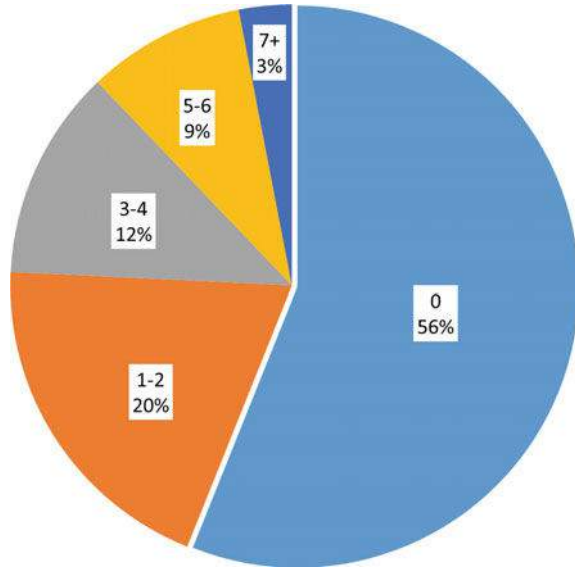
mold growth; and finally, degradation of finishes (paint/wallpaper, etc.). At around 16 % moisture content, fungal attack is likely to occur, with the possibility of danger to occupant’s health (Andrews 2002; Lstiburek 2002). These expectations are matched by the experience of house surveyors. Figure 11 shows this was found nearly a quarter (23 %) of the inspected houses.

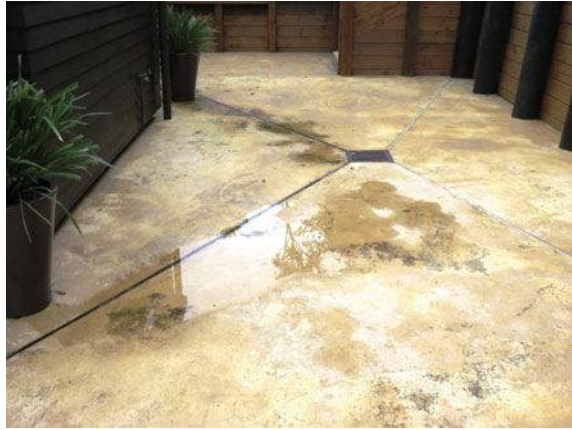
shown in Fig. 4. If regular flooding is likely, then exterior water management work is required.

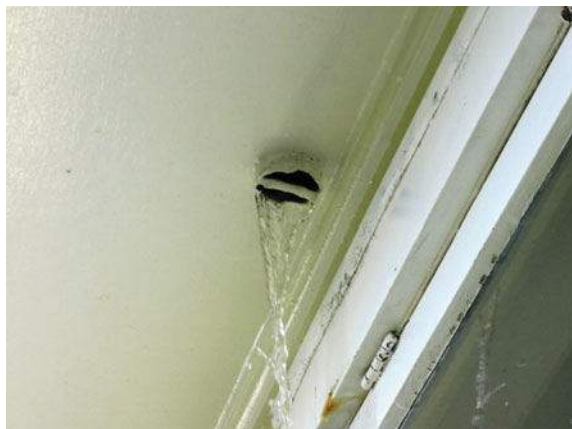
Fig. 15 Guttering blocked by vegetation

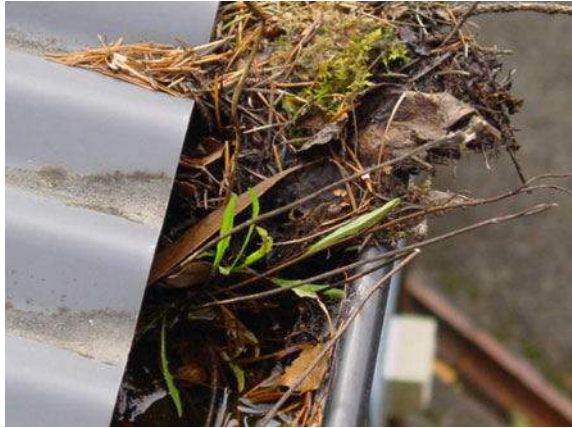
Fig. 16 Gutter joint failure

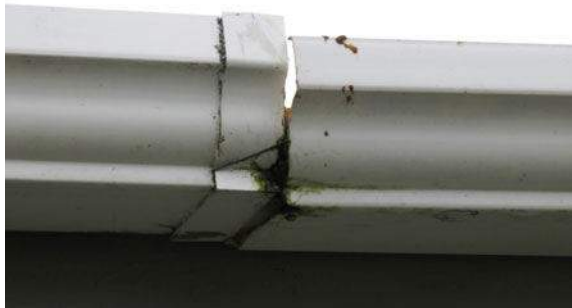
Overhanging vegetation, including trees and creepers, can lead to debris being left in the gutter which may not be either readily visible or removable. Figure 15 shows a gutter blocked by vegetation from nearby trees and plants. Regular maintenance is required; otherwise, the trapped water can lead to corrosion and ultimate failure of the gutter or to overflowing and the delivery of stormwater to areas ill-equipped to deal with it.

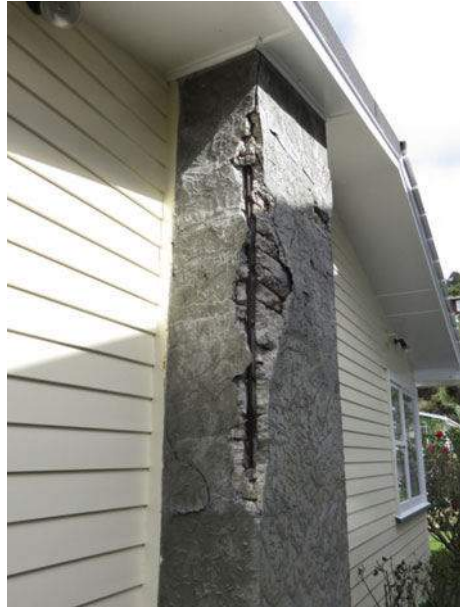
steel reinforcing rusting. As the rust occupies a greater volume than the steel from which it is originated, the expansion can push off the external concrete, exposing the steel and creating a cycle of self-destruction.

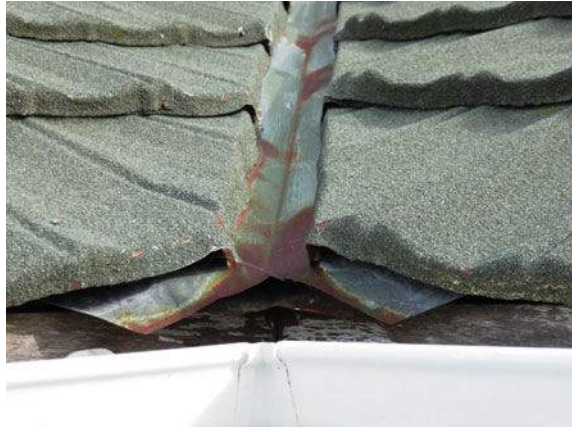
6.7 *Fungal, Plant, and Animal Impacts*

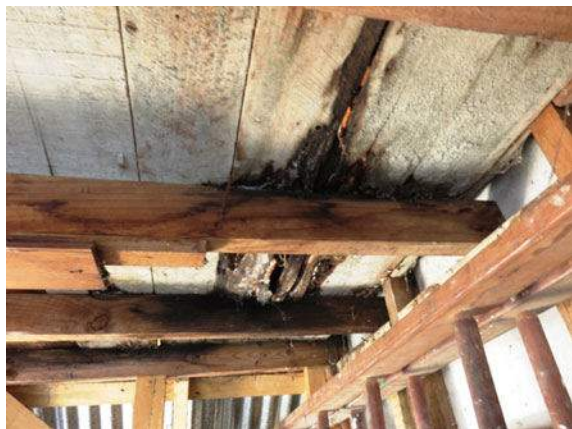
Fig. 20 Weatherboard decay probably due to ground moisture

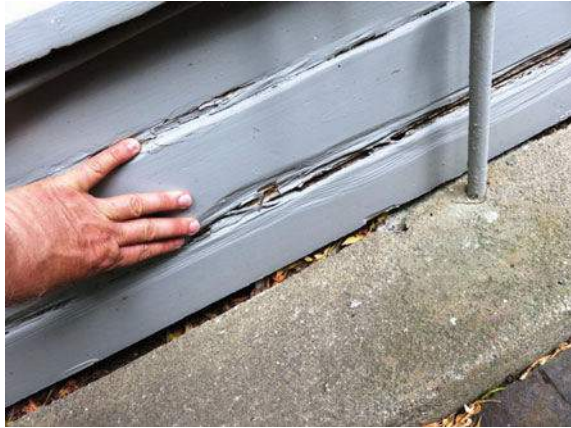
borer has a similar impact to woodworms found in other countries. The flying insect lays its eggs inside timber, originally native timbers, but it adapted well to imported exotic timber. When the eggs hatch, the grub bores its way to the surface before starting the cycle again (BRANZ Ltd 2000; New Zealand Technical Correspondence Institute 1980). Figure 21 shows the lighter colored “frass” which has fallen from the grubs’ flight holes.

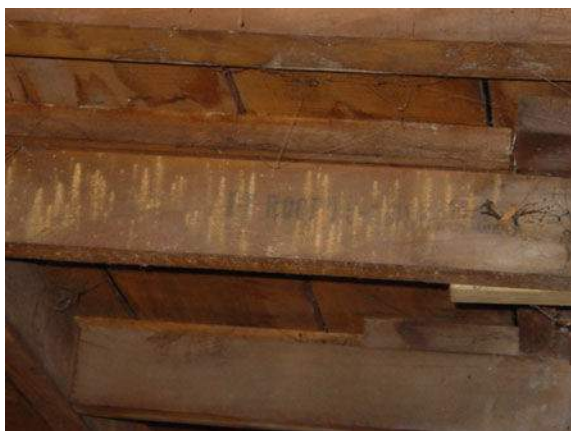
Fig. 22 Insect damage revealed by floor sanding

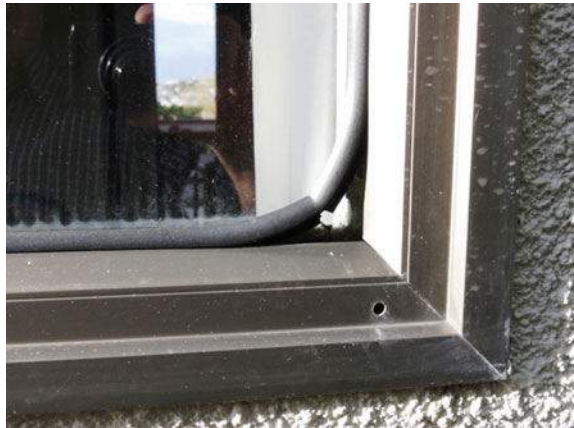
Fig. 24 Poor timber joinery maintenance

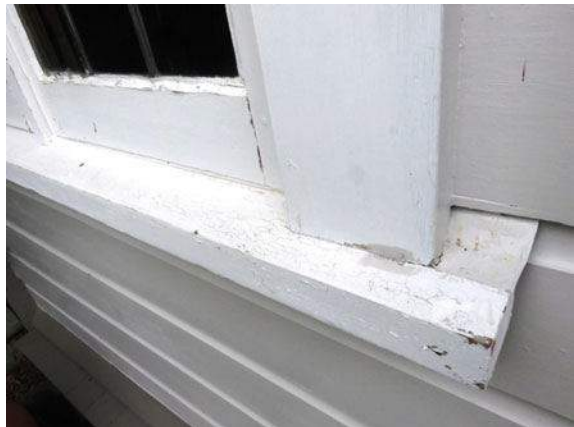
to UV, wind, salt, etc. Where maintenance has been deferred or ignored, cracks between the timber pieces can open or the putty holding the glass in place can fail. An early repair can minimize costs, but eventually, the failure can reach a level where the only solution is complete replacement of the joinery.

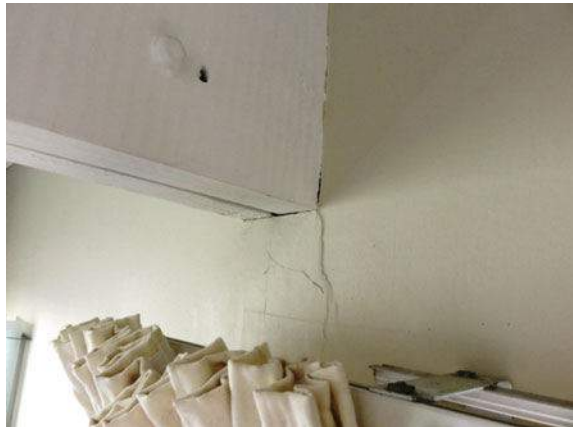
Fig. 26 Crack in monolithic cladding allows water ingress

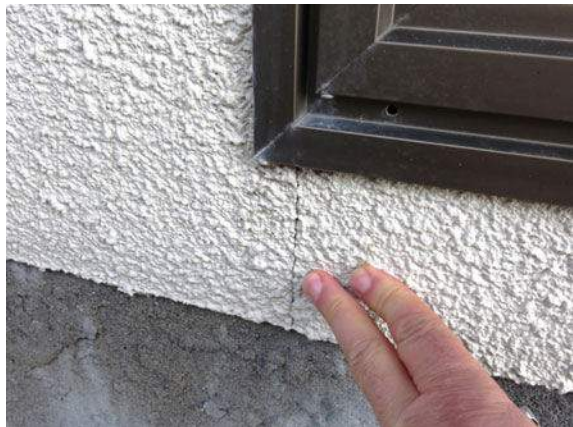
knowledge and skill not just of the material but also the use of flashings and the conditions likely to be created behind the panels. Over the 1990s to early 2000s, this led to the so-called leaky buildings problem. Large numbers of houses and apartments built during this time are expected to require significant investment to correct the problem (Hunn et al. 2002). This part of the inspection can be essential for the inexperienced purchaser.

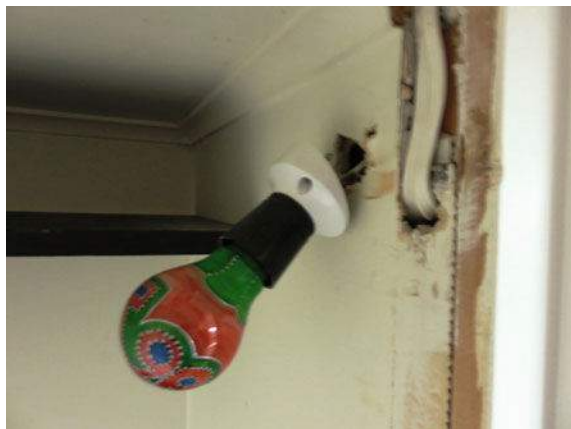
Fig. 28 Three generations of wiring insulation—only one is safe

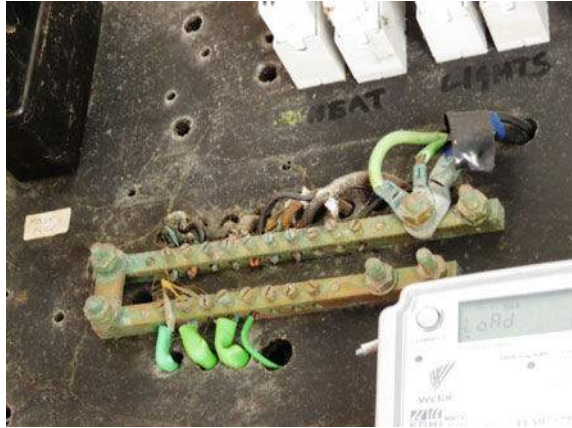
Figure 28 shows a close-up of an electrical switchboard in an older house with three generations of electrical cable visible. The older rubber-insulated cables need to be replaced to reduce the risk of fire.

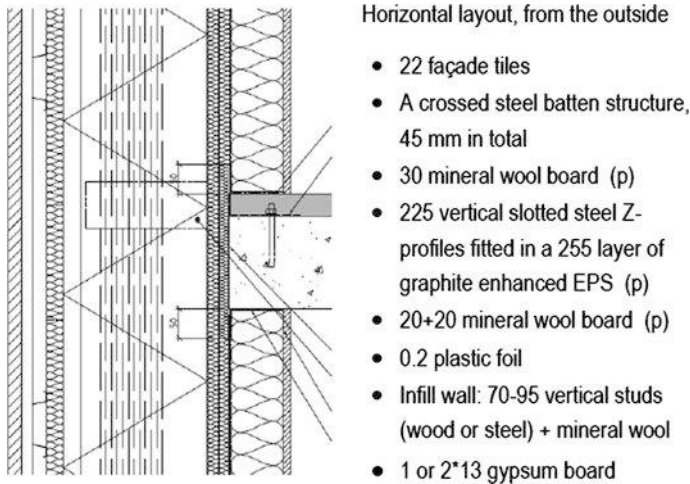
Fig. 2 Design of the wall element System B. Picture from Martinsson (2012)

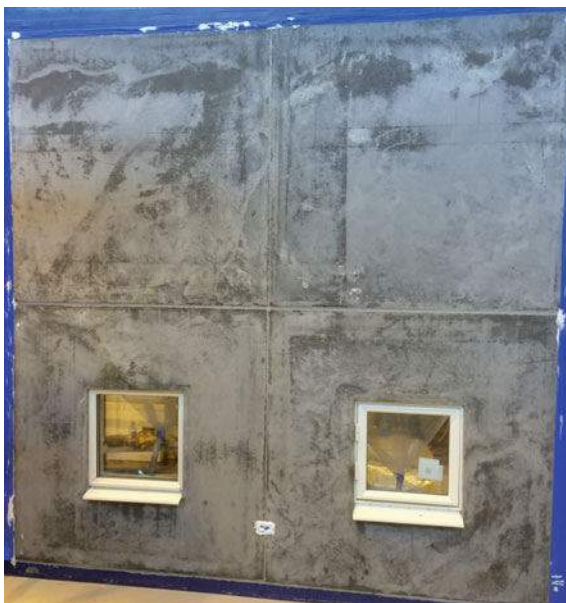
5 Experience from Using the Prefabricated Systems on Site

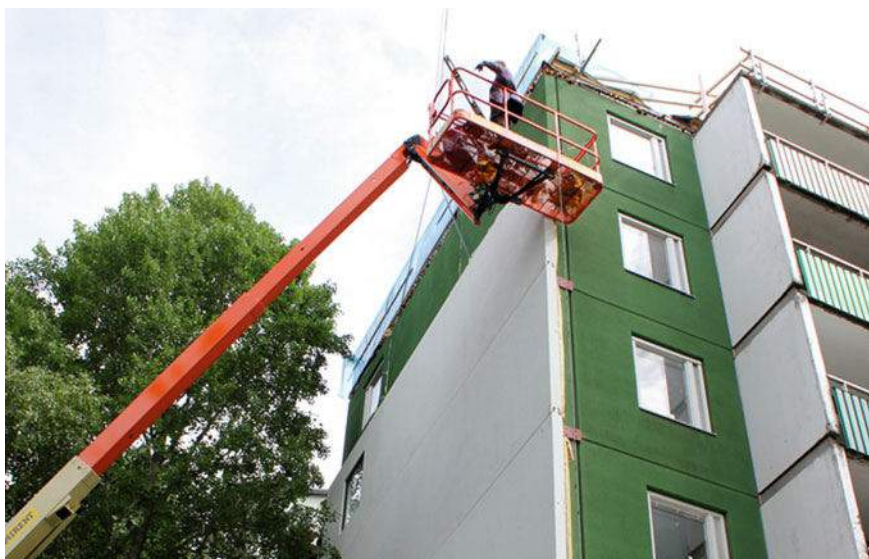
Fig. 5 Mounting of prefabricated elements was done with crane and sky lift

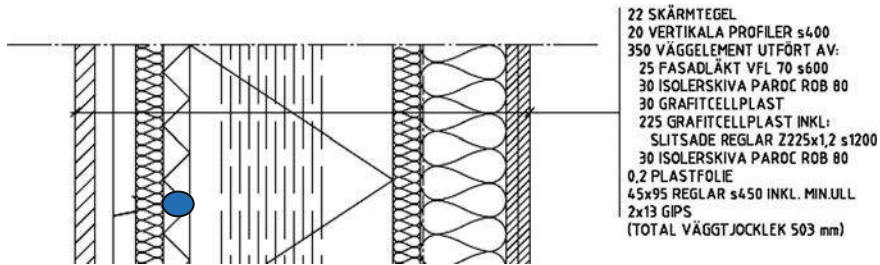
Fig. 10 Placement of gauges measuring relative humidity and temperature

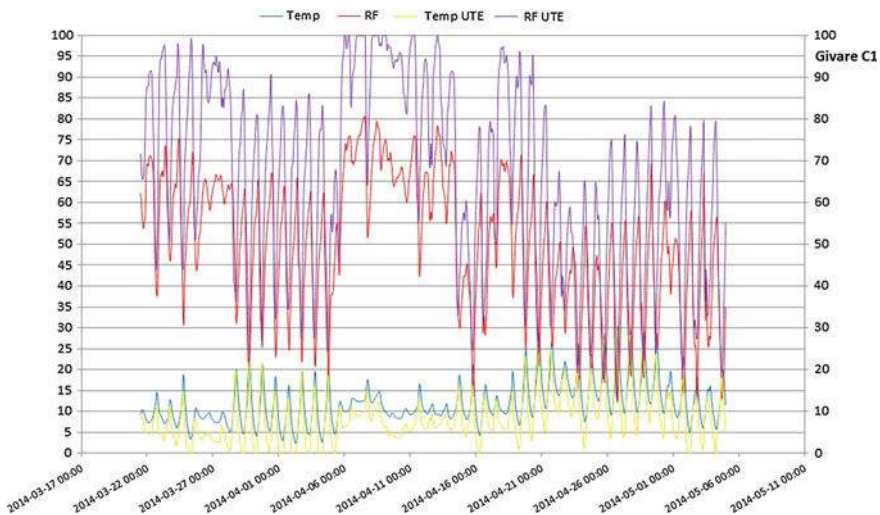
Fig. 11 An example of measured RH and temperature in the prefabricated wall element

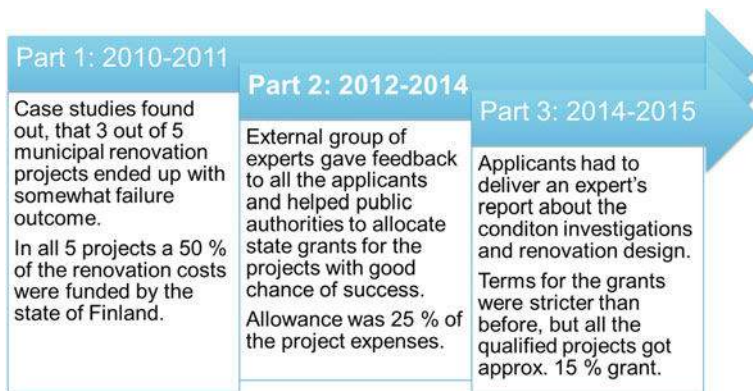
Fig. 1 Timeline of the research and development of the state grant procedures in Finland

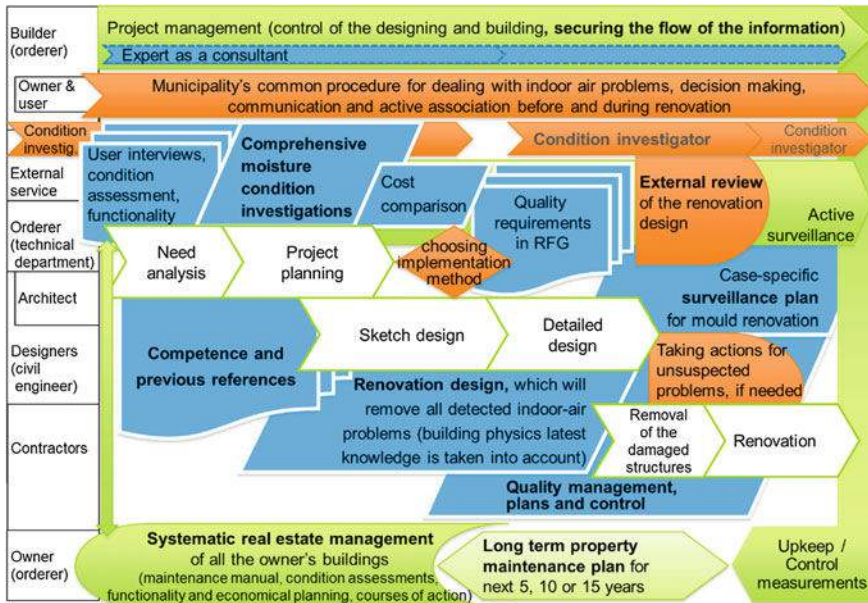
Fig. 3 Phases of the successful mould renovation

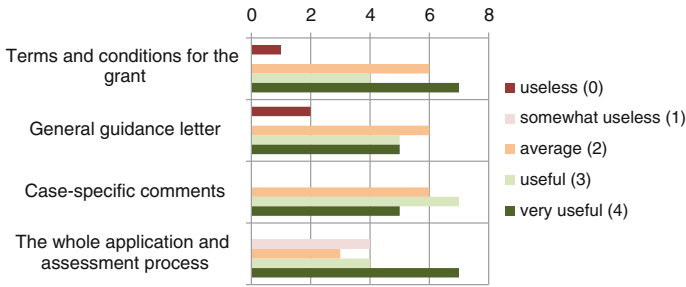
Fig. 4 Interviewees’ opinions about the different phases and the entirety of the application process. Scale is from 0 to 4, and 18 responses was collected. Length of the bar indicates the amount of opinions to the specific subject

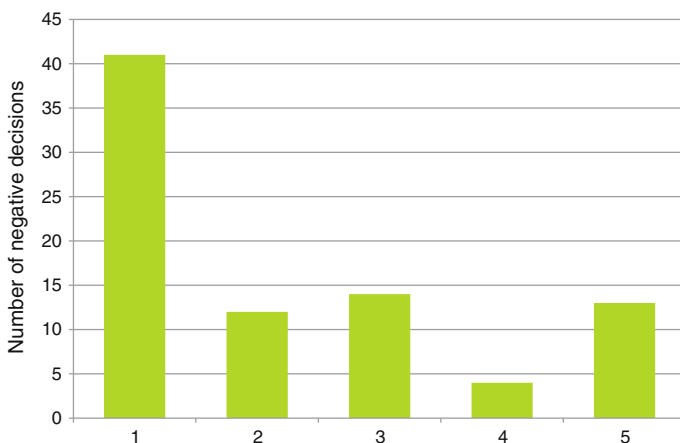
Fig. 5 Reasons for rejecting applications

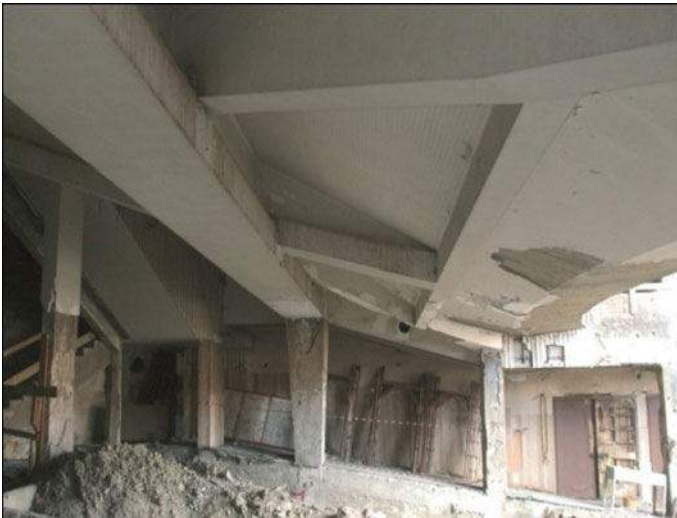
Fig. 5 The stall area view

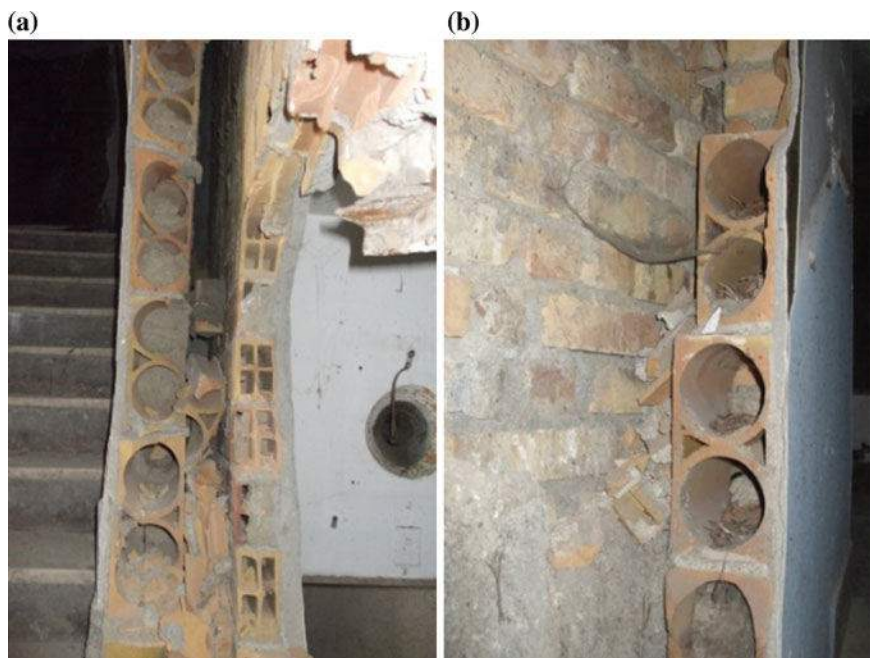
Fig. 7 Walls with “goggles”. **a** Wall with “goggles” type 1; **b** Wall with “goggles” type 2

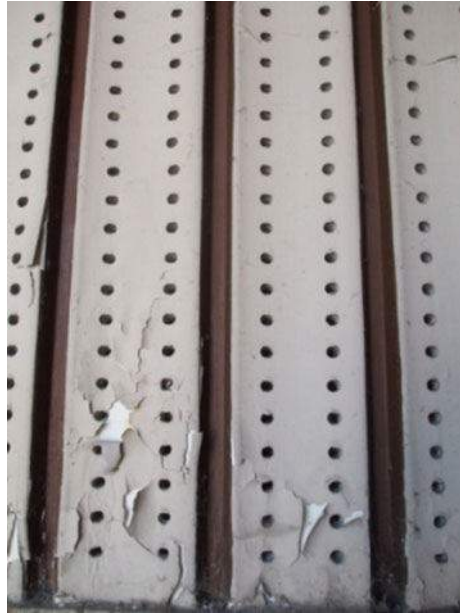
The horizontal elements, such as roofs and floors are made partly of hollow-core concrete and partly of reinforced concrete slabs, which were found in the steps of the circle and in the vaulted ceilings. The material survey made it possible to identify the different types of brick used, the various types of masonry adopted and the thickness of some walls that could not be measured easily. As for the cladding and finishing materials, it is important to note the acoustic panels, which can be divided into grooved, perforated panels in pink plaster, used for cladding the walls inside the theatre, and other grooved panels in blue plaster, in the foyer that were fixed onto a wooden framework (Fig. 9).

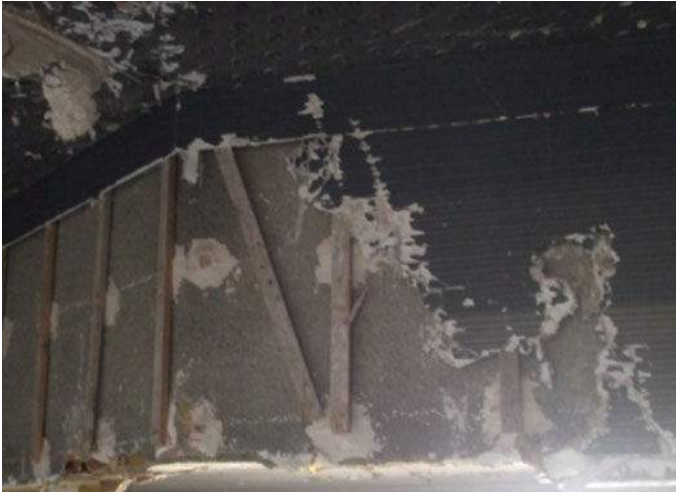
Fig. 9 Acoustic grooved panels in blue plaster

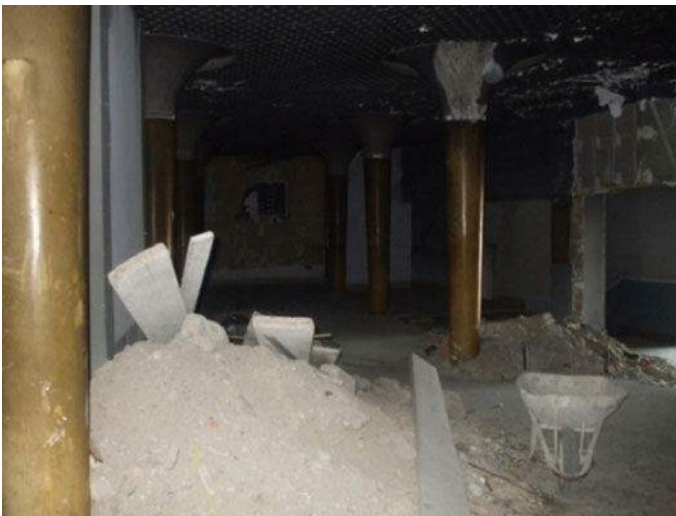
Fig. 10 Degradation of the foyer

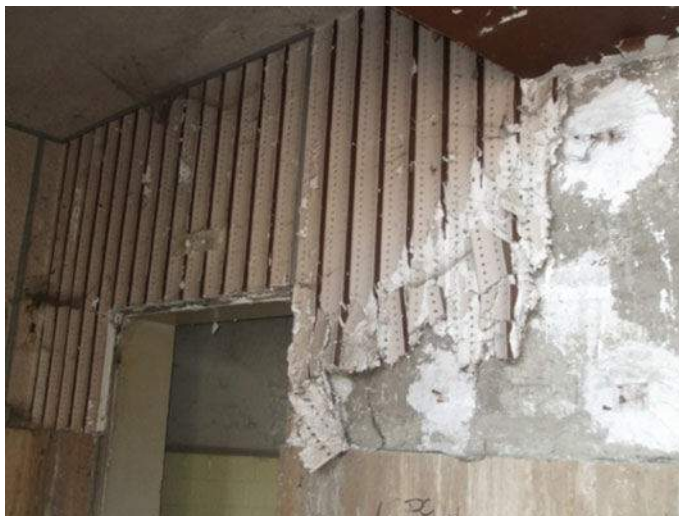
Fig. 11 Degradation of walls in the circle area

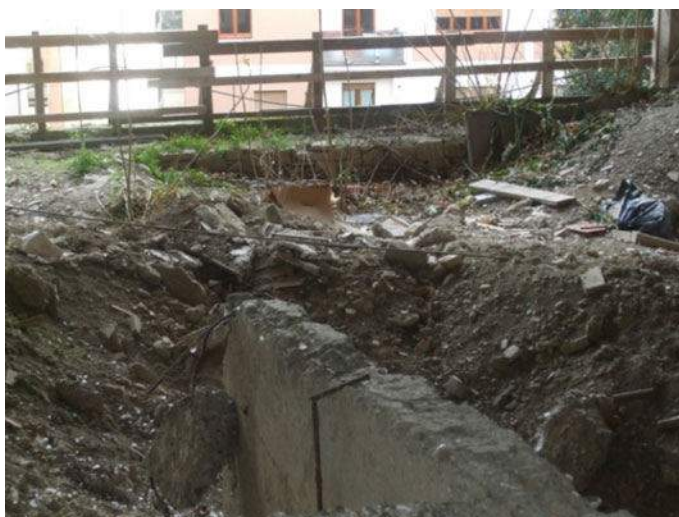
Fig. 12 Degradation of the stall area

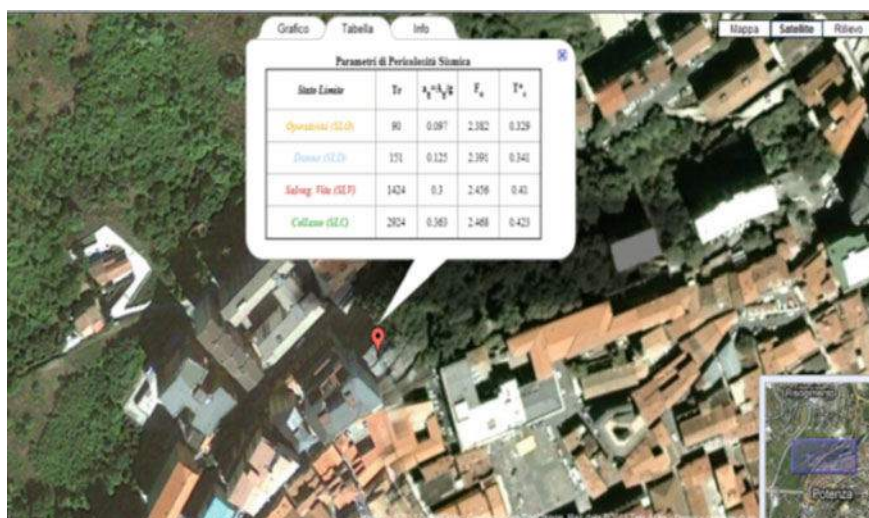
Fig. 15 Parameters of seismic hazard of the Cinema Ariston

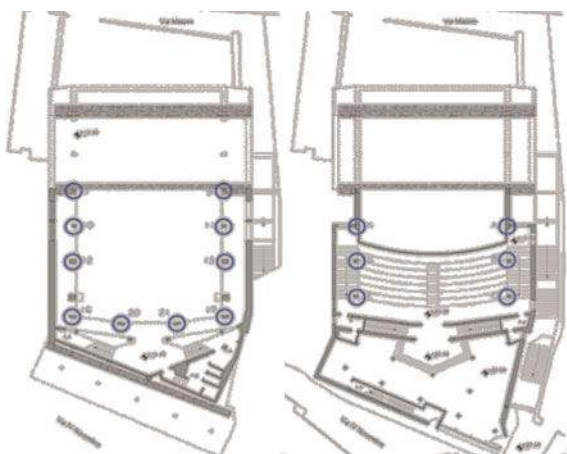
Fig. 17 Cladding of the structural elements in reinforced concrete

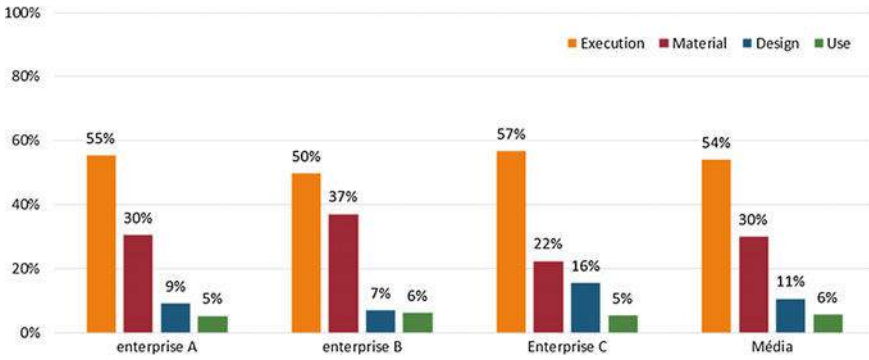
Fig. 1 Most likely causes of the plumbing system pathologies

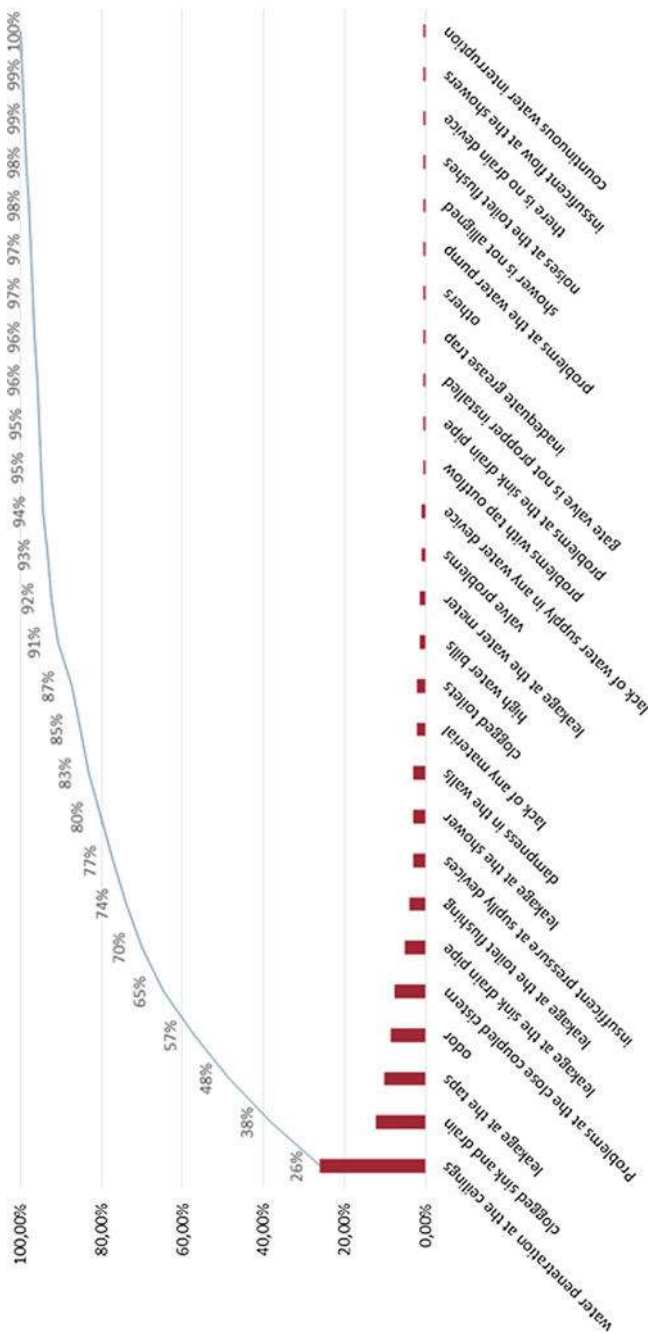
Fig. 2 Main reported requests related to hydraulic and sanitary facilities

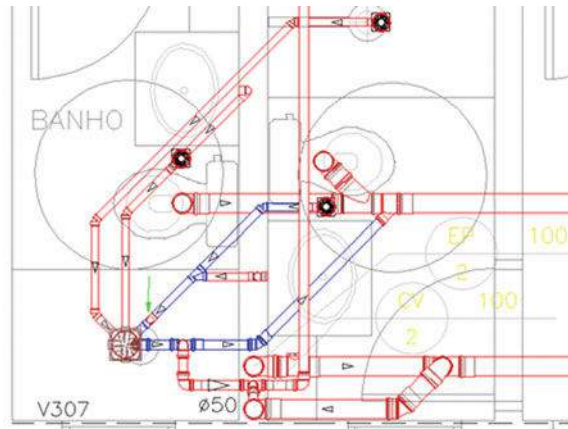
might be supposed. One of the major factors that can lead to frequent clogging is the connections used in pipes and deviations from the prescribed slope.

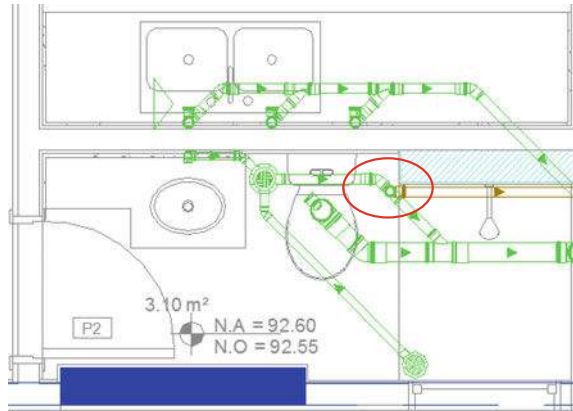
This could easily be avoided by replacing the use of a 45° junction in all horizontal deviation, as shown in Fig. 6.

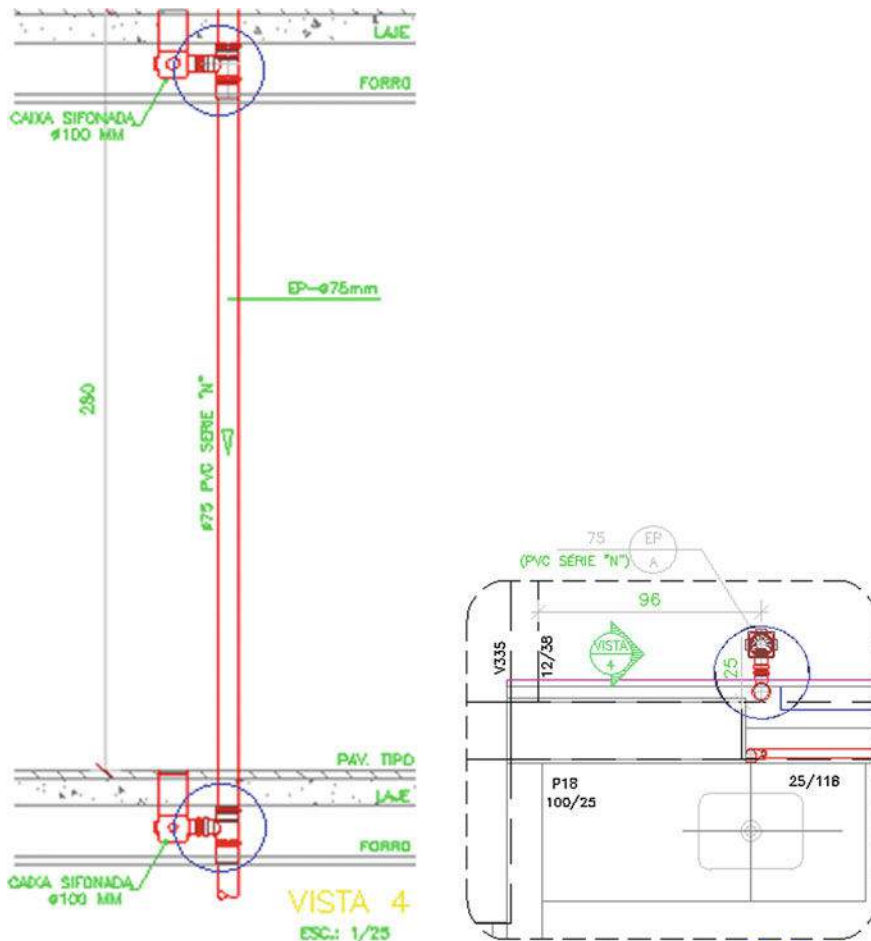
Fig. 7 Detail of siphoned box and sewage downpipe connection

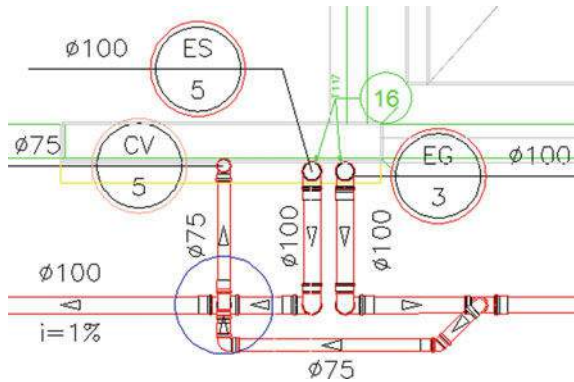
Fig. 11 Ventilation branch at the different level of the sewage pipes

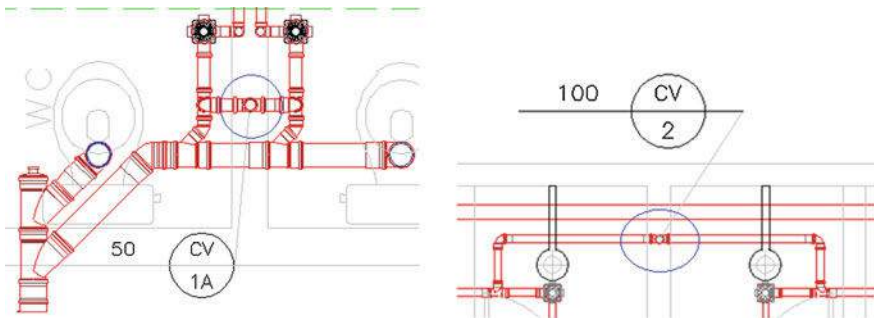
Fig. 12 Inappropriate ventilation loop

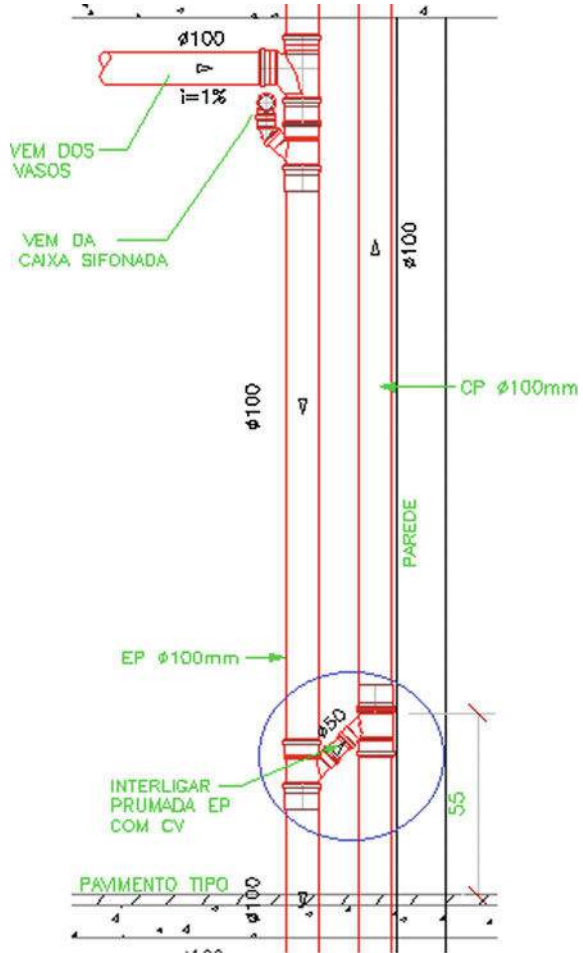
Fig. 15 Connection of the stack to the venting system according to the standard. Source ABNT (1999)

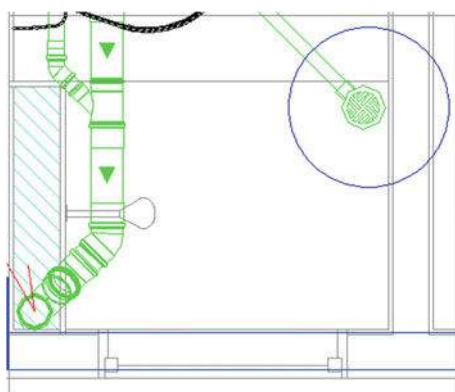
3.6 Analysis of the Results

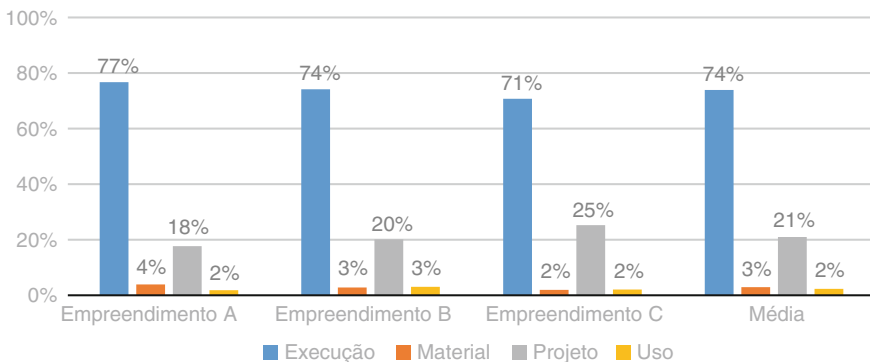
Fig. 18 Most likely causes of the plumbing system pathologies after reported reclassification

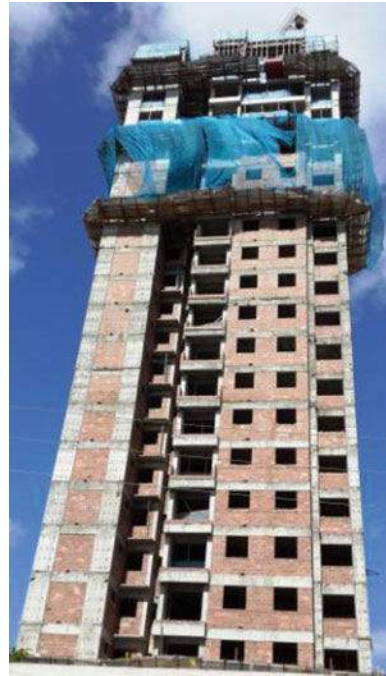
In contrast, wall partition masonries suffer from the reduced capacity to absorb deformations, resulting from the increased rigidity with the advent of more resistant and larger hollowed blocks as well as by the connection with the structure.

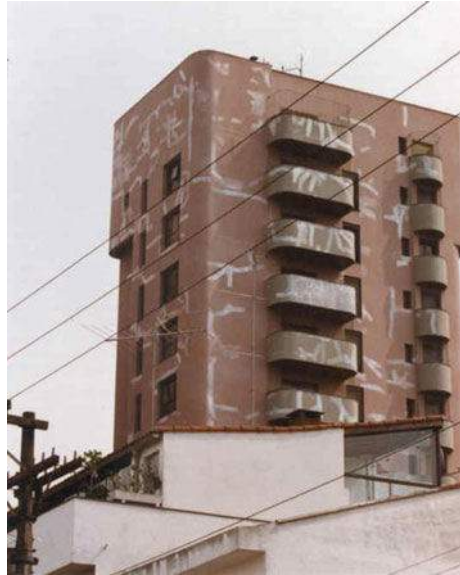
point of view, many of the user requirements are compromised: impermeability; the hygrothermal comfort; the visual comfort; the acoustic comfort; the tactile comfort and durability, as analysed by Martins (2010), Oliveira et al. (2010) and Silva and Abrantes (2007).

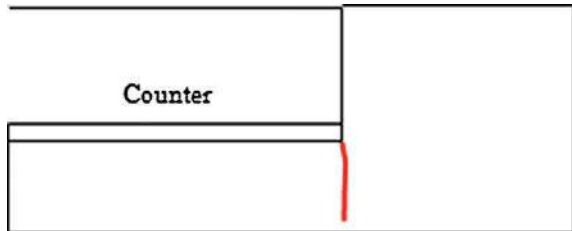
Fig. 6 Wall of the bathroom door and wall on the left

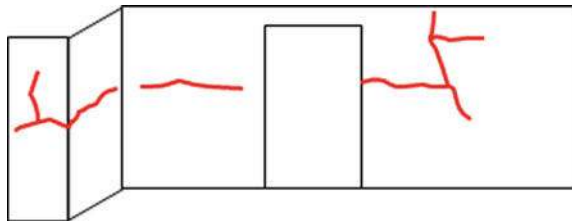
The cracks verified in the bathroom shafts are manifested on the mortar coating and also on the masonry partition walls. It was possible to verify in this region (Fig. 13), that the mortar coating was 5 cm thick [contrary to standard specifications (Costa 2012)], being the wall supported on a very deformable slab.

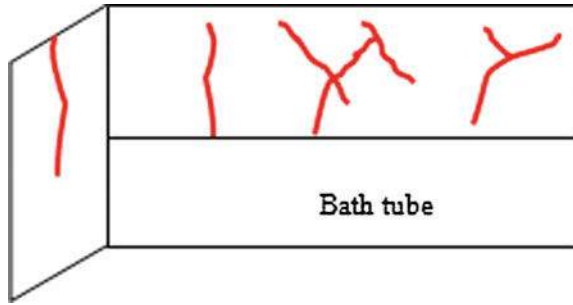
Fig. 8 Division wall living/bedroom

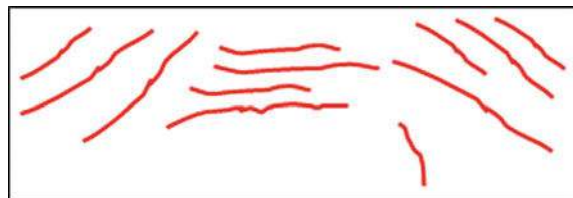
Fig. 11 Wall of the air conditioning room (mezzanine)

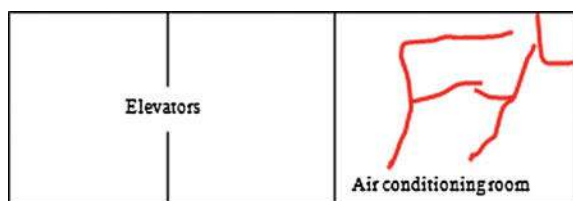
Fig. 12 Wall of the business center (mezzanine)

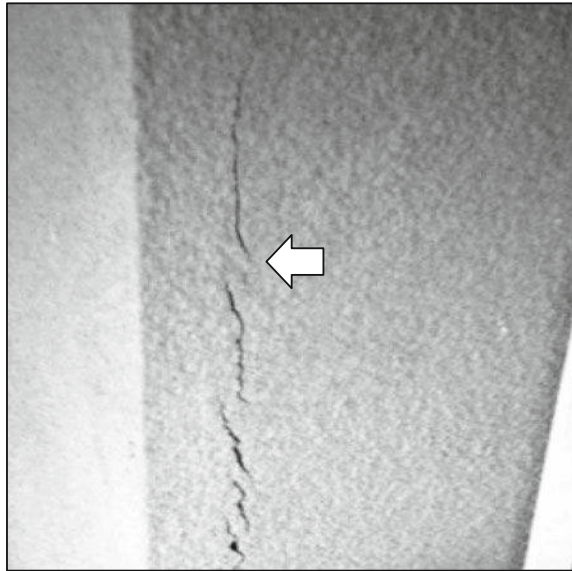
According to Franco et al. (1994), slabs with thickness inferior to $C/60$ and beams under $C/16$ high are considered highly deformable elements, where C is the length of the wall.

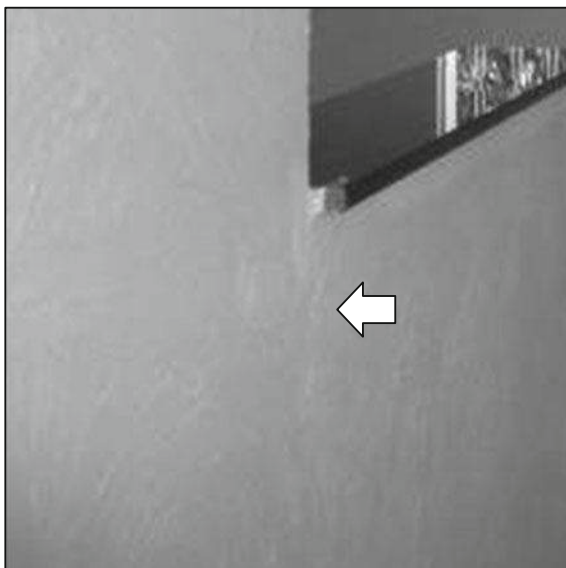
Cracks with mapped configuration observed in coatings above the bath tubs were probably caused by the retraction of mortar. The humidity loss at early stages triggers retraction movements, which generate internal traction stresses and hence, the fissuring of the coating.

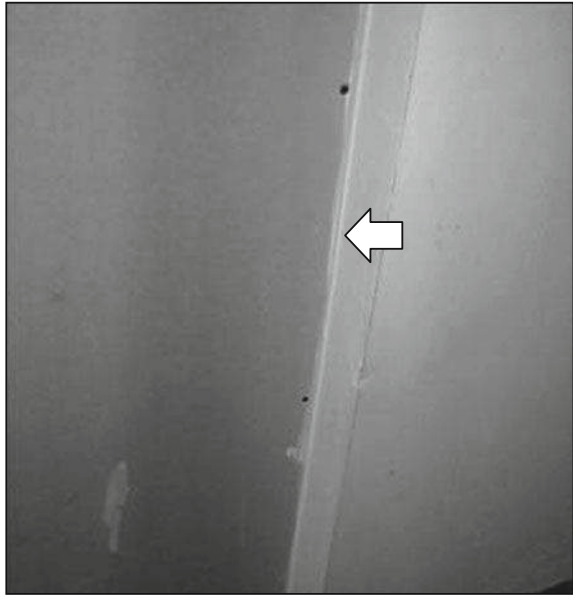
Fig. 16 The vertical crack on the corner of doors in plasterboard walls (not original—just for example)

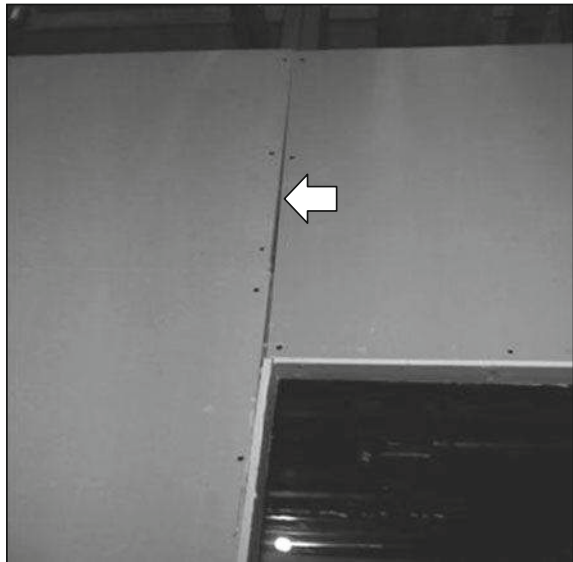
mezzanine, on the walls of the air conditioning business center rooms, are slanted and with analogous orientation, suggesting the occurrence of a more pronounced deformation on the opposite side of the elevator pillars, which are elements of high rigidity.
