Building Pathology and Rehabilitation

João M.P.Q. Delgado *Editor*

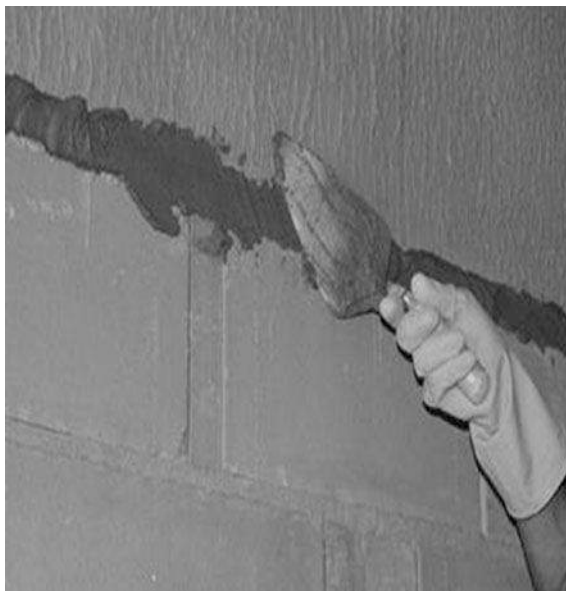
Additionally, in this region the wall is supported on a very deformable slab (10 cm thick).

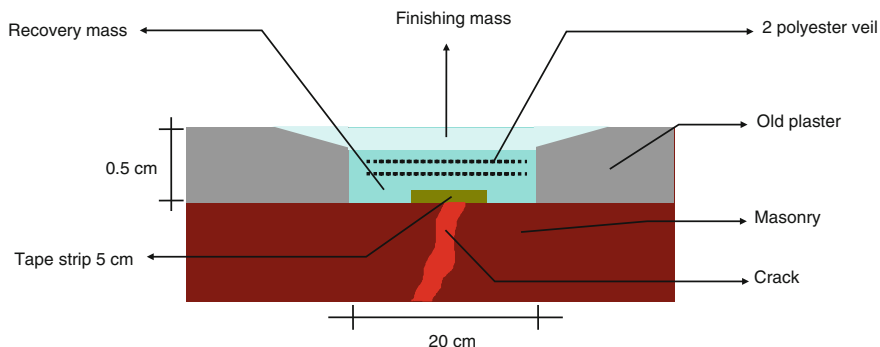
Fig. 18 Overview of the recovery procedure

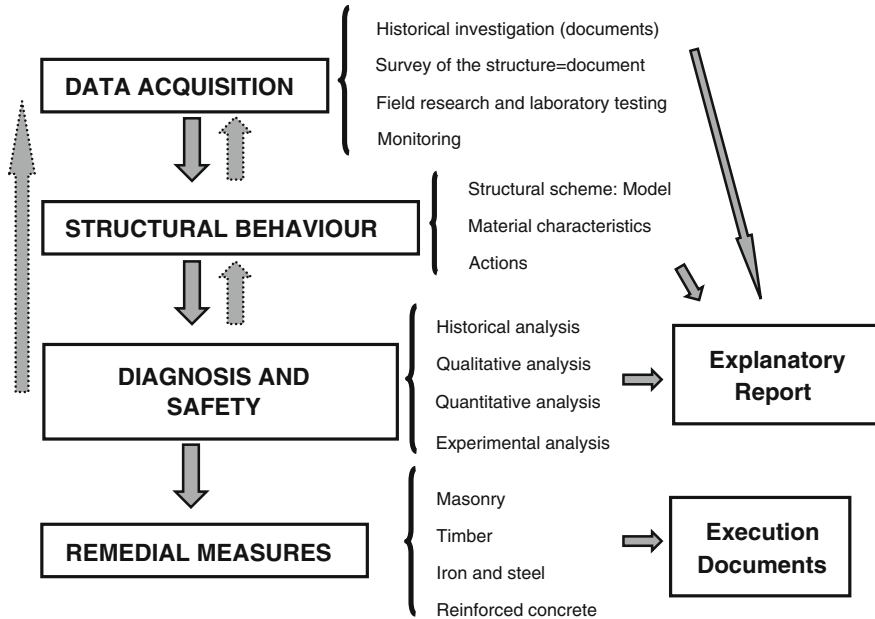
Fig. 1 Flowchart with methodology for structural interventions (ICOMOS 2005)

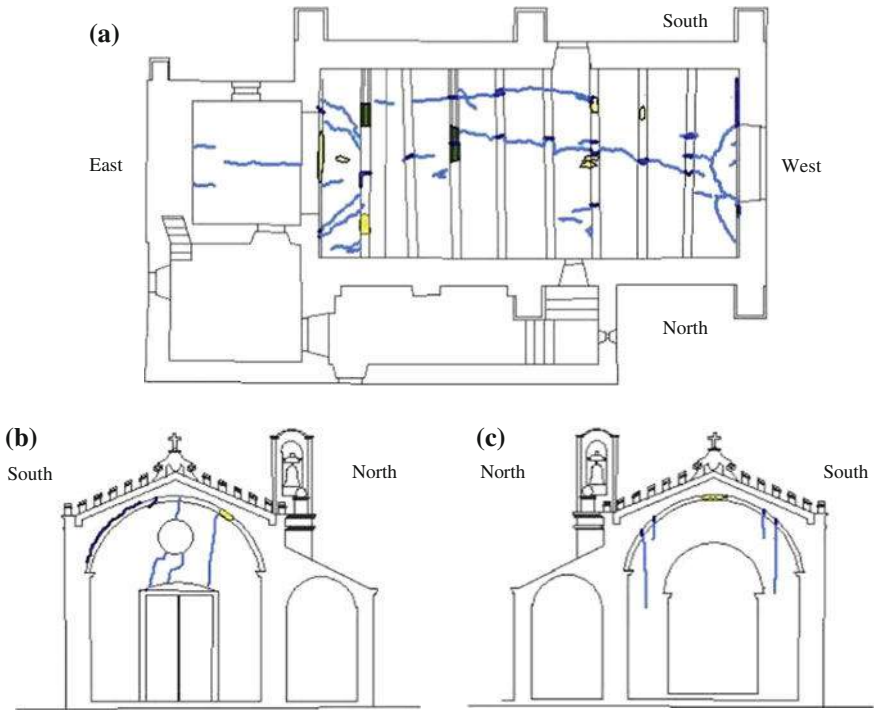
Fig. 5 Crack pattern (interior view): **a** barrer vault of the chancel and nave; **b** main façade; **c** chancel arch

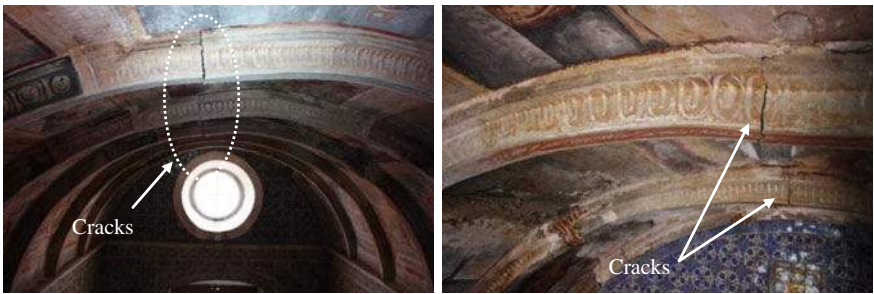
Fig. 6 Cracks at the barrel vault of the nave

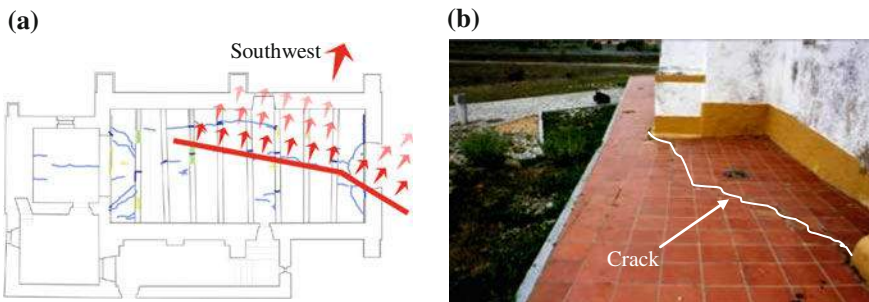
Fig. 7 Deformation of the external floor: **a** direction of the deformation; **b** detail of the crack on the external floor

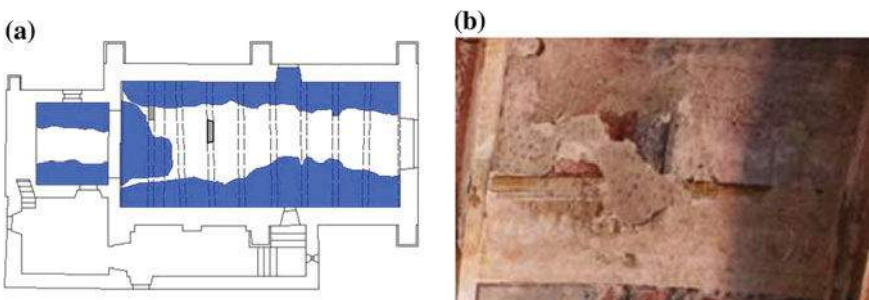
Fig. 8 Damp patches: **a** barrel vaults of the chancel and nave; **b** detail of the deterioration of the paintings at the ceilings of the nave

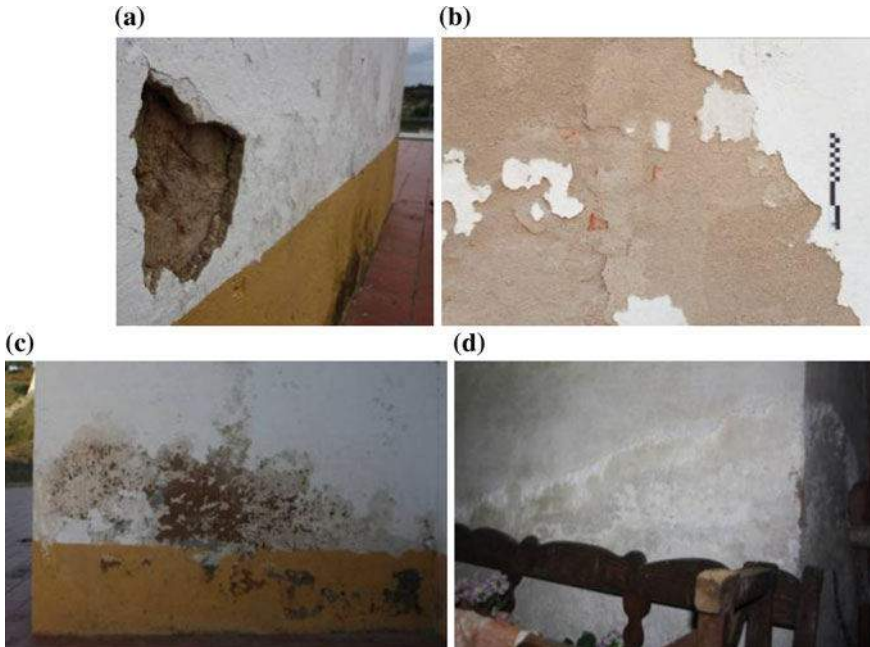
Fig. 9 Damage on the walls: **a** plaster detachment; **b** deterioration of the plaster and paint; **c** rising damp at the external surface; **d** rising damp at the interior surface

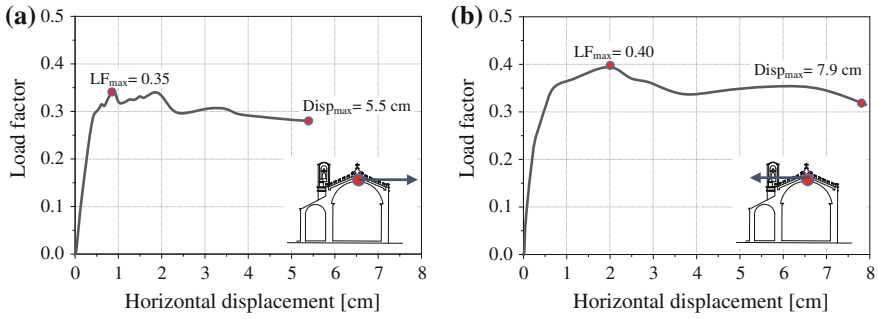
Fig. 14 Capacity curves for the pushover analysis in the transversal direction (X direction): **a** +X direction; **b** -X direction

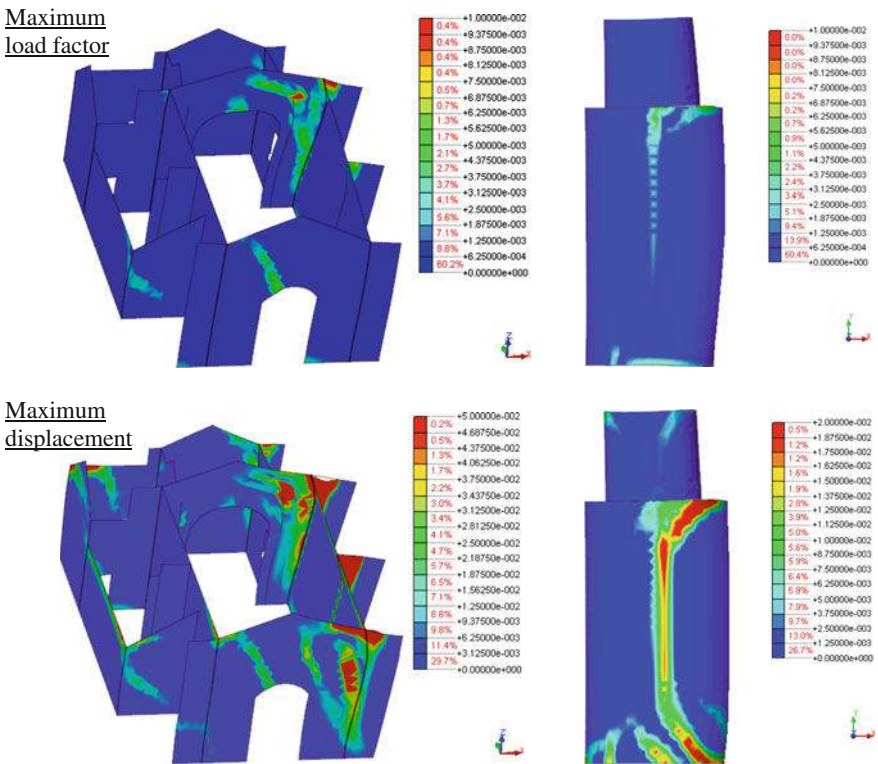
Fig. 15 Tensile principal strains for the pushover analysis in the +X direction

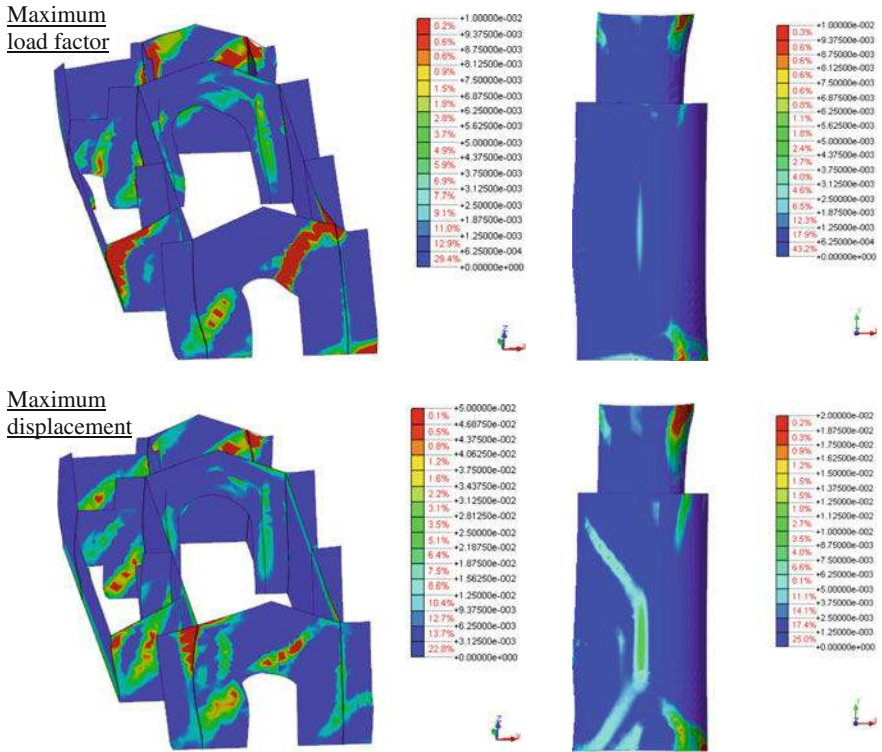
Fig. 16 Tensile principal strains for the pushover analysis in the $-X$ direction

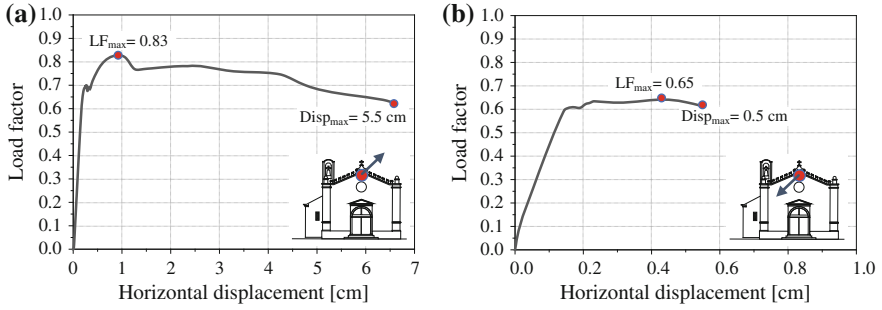
Fig. 17 Capacity curves for the pushover analysis in the longitudinal direction (Y direction): **a** +Y direction; **b** -Y direction

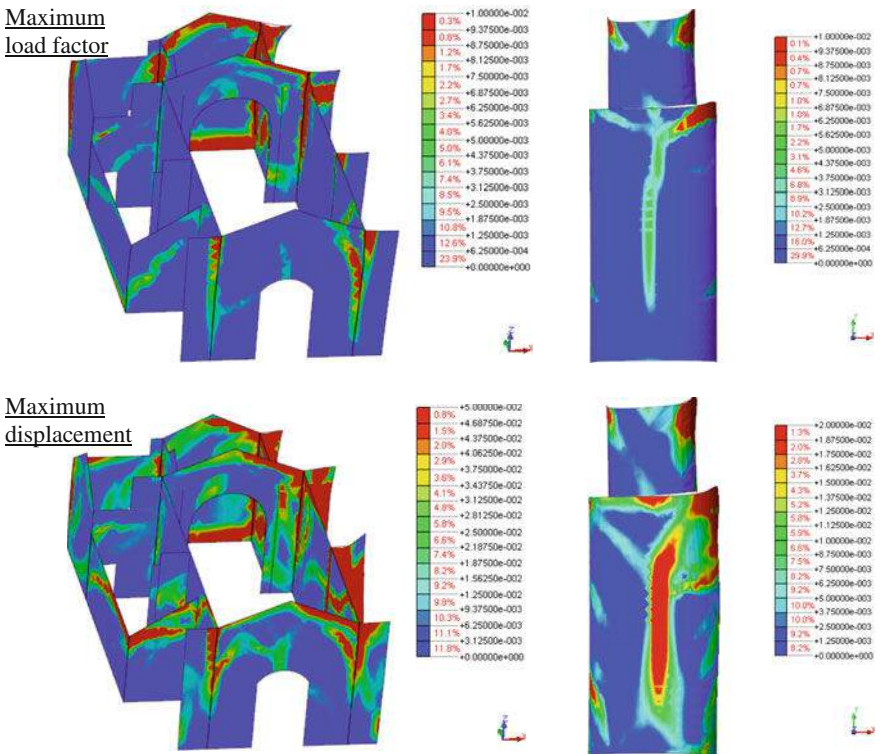
Fig. 18 Tensile principal strains for the pushover analysis in the +Y direction

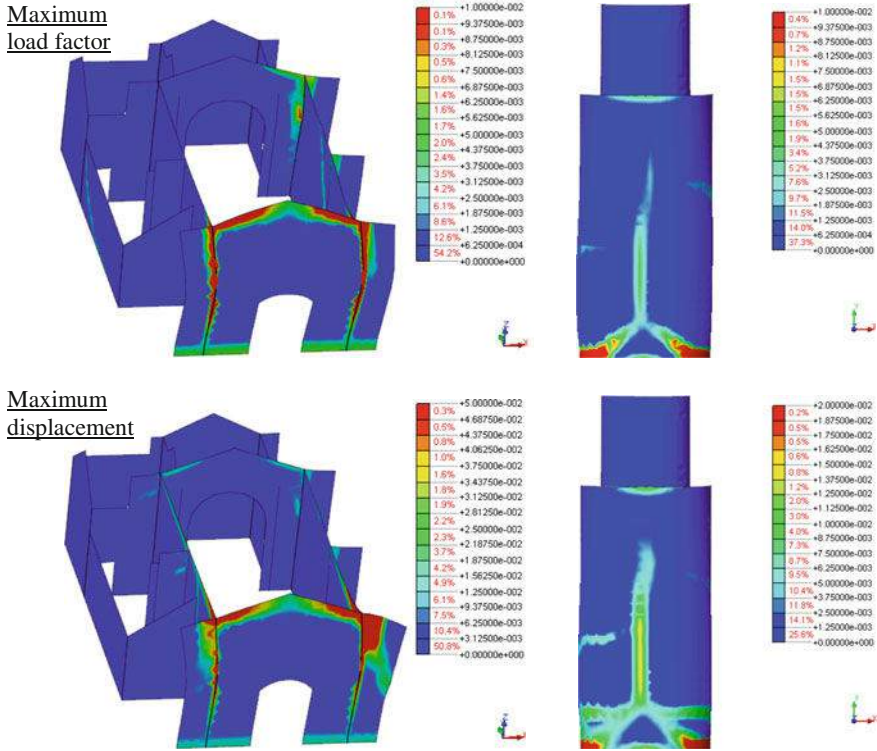
Fig. 19 Tensile principal strains for the pushover analysis in the $-Y$ direction

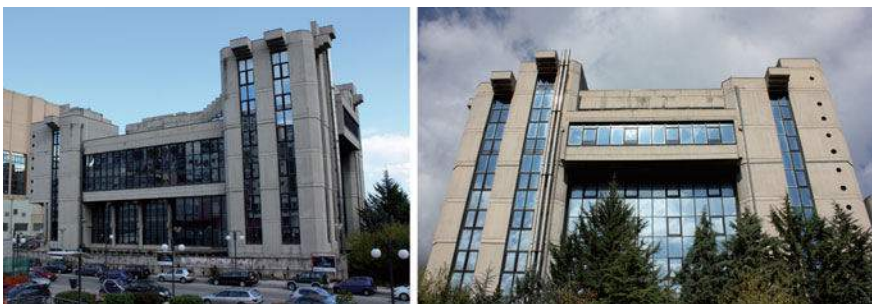
Fig. 1 West (on the *left*) and south (on the *right*) view

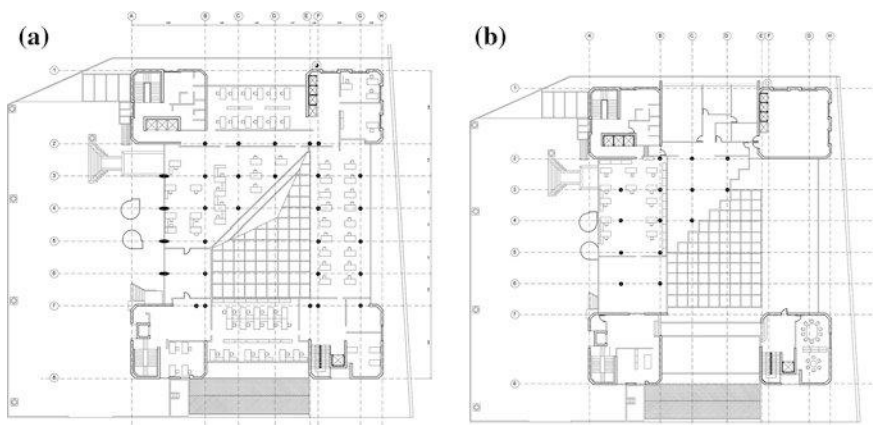
Fig. 3 Third-floor plan (on the left) and fourth-floor plan (on the right)

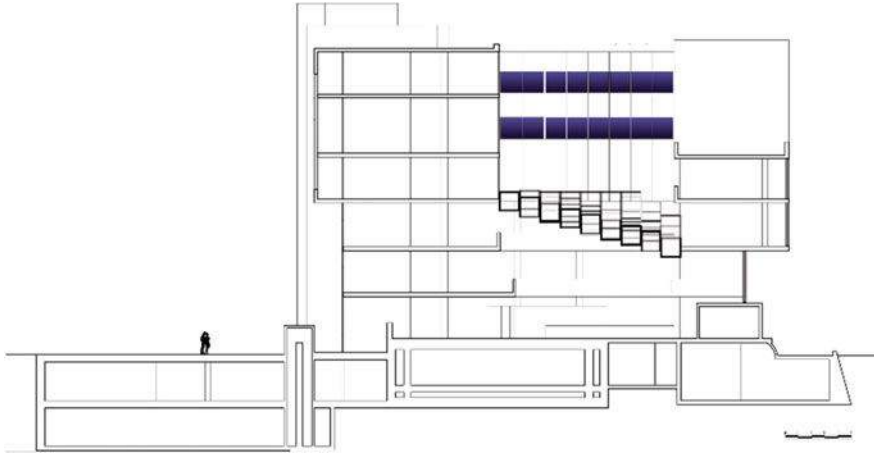
Fig. 4 East–west section

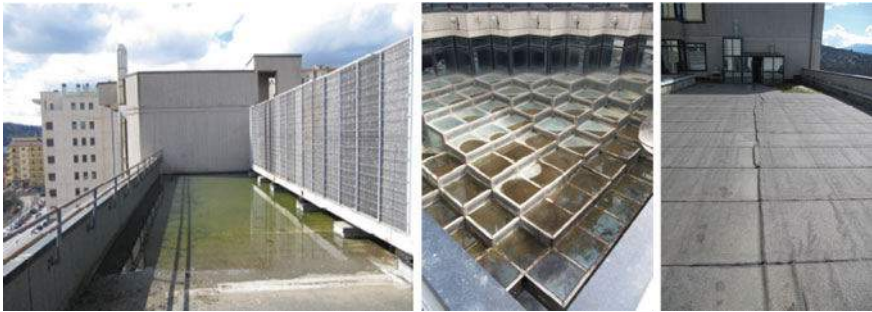
Fig. 5 Design errors and defects of the cover: water stagnation (on the *left* and *center*) and decay of the roof waterproofing (on the *right*)

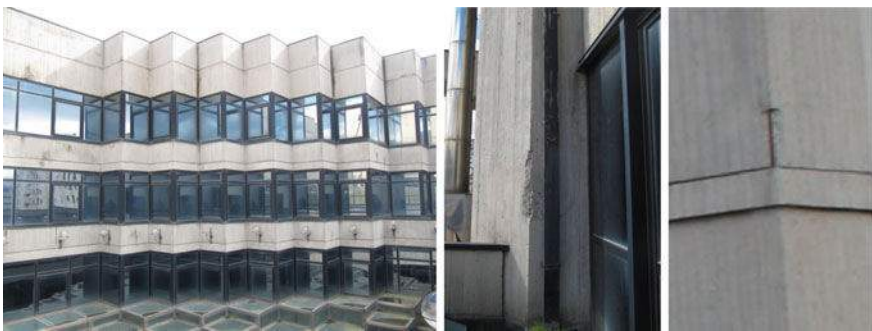
Fig. 6 Leaching on the surfaces of facing reinforced concrete (on the *left*); corrosion of reinforced steel (on the *center*); exposure of reinforcing bars (on the *right*)

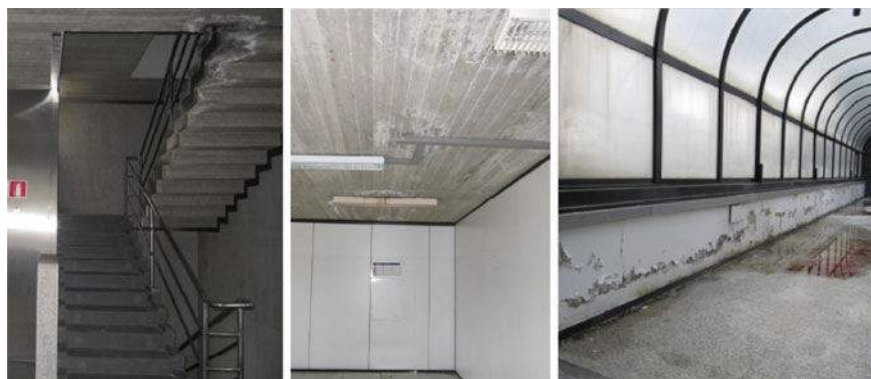
Fig. 7 Efflorescence and surface wash in the stairwells (on the *left*) and on the floors of the higher levels corrosion (on the *center*); gallery decay (on the *right*)

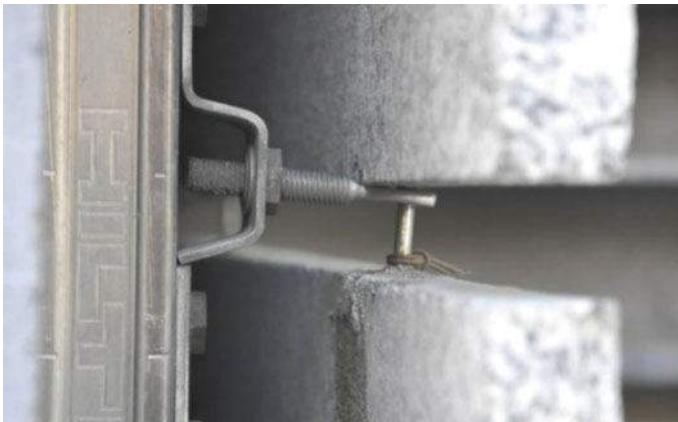
Fig. 3 Photograph of a stone panel with air chamber

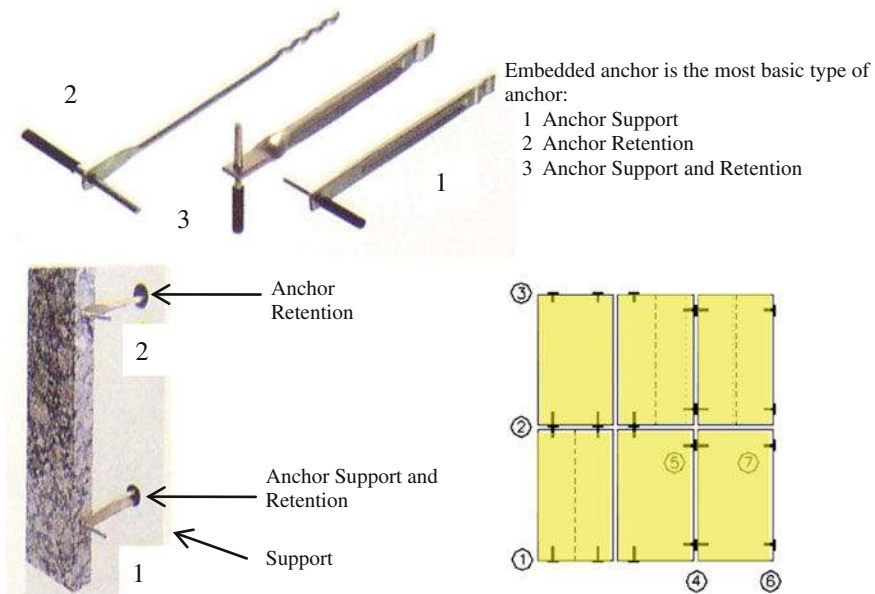
Fig. 4 Types of panel anchors

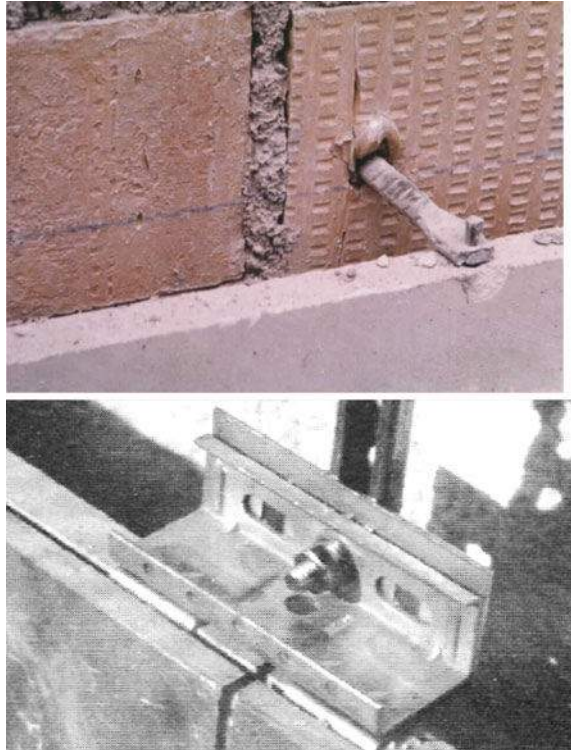
For greater joints, recesses are carved into the edge of the piece. False joints use a piece with greater hardness and thickness.

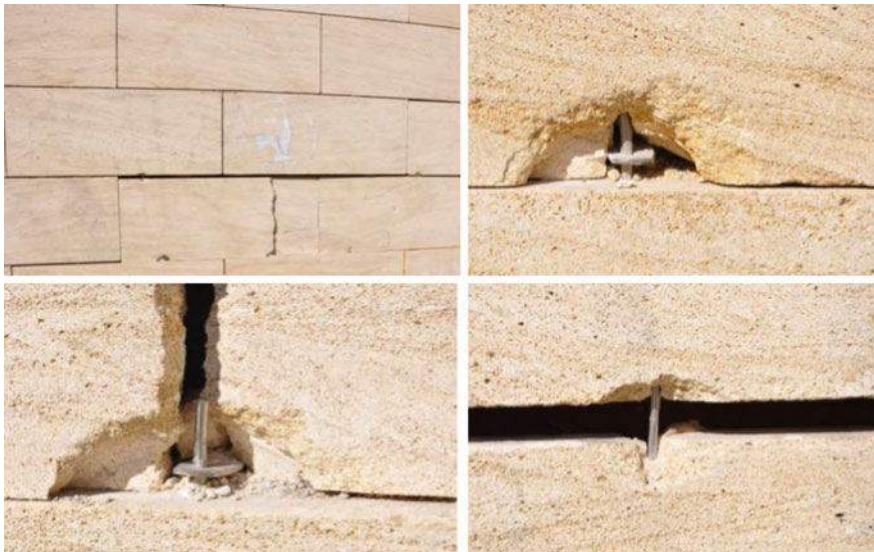
Fig. 6 Panel break around the anchor points

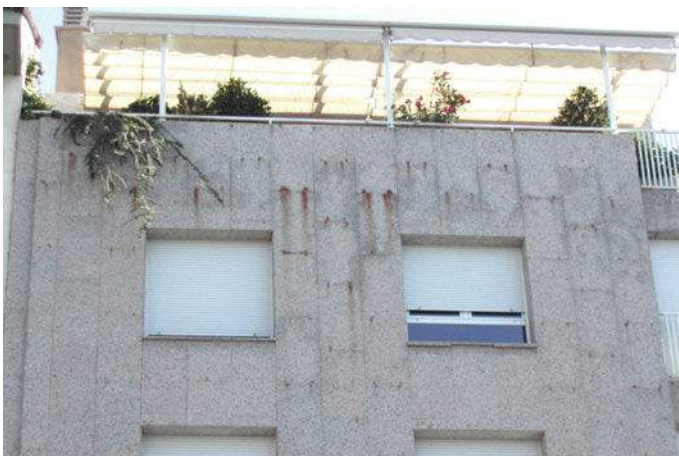
Fig. 7 Anchor corrosions

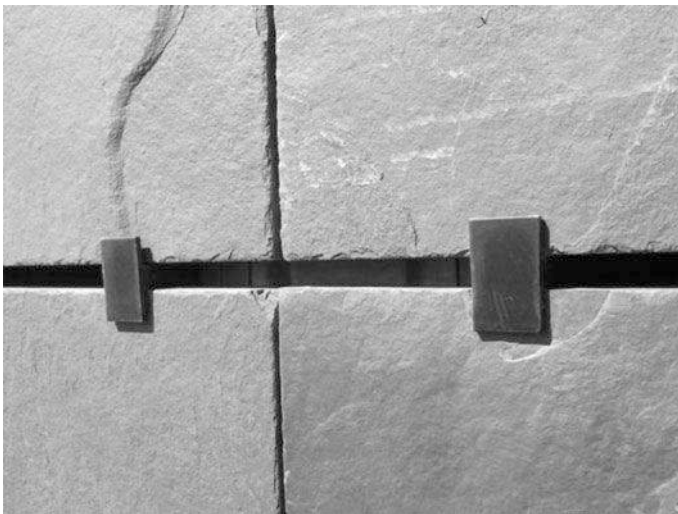
Fig. 10 Natural stone panels held by viewed fixings

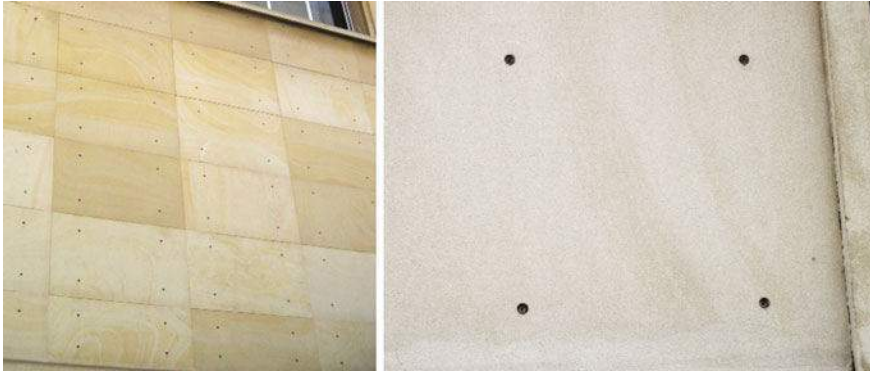
Fig. 11 Stone panels previously taken with mortar and repaired with screws

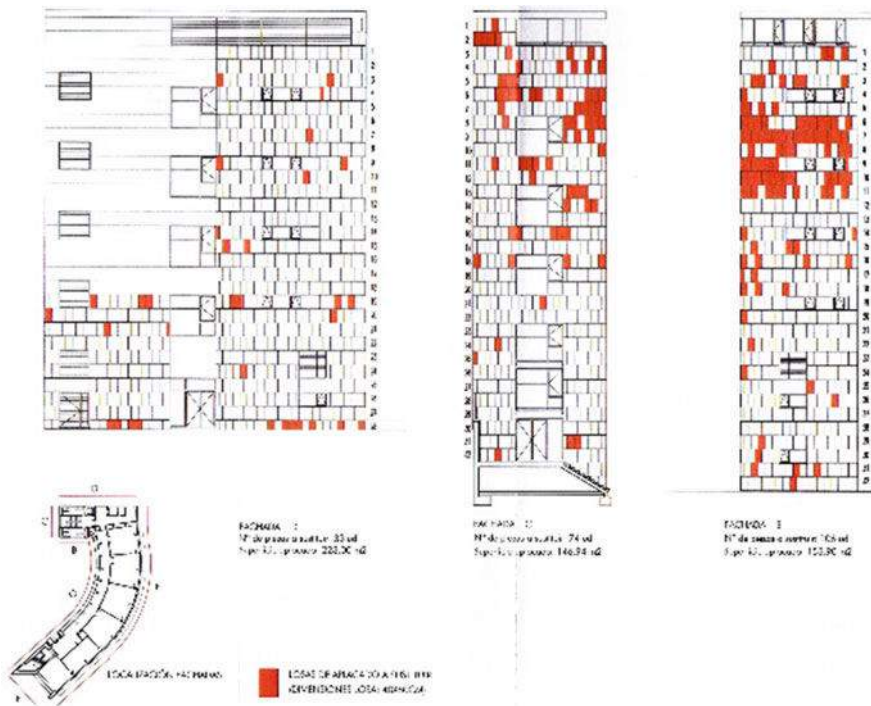
Fig. 12 Elevations and plant of Tourism Building of Valencia (Spain)

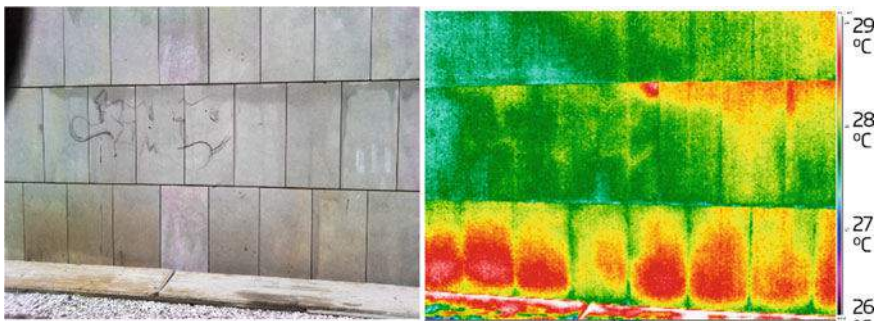
Fig. 16 Panels thermal response of the bottom of the façade

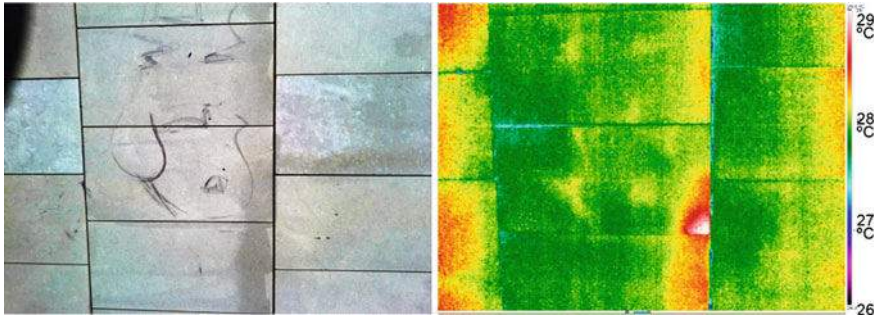
Fig. 17 Overview of the panels with defect in a corner

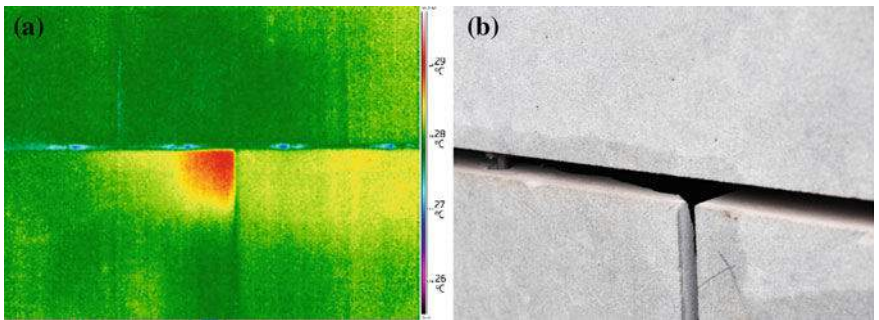
Fig. 18 The corner of this panel has less thickness than the rest

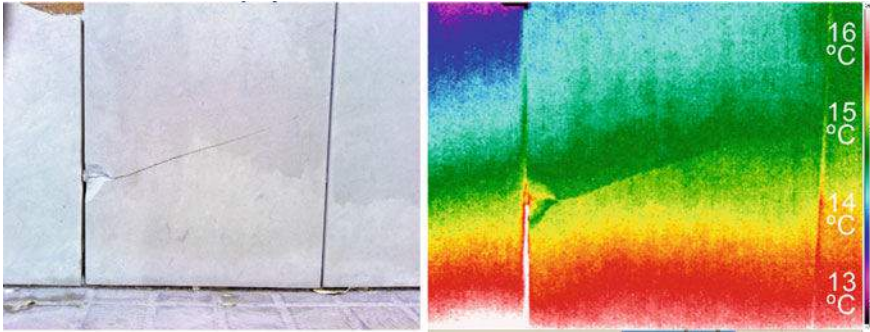
Fig. 19 Break from the anchor on a stone panel

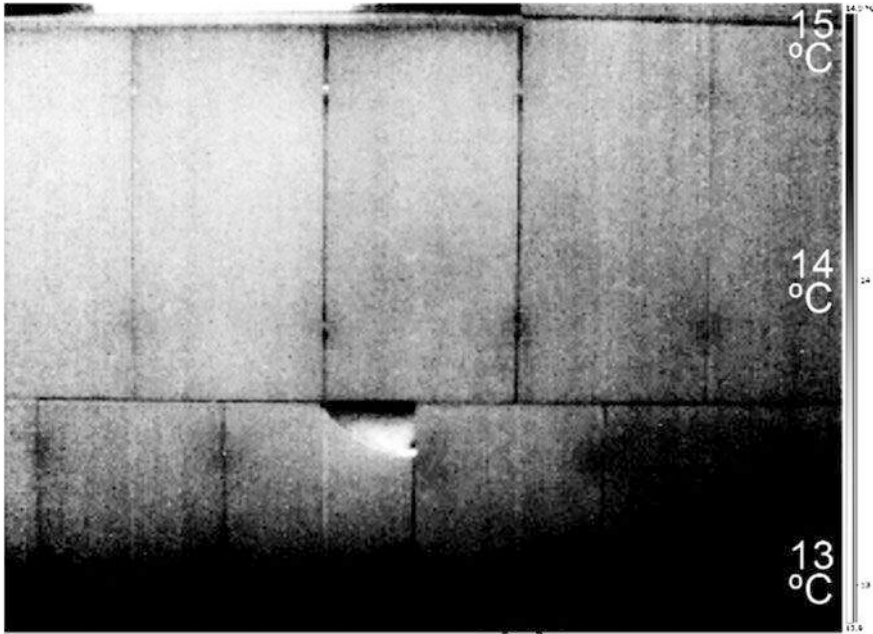
Fig. 21 Area around the anchors at different temperatures
