## **Technical and technological qualification of ancient buildings. The case of churches in "Sassi di Matera"**

Michelangelo LATERZA<sup>1</sup>, Antonella GUIDA<sup>2</sup>, Michele D'AMATO<sup>3</sup>, Antonello PAGLIUCA<sup>4</sup>, Daniela DÍAZ<sup>5</sup>,  
Marcella CHIETERA<sup>6</sup>

<sup>1,2,3,4,5,6</sup> DICEM, Dept. of European and Mediterranean Cultures (Architecture, Environment and Cultural Heritage),  
University of Basilicata, Matera, Italy

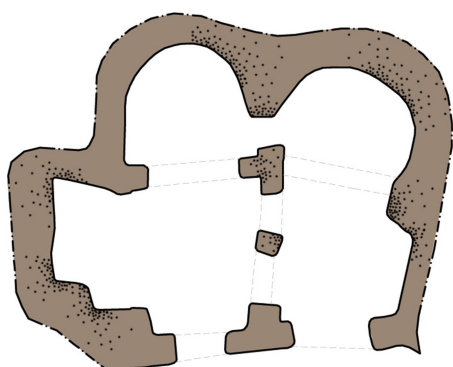
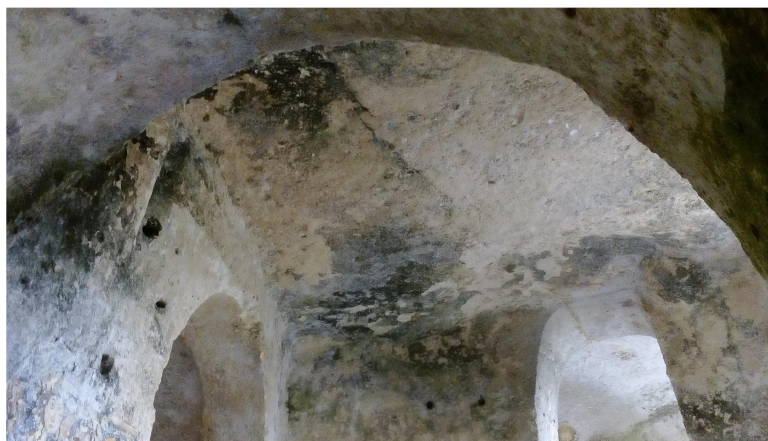
**Figure 2** – Floor plan and photo of the excavated church of *San Nicola dei Greci*.

The church of *San Nicola dei Greci* (Figure 2) corresponds to the fully excavated typology and currently it is open to the public and used as a site museum. It is approximately 6 m width and 7 m long, is divided by monolithic columns and still preserves two naves with their presbyteries in the cavity, in the right one there are two graves, and both accesses are built with an arched iconostasis. Regarding the constructive vertical elements of the church, three of them correspond to the excavated limestone rock, having the façade a column made in situ with the same limestone tuff. All of them have surfaces covered with frescoes. The main pathologies observed are the humidity infiltration, the presence of a biologic patina, mosses, lichens and saline efflorescence. The infiltration of rainfall has also produced the decay of the limestone rock due to a karst process. Regarding the horizontal elements, the original floor and roofing is basically the same excavated rock but shaping a vault in the ceiling, which has the same pathologies of the walls due to the infiltration of rainfall water.

The classification of the parameter that evaluates the *conservation status* was *Class D*, due to the karst process and biologic patina, which might be provoking a weakening of the columns for the loss of material.

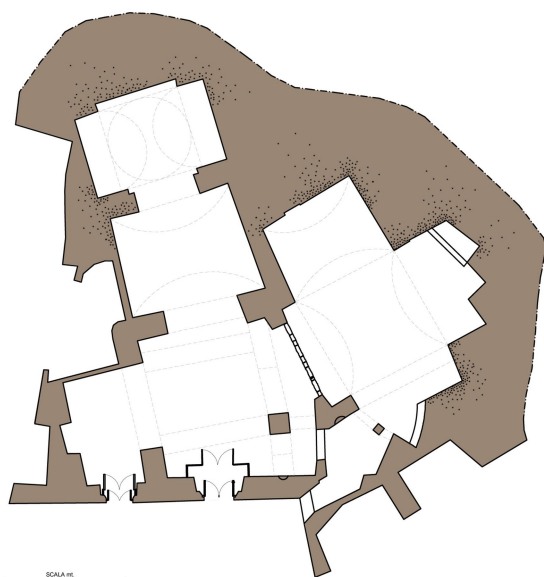
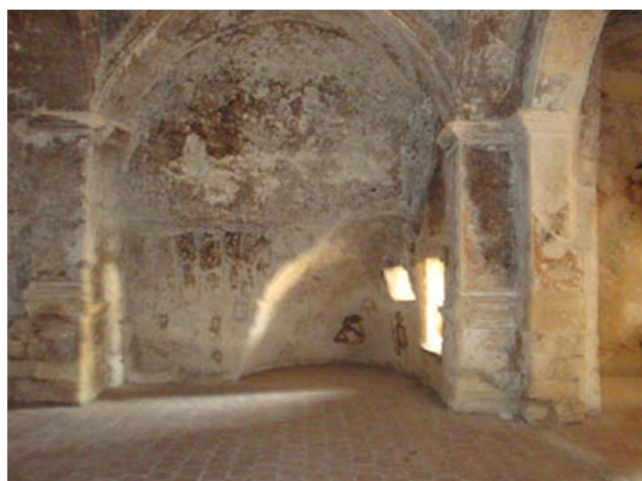
The church of *Santa Maria de Armenis* (Figure 3) corresponds to the built and excavated typology and currently it is open to public and used as a site museum. It has a maximum width of 37.2 m and a maximum long of 33.1 m, it is divided in two main spaces and presents a rich late Romanesque façade with series of pointed arches, and typical pilasters of the XII and XIII centuries. The interior rooms have large compartments and the pillars with trapezoid chapitels mark the liturgical spaces. Only traces of frescoes testify the pictorial presence (Tommaselli, 2002). Regarding the structural vertical elements of the church, three of them correspond to the excavated limestone rock, and the façade is a three-leaf masonry wall built with squared blocks of limestone tuff without finishing. The main pathologies observed are the humidity infiltration, the presence of a biologic patina, mosses, lichens, chromatic alteration and saline efflorescence. Regarding the horizontal elements, the floor has been recently covered by bricks, and there are vaults of limestone blocks forming the roof under the excavated rock, which has the same pathologies of the walls due to the infiltration of rainfall water.

**Figure 3** – Floor plan and photo of the nave walls with efflorescence in *Santa Maria de Armenis*.

The classification of the parameter that evaluates the *conservation status* is *Class C*, due to the localized biologic patina and efflorescence. As regards the *environmental alteration*, it was classified as *Class B*, due to the decay of the limestone rock, and in the *construction system alterations*, it is classified as *Class B*, as the modifications were built with compatible materials in terms of strength and stiffness, but they are not reversible. Regarding the *vulnerability to fire*, it was classified as *Class A* for not containing flammable ornaments.

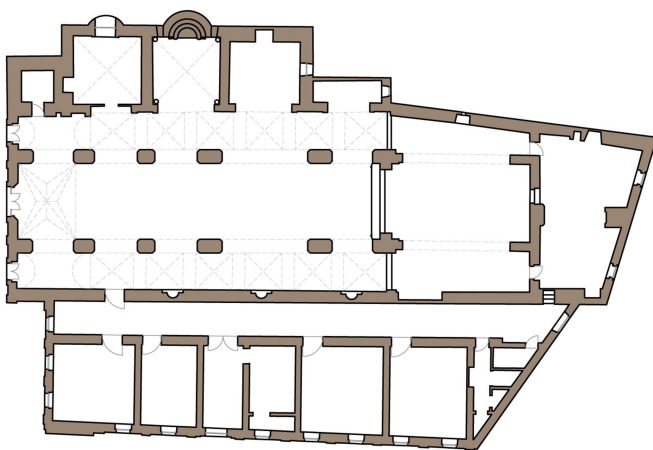
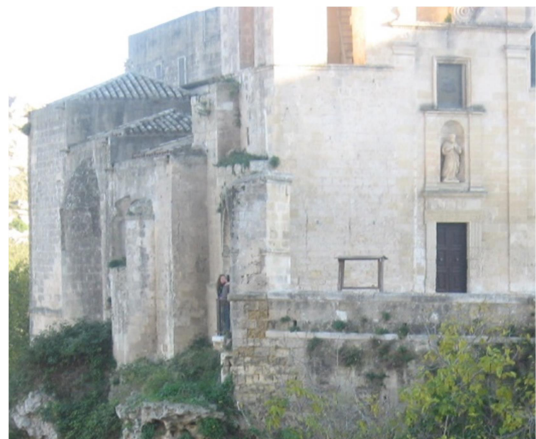
The church of *San Pietro Caveoso* (Figure 4) corresponds to the built typology and it is currently open to the public in order to maintain the original church use. It is 17.2 m width and 43 m long and is divided into three naves, having four of the original eight chapels on the left lateral nave. It also has a deep choir containing the presbytery with a XVIII century altar. The church façade has three portals according to the three naves configuration, and above, three semicircular niches contain the statues of the Saints Peter and Paul, and Our Lady of Mercy in the central position. To the left of the façade, rises the bell tower with three orders, decorated with a balustrade with geometric motifs and culminating with a pyramidal spire. The church has been recently consolidated, with a comprehensive project including soil consolidation and general anchor between the macro-elements of the building, and between the building and the foundation rock.

Regarding the constructive vertical elements of the church, the walls are built with a three-leaf masonry with squared blocks of limestone tuff without finishing. In terms of pathologies, there are some isolated fissures in the façade which may be due to differential settlements near the ravine, and there is exterior humidity infiltration that has caused chromatic alterations and saline efflorescence. Moreover, there is capillarity humidity generating karst erosion in the base of the walls. Regarding the horizontal elements, it has a ceramic pavement in the floor, a wooden structure in the main nave roofing, and groin vaults built with the same limestone tuff in the lateral naves. The horizontal elements do not have evidence of decay.

Figure 4 – Floor plan and photo of the fissures in the buttresses due to differential settlement in *San Pietro Caveoso*.
