**A simplified procedure for risk assessment of cultural heritage:  
definition and application to religious architecture**

**Keywords:** risk assessment, vulnerability, hazards, religious architecture

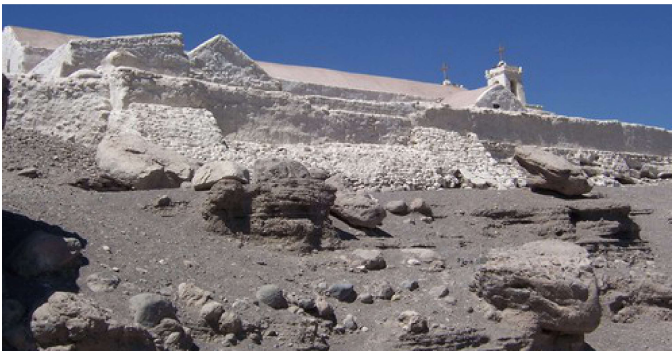
In according to the proposed procedure, the seismic risk assessment is obtained by applying the *Tool 2* in which the worst hazard scenario is supposed. Therefore, the vulnerability of the Church of Chiu Chiu to the seismic threat is increased by its high seismic location, and also there might be a catastrophic scenario caused by rainfall, which produces every year the Loa River flood and mudslide. Considering that the church is sited within 10 meters from the river, differential settlements and humidity in the basement of the church could be presented, which may affect the resistance of the adobe walls (Fig. 5).

Fig. 5 From left to right: Church of Chiu Chiu and landslide of the eastern slope of Loa River due to flooding in Google Earth (2015); Stone deterioration in the tower of San Vito Church.

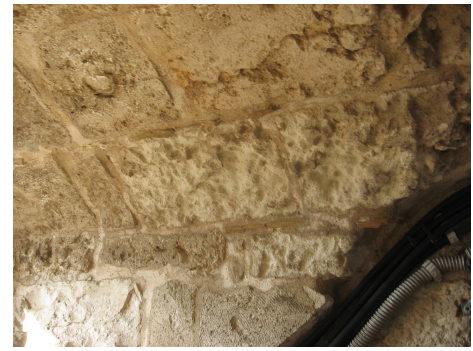
Among the threats that could generate scenarios of minor or gradual damage, the worst is the *air pollution* because its concentration along the direction of the prevailing winds from the north, where an industrial zone is located [11] may produce acidulated rainfall for carbonic acid which may cause the dissolution of the limestone blocks of the Church of San Vito. Other threat is the *erosion* due to the constant rainfall throughout the year, the high relative humidity (above 70%) [12] and the proximity to the coast, conditions that could produce a gradually increasing deterioration without adequate maintenance. On the other hand, in summer time the *socio-organizational threat* may be presented as the Church of San Vito is the only museum in the old town and it is located in the main touristic route, so if there were crowds of people inside the building there might be damage for condensation of vapor. The *serious demographic decline producing lack of maintenance* and the *physical stress threats* are not present.

On the other hand, although the seismic vulnerability of the Church of Ostuni is reduced by being located in a low seismicity area, some mitigation actions shall be done in reducing erosion and air pollution threats which are causing the dissolution of the limestone blocks of the church tower. Therefore, monitoring of the material deterioration is necessary and conservation actions shall be addressed to avoid the material worn out (Fig. 5).
