## **THE ROLE OF DIAGNOSTICS IN THE RESTORATION PROJECT**

### 3. APPLICATION IN A RESTORATION PLAN: THE CASTLE OF CANCELLARA

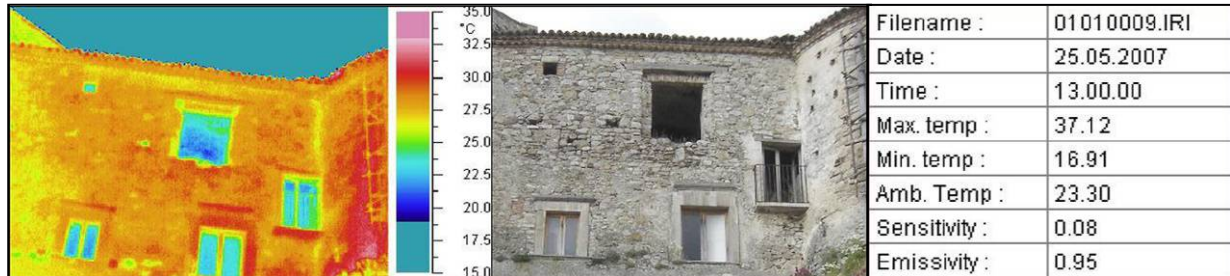
For the northern facade, the shots have been carried out from the bottom and they are accompanied by digital photos for a short visual comparison. Then the thermal images have been processed, on the same emissivity, with the same temperature range and compared, to get qualitative information on the materials of the facade and their degradation. In the part of the facade included between the towers, different geomaterials are pointed out. They make up the vertical masonry in comparison with finishing materials, slabs, angles and also wooden flanges which are hotter (fig. 3).

Figure 3. Outside Thermogram Northern view

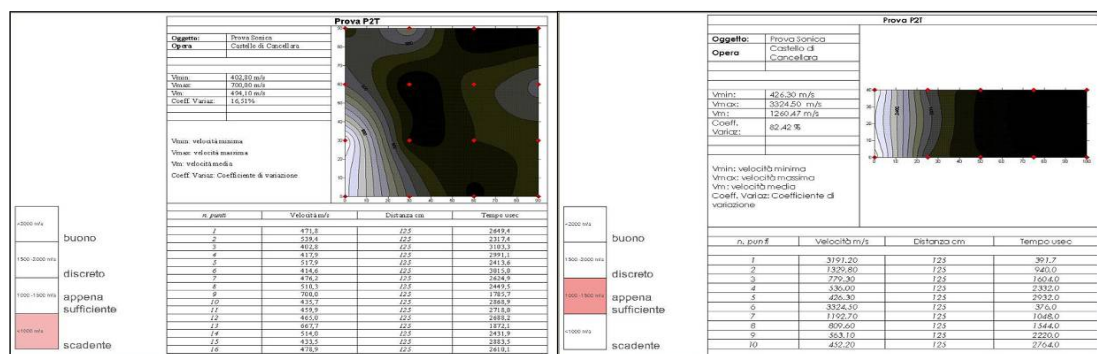
Both direct and indirect sonic tests have been carried out. On facing panels, where transparency tests have been carried out, the values of average speeds are very variable and anyway they do not overcome 1500 m/s. In some cases – P2P and P8T tests – they are actually below 1000 m/s. The coefficient of variation inside every examined panel is highly variable, in order to prove that there is a remarkable data loss and therefore the facing panel is not homogeneous. Only the P1P panel presents an average value of the elastic wave speed higher than 1500 m/s, in order to prove what aforesaid, it presents the highest value (34.98%) of the coefficient of variation among the tests and therefore the high value of the average speed is not trustworthy (fig. 4). Indirect tests also show the poor quality of the masonry, since they also present average speeds included between 1260.47 m/s and 562.30 m/s and coefficients of variation included between 82.42% and 76.44%.

Figure 4. Direct and indirect sonic survey on panel
