# Diagnostics archive data for the analysis of the Architectural Heritage's conservation state

Troia Cathedral, Diagnostic methods and tools, Archive diagnostics, Big Data, Architectural conservation

### **The case study of the Cathedral of Troia: history of the diagnostic investigations and monitoring**

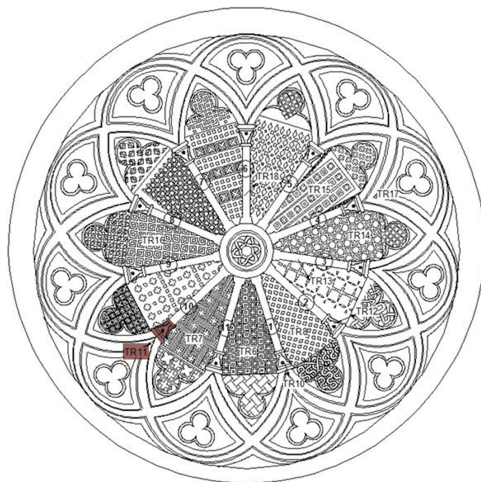
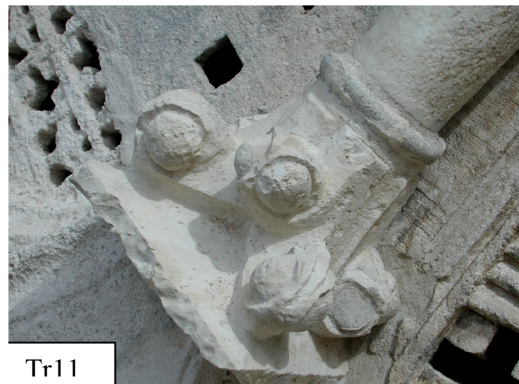
Tr 11 | Points on the rose window and photo

Card n. 1

Sample	Sampling point - Architectural element	XRD Analysis
TR1	Column 11	Calcite, quartz traces
TR4	Central oculus	Magnesium calcite
TR5	Capitals, column 1	Magnesium calcite gypsum and opal traces
TR6	Carved triangular panels between columns 1-11	Magnesium calcite quartz traces
TR10	Capital, column 1	Magnesium calcite
TR11	Capital, column 10	Magnesium calcite opal traces
TR14	Carved triangular panels between columns 3-4	Calcite, gypsum

The rose window presented a set of damages and deformations of seismic origin which could be ascribed to a rotation of the facade around a horizontal hinge. This condition caused cracks and detachments in the architectural elements, as well as the noticeable out-of-plane strains at some ashlars in the circular curb, and the loss of perfect verticality of the plane of the rose window. Disconnection and rotation of the capitals and compression failures of the columns could be seen.

The GPR survey provided fundamental information on the internal structure and state of preservation of the rose window, detecting cracks in the columns and calcarenite elements with intersecting arches, as well as the boundaries between original and restored parts. Moreover, metal elements between columns and capitals, and between columns and central oculus have been localized, giving useful information about the original construction techniques, essential to planning restoration strategy.

Ultrasonic tests were conducted on six measuring points per column, internal and external, at 20 cm intervals with frequencies between 40 and 200 kHz. For most of the columns, the lithotype, the main problems of deterioration (scaling, erosion) and instability (cracks from crushing, joint dislocations) and the existence of critical points from a constructional point of view were already known. The aim of the ultrasonic tests was a) to assess the pathologies already known; b) to discover anomalies in those points in which measured velocities were very low. The tests have shown a good average propagation speed, generally between 4000 and 5000 m/s, with some 'drops', corresponding to damage condition. To complete the diagnostic survey described, for the purposes of a more correct possible restoration and consolidation intervention, it was agreed to also proceed with a structural diagnosis. The diagnosis established that the deformation/deflection framework of the facade is essentially attributable to rotational motion with sub-horizontal hinge at approximately 9.05 m on the external surface and at approximately 10.55 m on the internal surface<sup>4,7-9</sup> (Nuzzo et al., 2010; Masini et al., 2007, 2016).
