Article

Holistic Assessment for Social Housing Retrofitting: Integrating Seismic, Energy, and Social Aspects in the REHOUSE Project

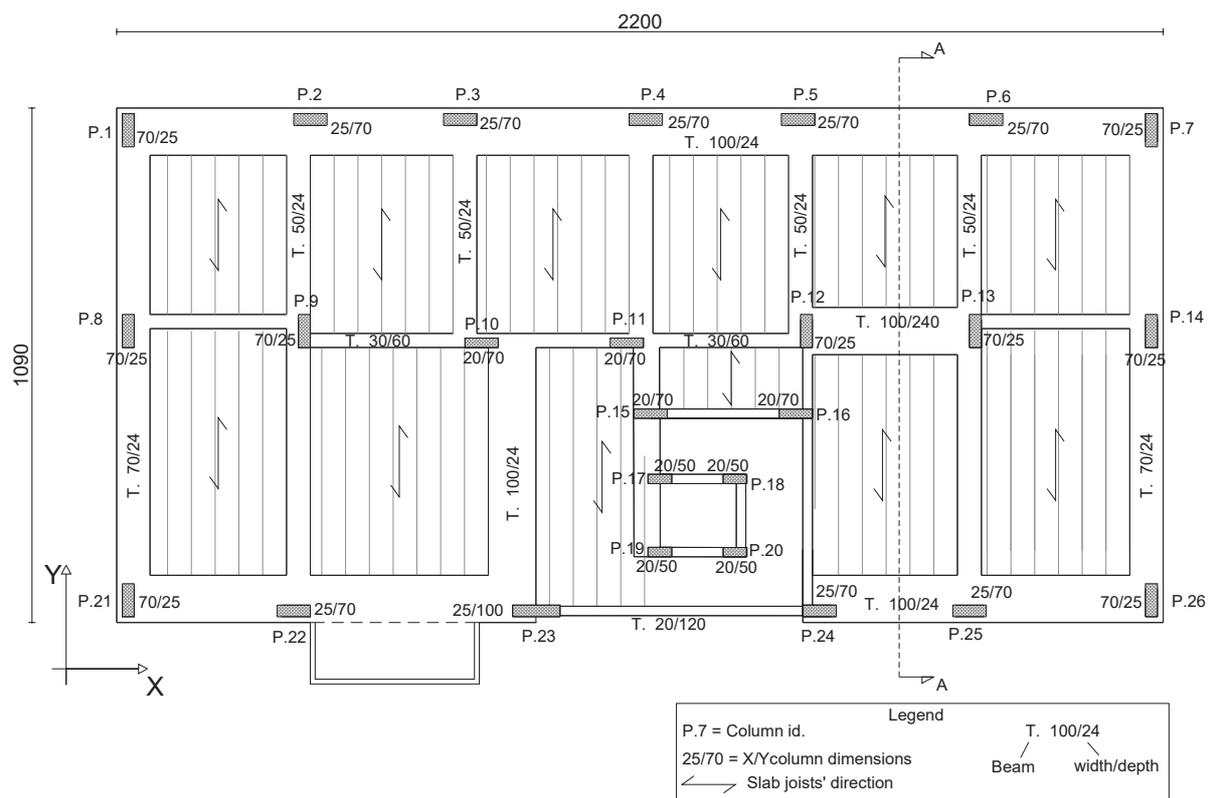
Figure 2. Typical structural plan.

The frames show a prevalence of wide beams (depth lower than width). Floor slabs are composed of reinforced concrete T-shaped joists with hollow clay lightening bricks. Their total thickness is 24 cm, including 20 cm for the joists and 4 cm for top plate, which is reinforced with a steel net. Therefore, floor diaphragms can be considered to be rigid for in-plane actions (Figure 2).

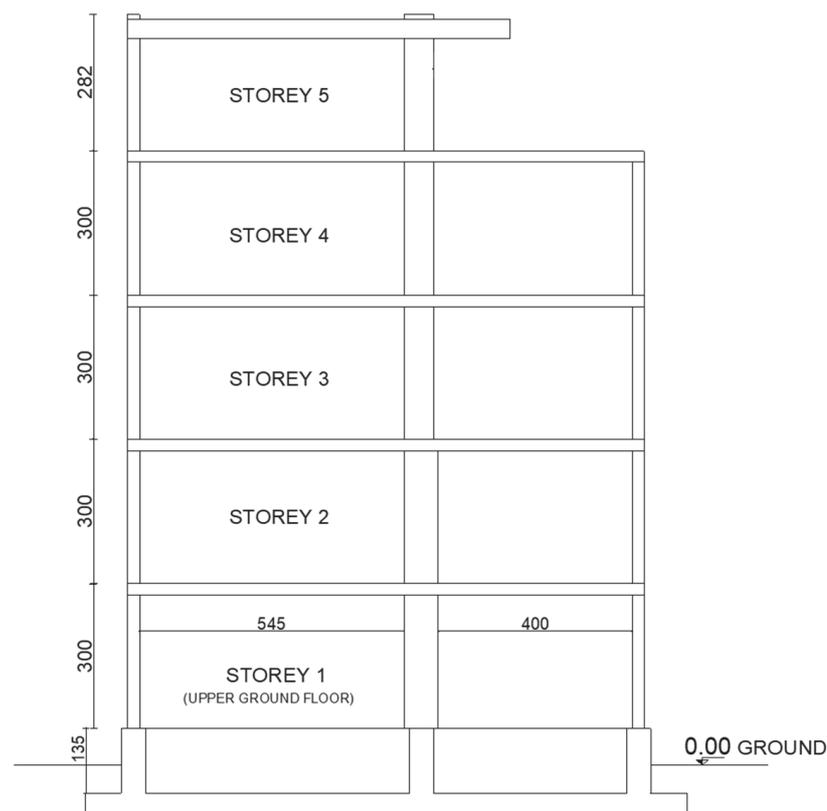
Figure 3. Structural section A–A (dimensions in cm).

The structure has globally 5 stories (4 ordinary + roof story) with a floor area equal to 220 m^2 and an interstory height of 3 m (Figure 3).

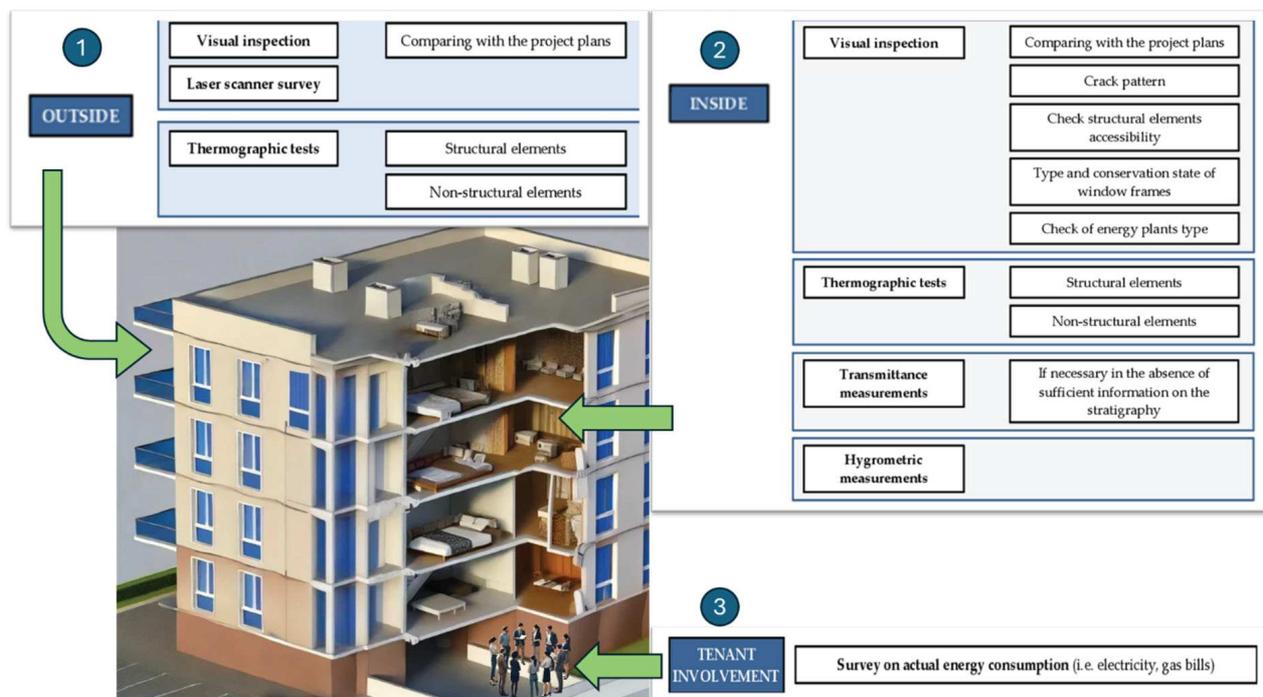
Figure 4. Example overview of preliminary surveys and inspections on the building.

Figure 4 summarizes the operations necessary for the preliminary knowledge of the building in order to plan the test campaign on the structural and non-structural elements for more detailed knowledge. The three blocks in the diagram are non-consequential operations, for which the procedures can also be carried out at the same time.

The first block (1) concerns the external survey, which involves visual inspection and surveying with laser scanners and other diagnostic techniques (thermographic, hygrometric, pacometric, and GPR measurements) to be compared with the design drawings. The thermographic inspection, in particular, makes it possible to identify any discontinuities or deterioration, structural or non-structural, of the building envelope, in particular on columns, beams, and floors; it also makes it possible to identify thermal bridges, infiltrations, and surface cracks on walls and other surfaces.

The second block (2) involves the survey operations carried out inside. Among these, in order to obtain further information, it is important to be able to carry out, in addition to thermographic measurements, hygrometric measurements since they enable (without affecting the concrete) verifying the presence and/or distribution of moisture up to a depth of 30 cm and to determine whether it is a temporary or persistent phenomenon on the masonry materials and packages also affected by hygroscopic moisture phenomena.

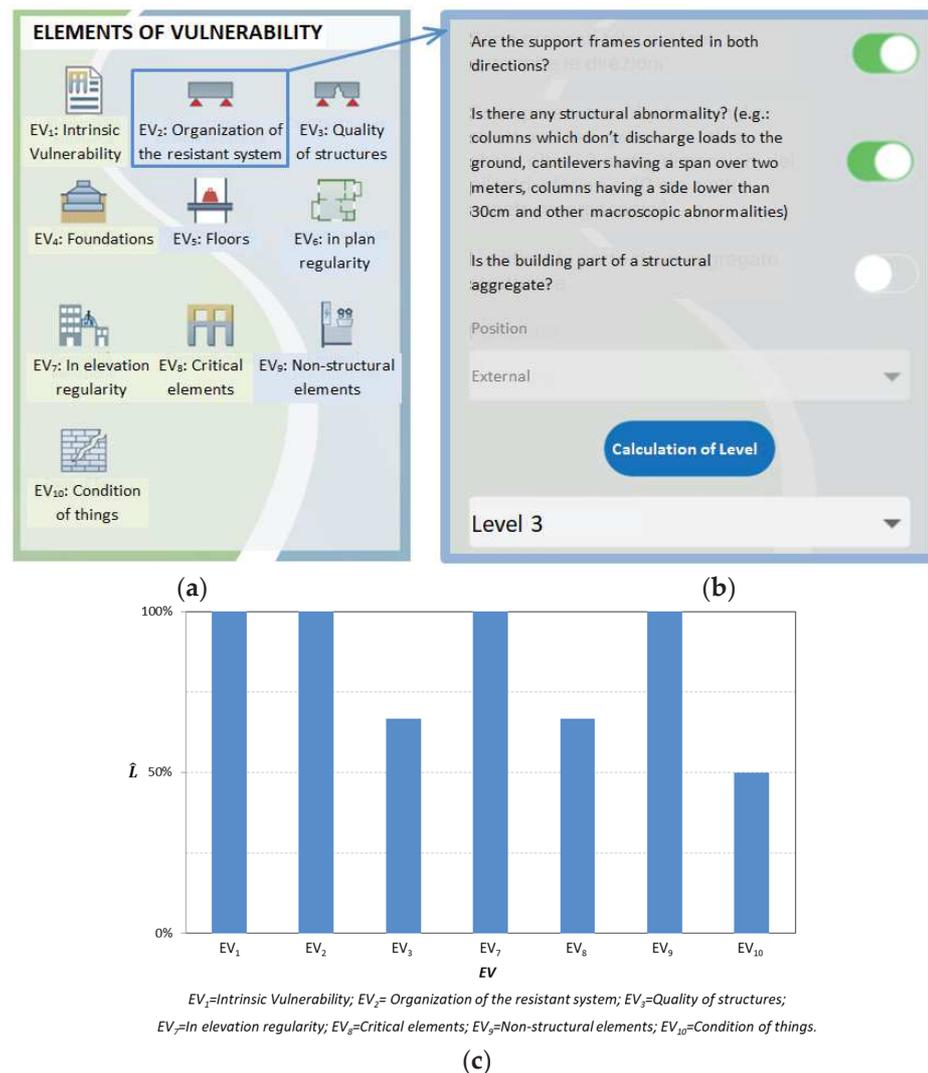
Figure 5. (a) List of EV_i investigated through the app; (b) example of calculation of the level of intervention concerning the organization of the resistant system; (c) synthetic representation of EV_i with $\hat{L}_i \geq 50\%$ (extracted from ENEA app “Condomini+ 4.0”).

A preliminary structural assessment of the building was performed through the ENEA app “Condomini+ 4.0” [22]. This evaluation, which can be defined as expeditious and qualitative, is not based on instrumental tests and numerical simulations and therefore does not return a vulnerability analysis. However, resting on well-known structural deficiencies and seismic effects, it enables revealing the structural criticalities inferable from a thorough study of the technical documentation and a visual inspection of the building. A wizard guides the specialist through the investigation of the most representative elements of vulnerability (EV_{is}), listed in Figure 5a, up to obtaining an estimation of the level of intervention (L_i) expected for each of them. Each L_i can take a value between 1 and L_{i_max} , and it increases with the relevant issues. If $\hat{L}_i = L_i/L_{i_max} = 100\%$, it means that L_i reached its threshold value and the corresponding EV_i is highly critical. For the case study, the calculation of the level of intervention concerning the organization of the resistant system is reported, by way of example, in Figure 5b, and all the EV_{is} with $\hat{L}_i \geq 50\%$ are synthetically represented in Figure 5c. The corresponding criticalities are briefly described below.

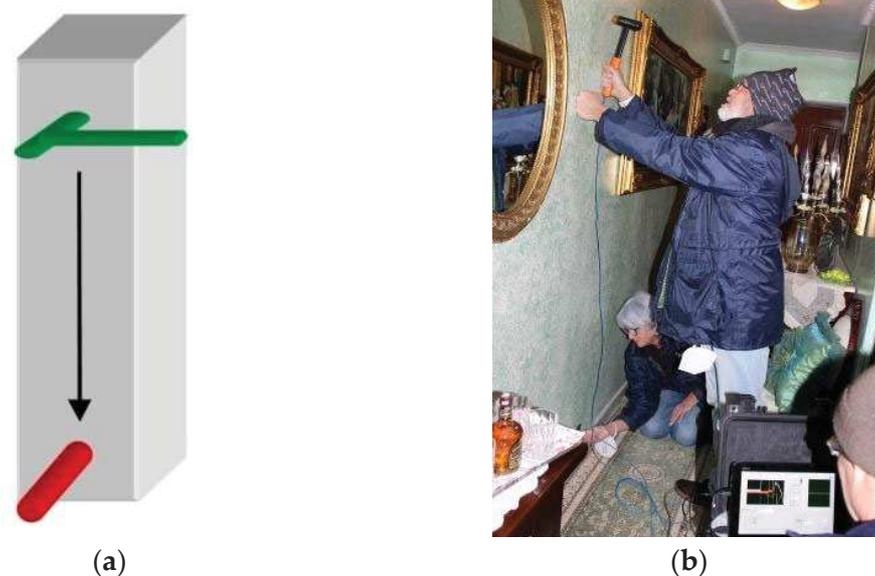
Figure 6. Indirect ND measurements on a column: (a) testing scheme and (b) execution.

Indirect sonic measurements were performed on the IDSB's columns to help in selecting the columns from which to extract the cores. The sonic velocity test technique is based on the generation of mechanical impulses with frequencies in the sound field. The sound wave is generated on the element, the column in the specific case of this measurement campaign, by impacting with an instrumented hammer (green object in Figure 6a) and is received by a sensor (piezoelectric accelerator) placed at a different point on the element (red object in Figure 6a). To calculate the sonic velocity, it is necessary to measure the travel time of a sonic signal through a surface. In our case, indirect measurements were carried out, placing the impact point of the instrumented hammer and the receiving accelerometer on the same face of the column as reported in Figure 6a. It was necessary to conduct indirect measurements due to the difficulty in taking direct ultrasonic measurements because the opposite sides of the pillar were not accessible. The measurements were carried out by Level 3 personnel (Figure 6b) trained according to [26].

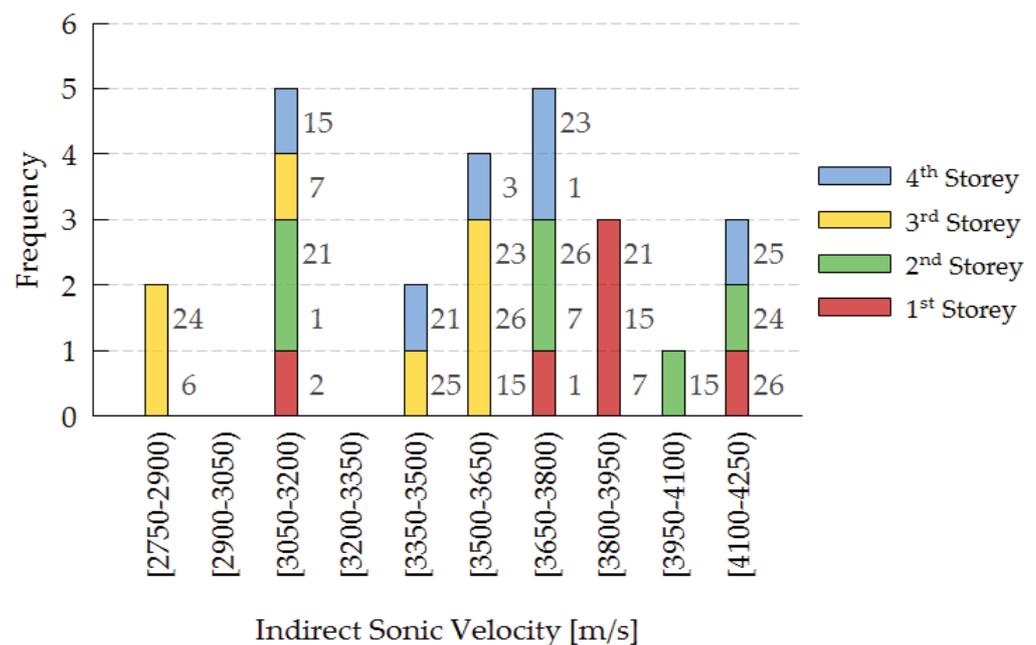
Figure 7. Distribution of indirect sonic measurements.

The distribution of the measurements is shown in Figure 7, and the average values of the sonic velocity measurements have a normal distribution for values between 3350 m/s and 4100 m/s, whereas there are concentrations for both low sonic speed values and high values.

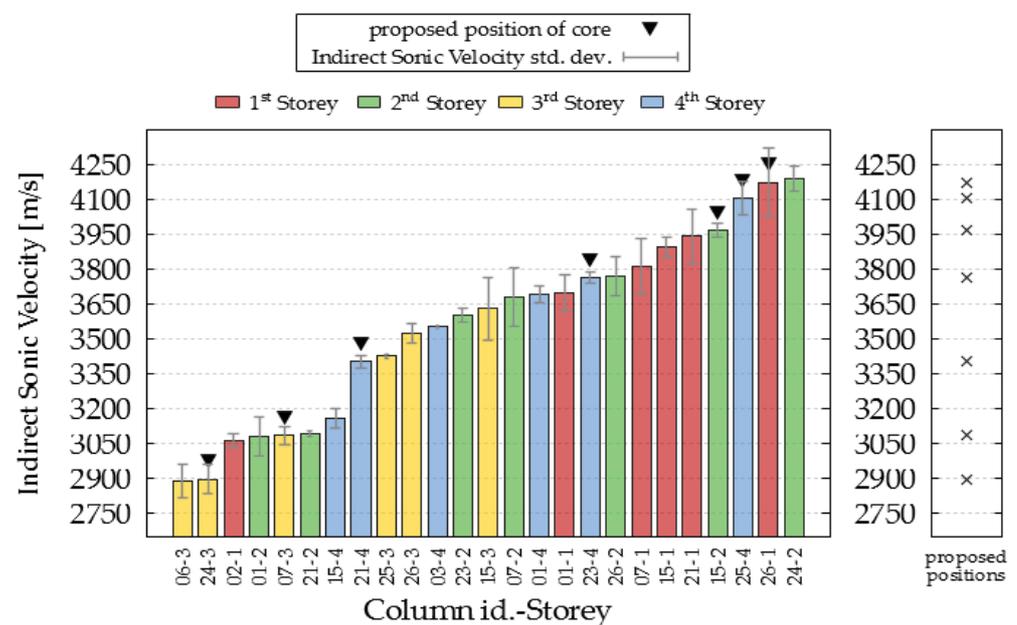
Figure 8. Sonic measurements and proposed positions for core extraction (velocity values sorted by ascending order).

To provide a more effective graphic representation, the entire series of sonic velocity measurements, sorted by increasing value, is shown in Figure 8 on the left, and the seven positions where core drilling was proposed are highlighted by black triangles. The right chart of Figure 8 shows the actual dispersion of the indirect sonic velocity measurements corresponding to the proposed coring positions (proposed positions in Figure 8).

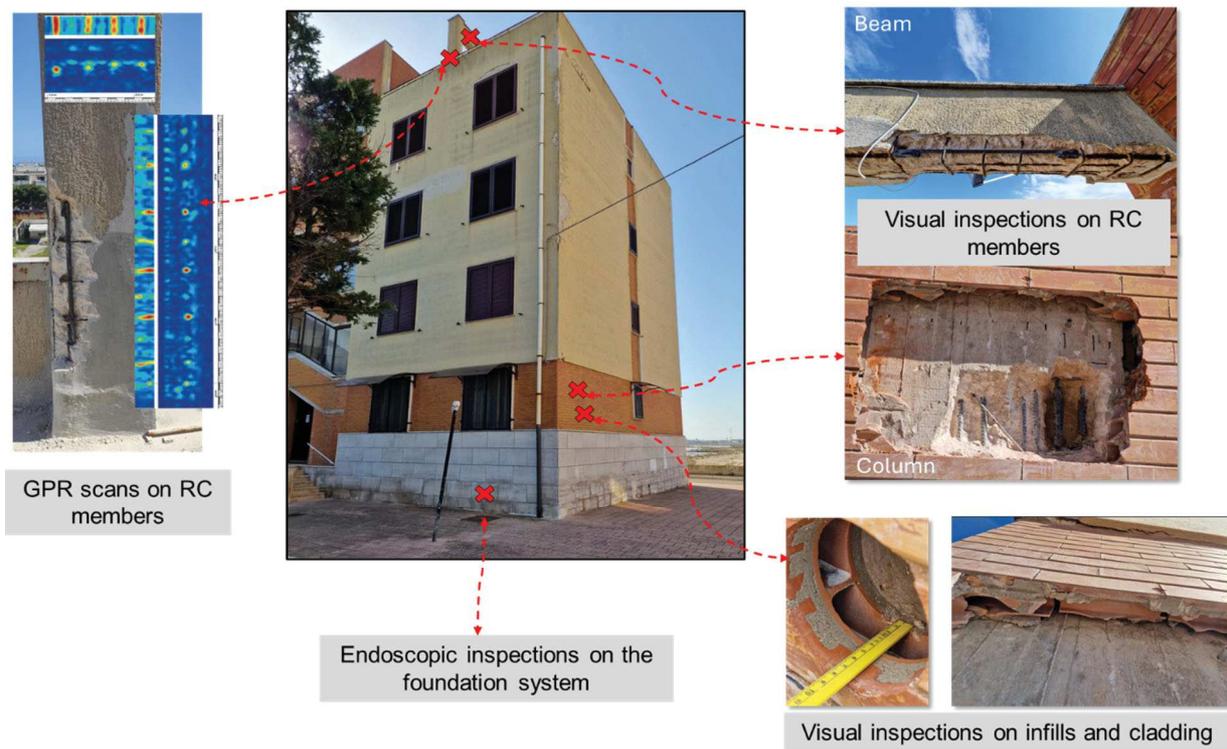
Figure 9. Overview of destructive investigations.

The visual inspections (Figure 9) of the reinforcement details (type, diameter, and number of bars actually present) were conducted by means of seven exploratory tests distributed across various stories between the beams and columns, utilizing the extraction points of the reinforcement samples. In fact, the extraction of rebars requires concrete cover removal, and this represents an opportunity to also visualize the reinforcement layout, preventing additional visual inspections. Regarding the external column elements, given the typological homogeneity, it was sufficient to carry out only one test at the first story. The exploratory test on the infills and cladding elements occurred through a hole, combined with endoscopic investigation, to recognize the stratigraphy and transverse thickness of the infill panels. As the foundation level was not accessible, two additional endoscopic investigations were carried out through the foundation beams around the perimeter of the building to check their typology.

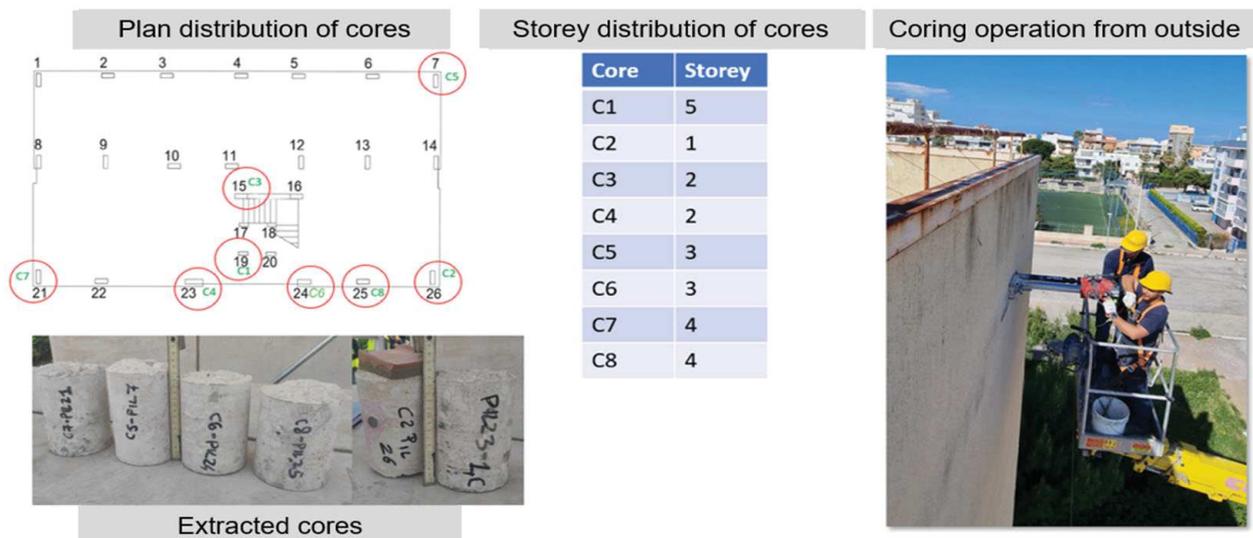
Figure 10. Concrete core drilling (for column and storey numbers, see Figures 2 and 3 respectively).

The building has a floor area of approximately 220 m². To achieve the knowledge level KL2, a total of eight cores were extracted (two per storey). Considering the difficulty of extracting samples from wide beams, the coring activities focused only on the columns. Each core has a diameter of 10 cm and a length of approximately 13 cm (Figure 10). The extraction procedure followed the standards of UNI EN 13791:2019 [9].

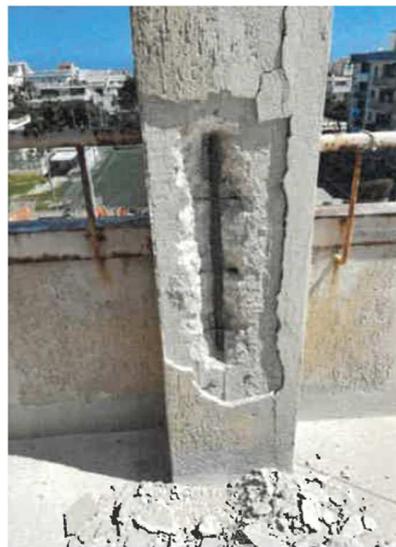
Figure 11. A column rebar before the extraction.

The reinforcement-extracted specimens, with a length of approximately 60 cm (Figure 11), underwent tensile failure testing in accordance with standard UNI EN ISO 6892-1:2020 [29].

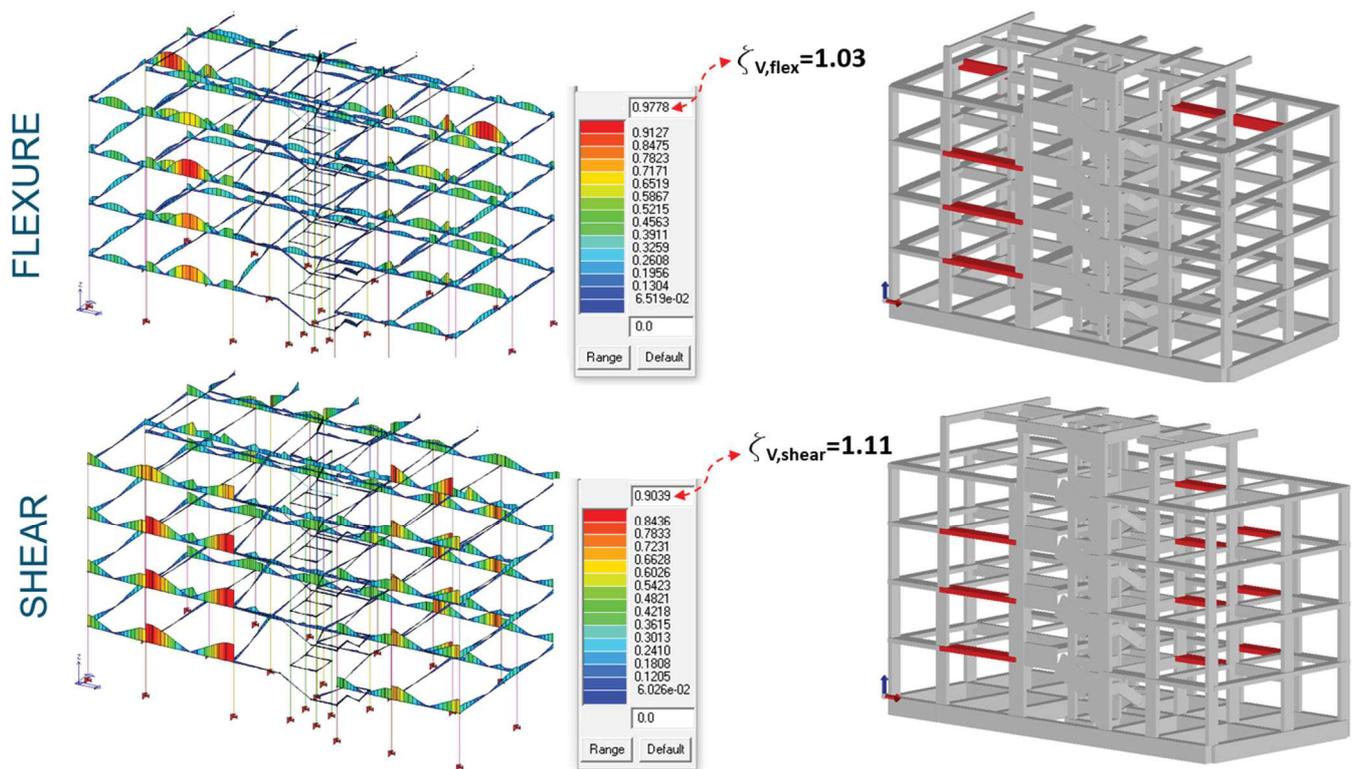
Figure 12. Gravity load verification (extracted from Pro_SAP software Startup version).

Figure 12 shows the results of the gravity load verifications under the flexure and shear of the column and beam members. The colormaps report the demand/capacity ratio of the structural members, which is always lower than 1.0, meaning that no members reach the full-strength exploitation under gravity loads. This indicates that the gravity load verification is fully satisfied. Therefore, the capacity/demand ratio (safety factor) is higher than 1.0 ($C/D = 1.03$ for flexure and 1.11 for shear).

The red elements reported in Figure 12 on the right are those that first reach the limit condition represented by the achievement of the stress equal to the strength at the section level.

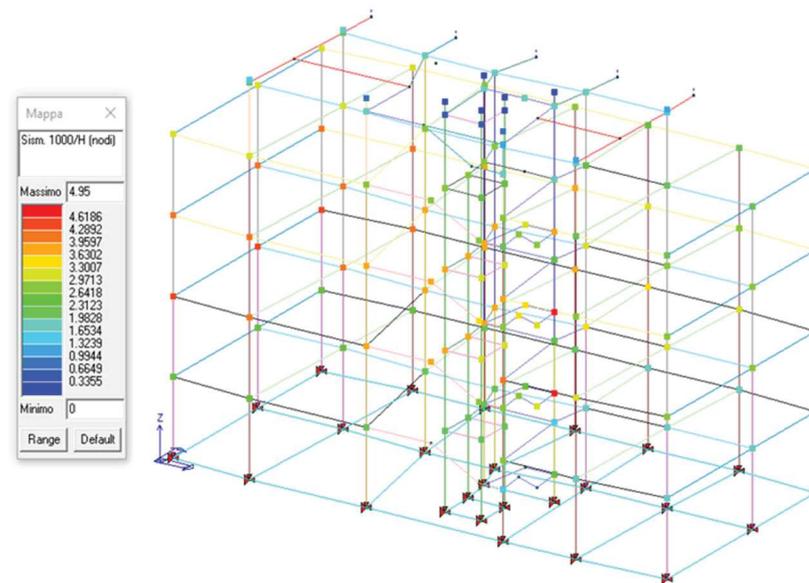
Figure 13. Colormap of interstory drift values (as % of interstory height, extracted from Pro_SAP software).

The Italian code prescribes that the interstory drift ratio must not exceed 5%. According to the analysis results, the maximum interstory drift ratio is equal to 4.95%, within the limit value. The maximum interstory drift is experienced at the second story, as reported in Figure 13. This check is crucial to understand that no intervention to reduce displacements is needed. Therefore, the structural stiffness does not need to be increased.

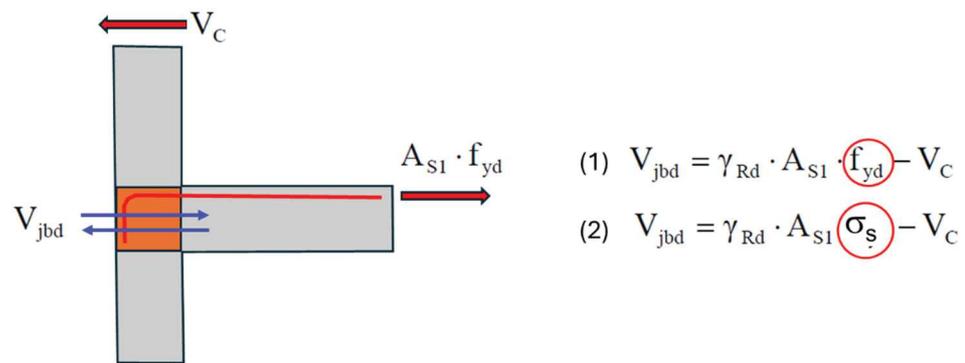
Figure 14. Safety checks of beam–column joints.

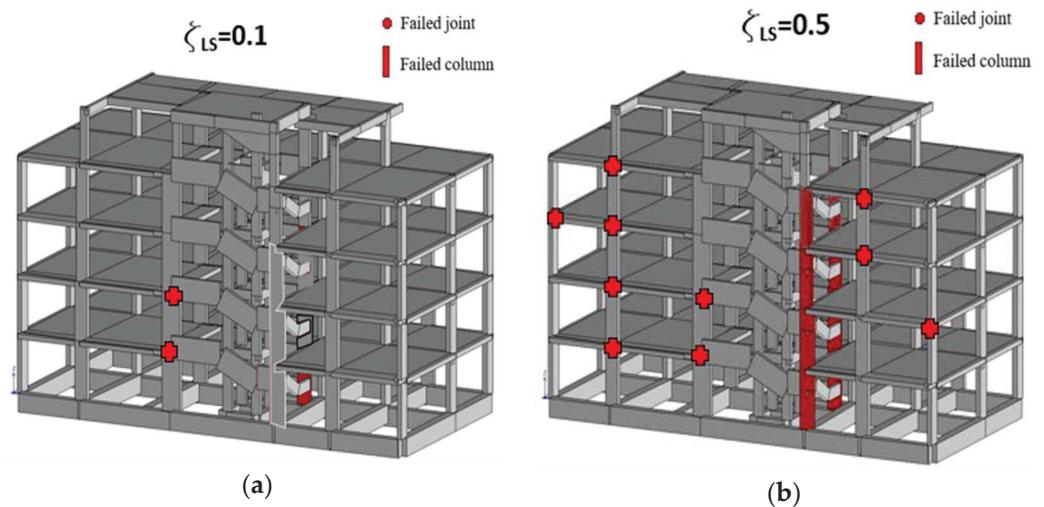
Figure 15. Safety checks of beam–column joints for $\zeta_{LS} = 0.1$ (a) and $\zeta_{LS} = 0.5$ (b) (extracted from Pro_SAP software).

This enables greatly reducing the number of unchecked joints, preventing overconservative assessments. Following this procedure, the LS limit state seismic acceleration was found and the safety index calculated, as reported in Figure 15a.

In fact, $\zeta_{LS} = 0.1$ indicates that the building structure in the as-built condition is able to sustain only 10% of the design seismic action. At that stage, two beam–column joints and one column member failed under shear. A fully code-conforming structure should have an index value equal to at least 1.0.

In order to obtain an outline of a possible retrofit intervention, the seismic action has been gradually increased. Increasing the seismic action to 50% of the seismic design value, seventeen joints and six column elements failed under shear, as indicated in Figure 15b. It must be noted that, without the assumption of Figure 14, there would be sixty-three failed joints, with severe consequences regarding the retrofit intervention.

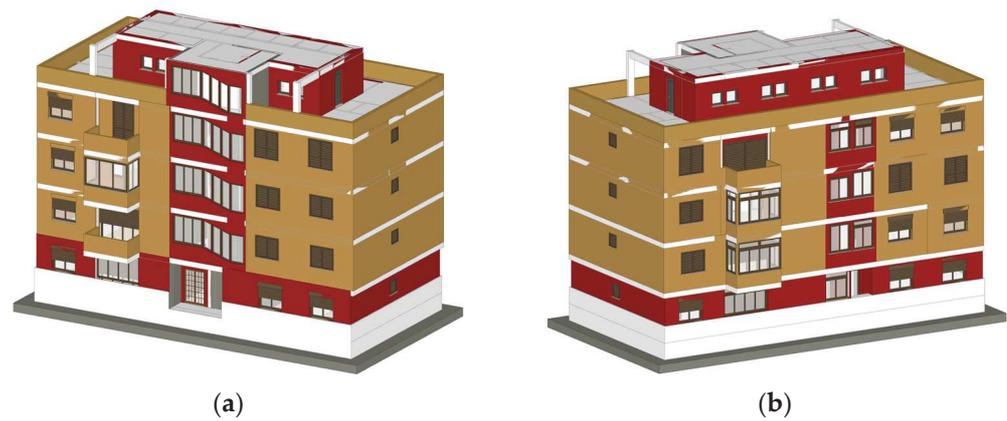
Figure 16. The three-dimensional model: (a) east view and (b) west view (extracted from TerMus BIM software, 52.00e version).

In Figures 16 and 17, the created three-dimensional model is shown.

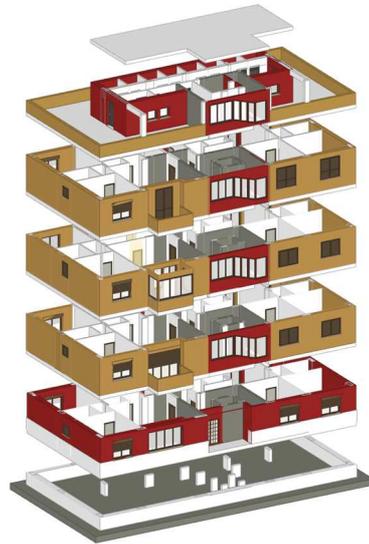
Figure 17. Vertical building development (extracted from TerMus BIM software, 52.00e version).

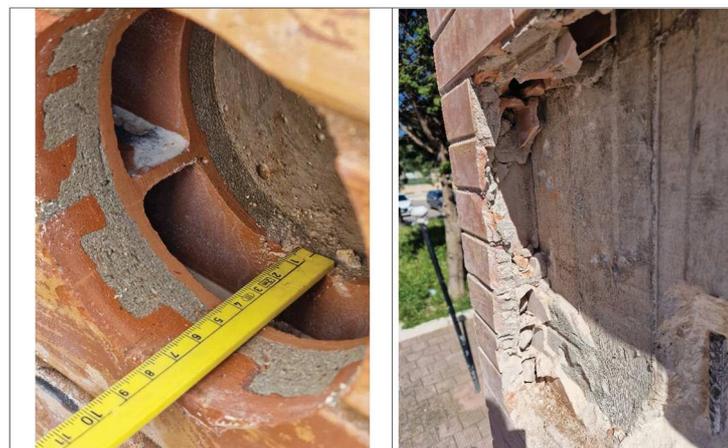
Figure 18. Results of the coring tests and visual inspections.

The transmittance, used in the simulation software, was calculated from the results of the coring tests performed on the wall package. In Figure 18, two wall packages are evidenced.

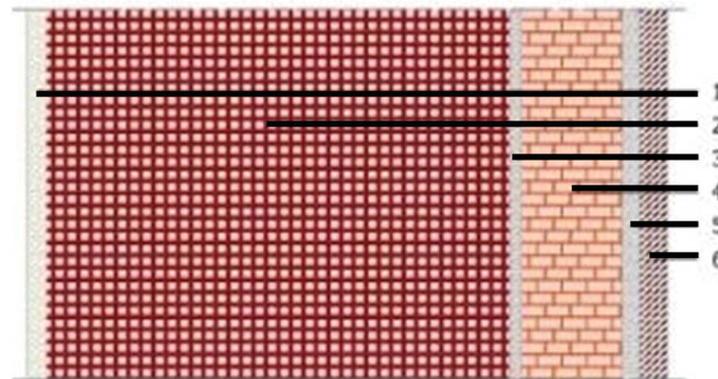
Layer	Description	Thickness [mm]	Conductivity [W/mK]	Conductance [W/m ² K]	Surface mass [kg/m ²]	Vapor resistance [-]	Specific heat [J/kgK]	Thermal resistance [m ² K/W]
	Internal adductance	0		7.7				0.1299
1	Internal plaster	15	0.7	46.6	21	10.7	1,000	0.0214
2	Perforated brick block 370x250x250	370	-	0.94	248	9.3	840	1.06
3	Cement mortar	10	1.4	140	20	22.7	1000	0.0071
4	Solid, perforated, light bricks - density 800	80	0.297	3.7	64	5.7	840	0.2694
5	Cement mortar	15	1.4	93.3	30	22.7	1,000	0.0107
6	Marble	20	3.5	175	56	10,000	1,000	0.0057
	External adductance	0		25				0.04

Figure 19. Detailed stratigraphy of the envelope infill wall with marble cladding (adapted from TerMus BIM software).

The stratigraphy is visible from the coring tests, and four types of infills were considered and modeled in the TerMus software. Figure 19 shows the detailed stratigraphy of the envelope wall equipped with marble cladding, located at the building base, while Table 5 shows the physical characteristics assumed in the energy audit.

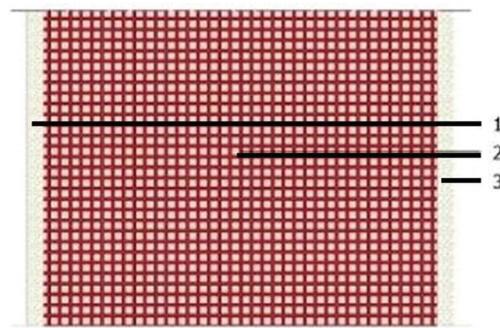
Layer	Description	Thickness [mm]	Conductivity [W/mK]	Conductance [W/m ² K]	Surface mass [kg/m ²]	Vapor resistance [-]	Specific heat [J/kgK]	Thermal resistance [m ² K/W]
-	Internal adductance	0	-	7.70	-	-	-	0.13
1	Internal plaster	15	0.7000	46.66	21.00	10.72	1,000	0.021
2	Perforated brick block 370x250x250	370	-	0.94	248.00	9.38	840	1.06
3	External plaster	15	0.9000	60.00	27.00	22.70	1,000	0.017
-	External adductance	0	-	25.00	-	-	-	0.04

Figure 20. Detailed stratigraphy of the general envelope infill wall (adapted from TerMus BIM software).

Figure 20 shows the detailed stratigraphy of the general envelope wall composed only of perforated blocks with plaster inside and outside, used in most of the building's perimeter walls.

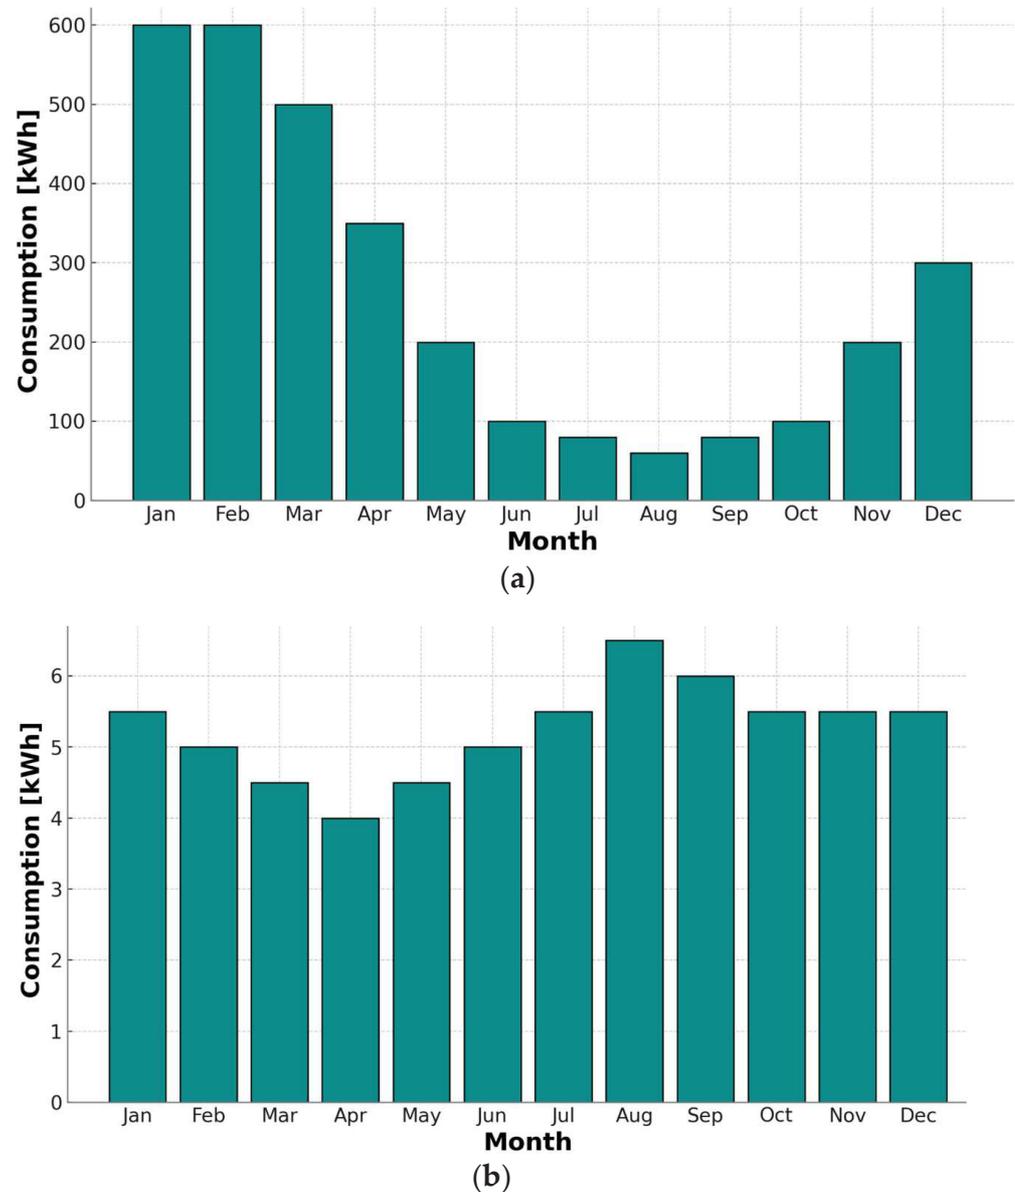
Figure 21. (a) Natural gas and (b) electricity consumption over one year (adapted from TerMus BIM software).

The consumption data were obtained through the customer service of local distributors (Figure 21). In particular, for electricity, we received data from Enel Distribuzione and data for natural gas from Italgas. These data were entered into the model by dividing the information for each individual apartment.

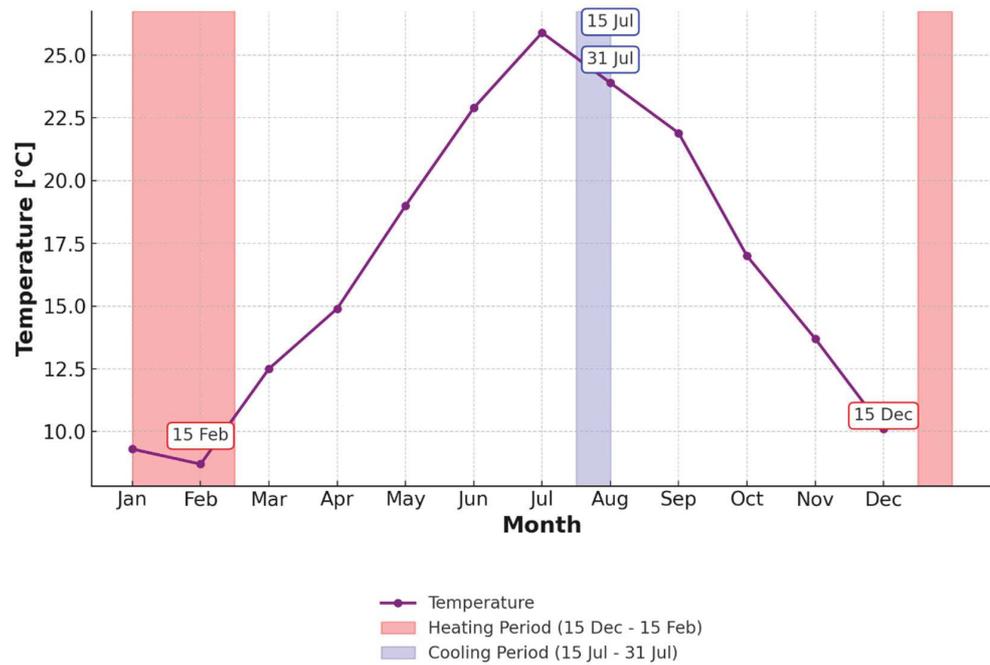
Figure 22. Regulation of the operating periods of air conditioning systems for an apartment (adapted from TerMus BIM software).

This aspect is due to the fact that the regulations, for climate zone C, stipulate an on-time period for heating that runs from November 15th to March 31st and an on-time period for cooling that runs from June 10th to September 4th (Figure 22), while, in reality, based on the information provided by the tenants, the operation periods do not coincide with those in the regulations but are related to the habits of the tenants.

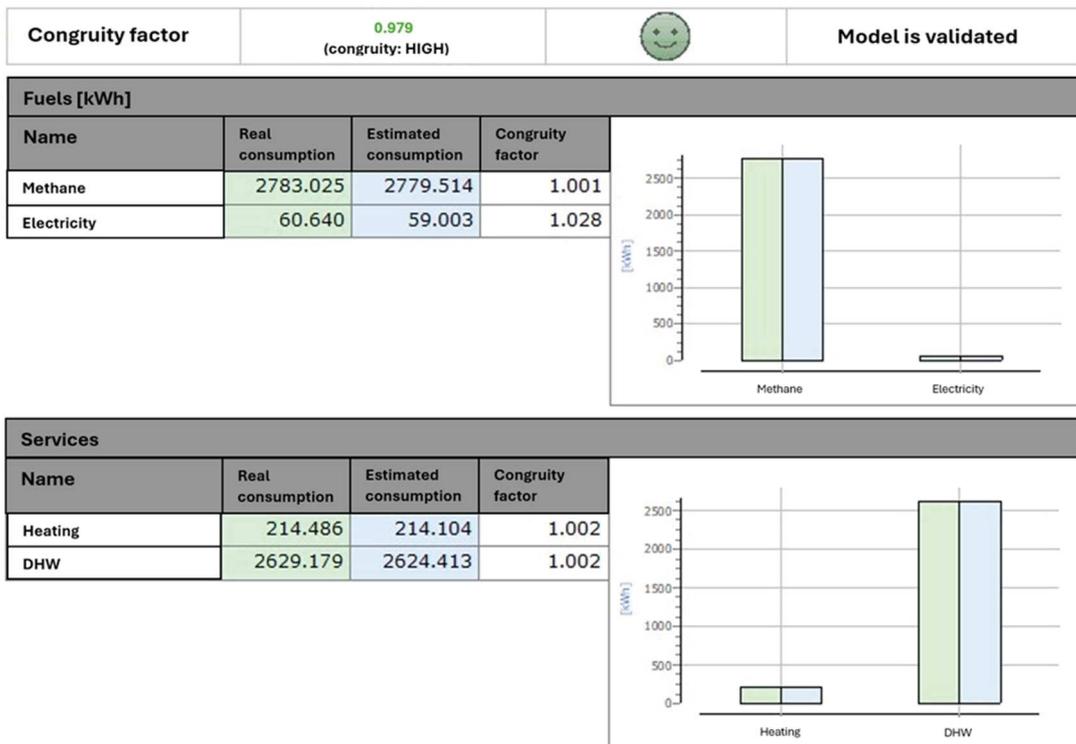
Figure 23. Model validation (adapted from TerMus BIM software).

Therefore, to calibrate the model, a consumption analysis was carried out, acting, for each apartment, on the turn-on period of the winter and summer air conditioning systems, as in Figure 23.

In Figure 23, the positive validation of the calculation model is shown, with a congruity factor of 0.979.
