Natural Hazards, Human Factors, and “Ghost Towns”: a Multi-Level Approach

Geoheritage

DOI 10.1007/s12371-019-00377-y

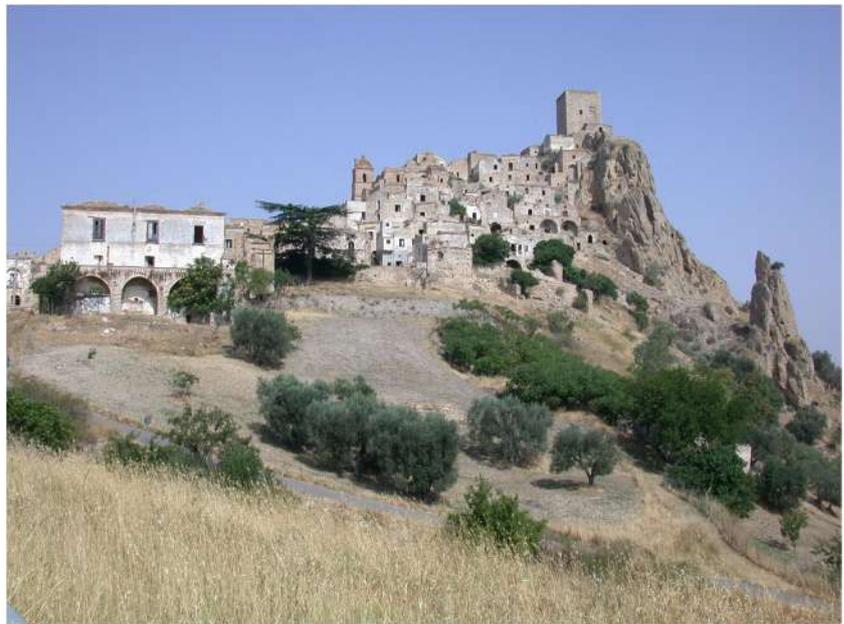
Fig. 3 The Craco old town taken from south-east (photo by Bentivenga M)

The old Craco is a small (abandoned) town located in the southern-eastern portion of the Basilicata Region (Southern Italy, Figs. 2 and 3), largely occupied by a tertiary fold-and-thrust belt that recorded episodes of both positive and negative inversion tectonics (Tavernelli and Prosser 2003). From the geological point of view, the Craco ridge on which the town of medieval origin was built is located just to the west of the buried front of the Southern Apennine Chain (Fig. 4a). It is situated at about 390 m a.s.l. and extends in a north-west-south-east direction, bounded on the south-west by
