Restoration Anamnesis as a Knowledge Tool: The Case Study of St. Nicholas' Basilica in Bari

Laura Morero , Antonella Guida , and Nicola Masini

2 St. Nicholas' Basilica and Its Restoration: From Its Origins to the 2000s

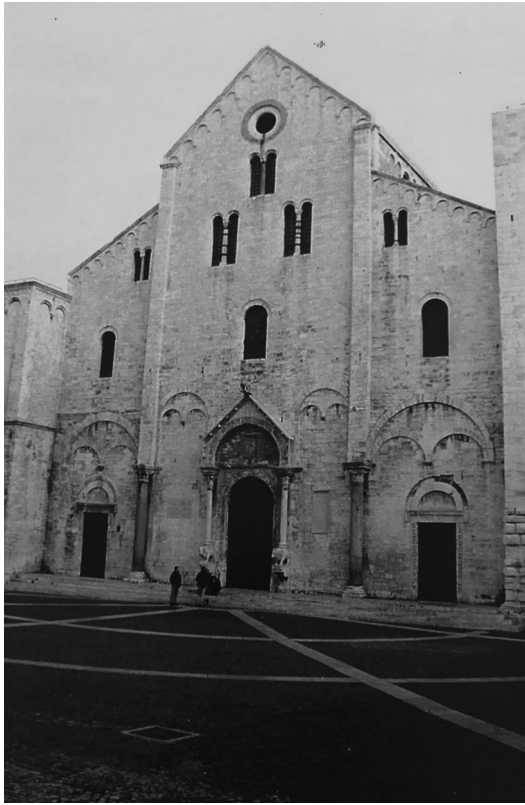
Fig. 3 1998, Basilica main elevation (west side) (A-SABAP-BA 1999)

The documentation reports a careful survey of the state of the church, which reveals a considerable difference in the state of conservation, from the interior to the exterior. Indeed, if the naves and the transept are in good condition, also thanks to recent restoration work (A-SABAP-BA 1990), the state of the exterior walls (Fig. 3), the spaces behind the apses, the towers, the crypt (Fig. 4) and the hexaforated galleries is quite different, as they are in need of major restoration work both from a structural point of view and due to the state of conservation of the materials, which are seriously deteriorated. In addition, the north-west tower, the masonry in the area behind the apse and, in particular, the masonry on the east elevation is affected by static instability, with evidence of lesioning and deformation phenomena in progressive evolution (A-SABAP-BA 1998, 1999).

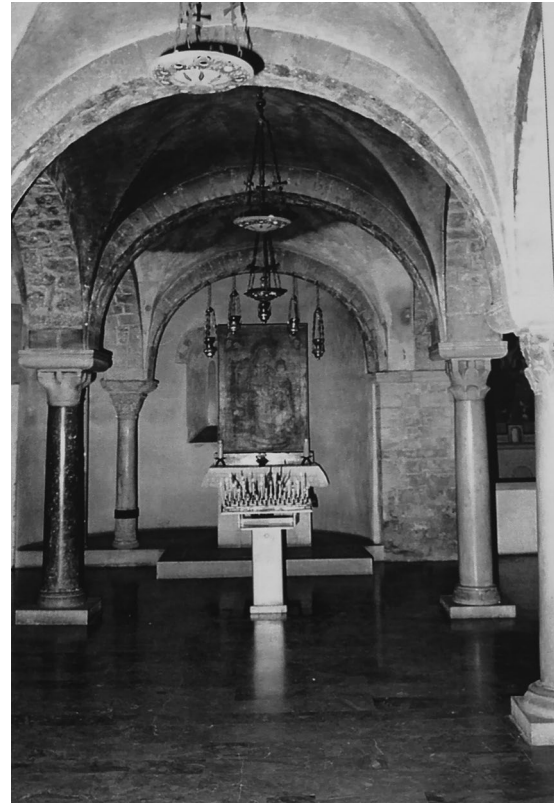
Fig. 4 1998, Detail of the crypt (A-SABAP-BA 1999)

The constant flooding that damaged the crypt for years (A-SABAP-BA 1998, 1999) is certainly an example of this and was not resolved by the drainage and consolidation work just described, even though it was considered one of the most important and consistent interventions to mark the basilica.

For example, we know from the documents that in 1999, both the crypt and the retro-apsidal areas showed widespread rising dampness and blackening, and that as a result new restoration and dehumidification work was carried out by creating an external perimeter cavity on the south side.
