# R/C Existing Structures with Smooth Reinforcing Bars: Experimental Behaviour of Beam-Column Joints Subject to Cyclic Lateral Loads

**Abstract:** The paper illustrates the results of experimental tests performed on sub-assemblages of R/C (Reinforced Concrete) existing structures, designed only for gravity loads. In order to estimate failure mechanisms and ductility properties, four internal and external R/C beam-column joints were built and tested. The specimens were built by using concrete with low strength and smooth reinforcing bars, without hoops into the panel zone. The tests were performed by increasing cyclic horizontal displacements up to the collapse. The experimental results show that seismic response of these kind of structures is mainly influenced by bond slips of longitudinal bars, and that the shear collapse regards external joints rather than the internal ones. Failure mechanisms observed (column plastic hings for internal joints, shear failure for external joints) point out the vulnerability of these structures due to the soft storey mechanism. The study is significant for better understanding of the inelastic seismic behavior of the R/C existing buildings with sm

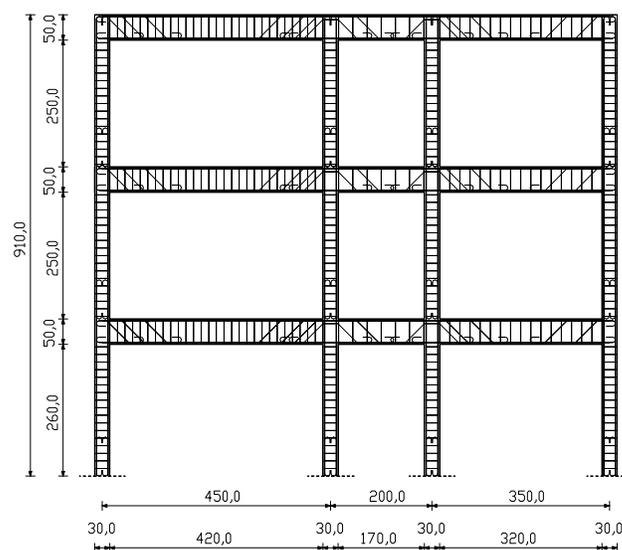
Fig. (1). Prototype R/C frame (all dimensions are in cm).

The experimental study, object of the present paper, refers to a prototype structure, which is a representative example of an inadequate seismic design. The prototype frame, whose geometry was chosen from a structural

typology, consists of 3 floors and 3 spans (Fig. 1). It represents a typical structure built in Italy in the '50s-'70s and designed to resist only to vertical loads in according to the regulations in force during that period [13, 14].

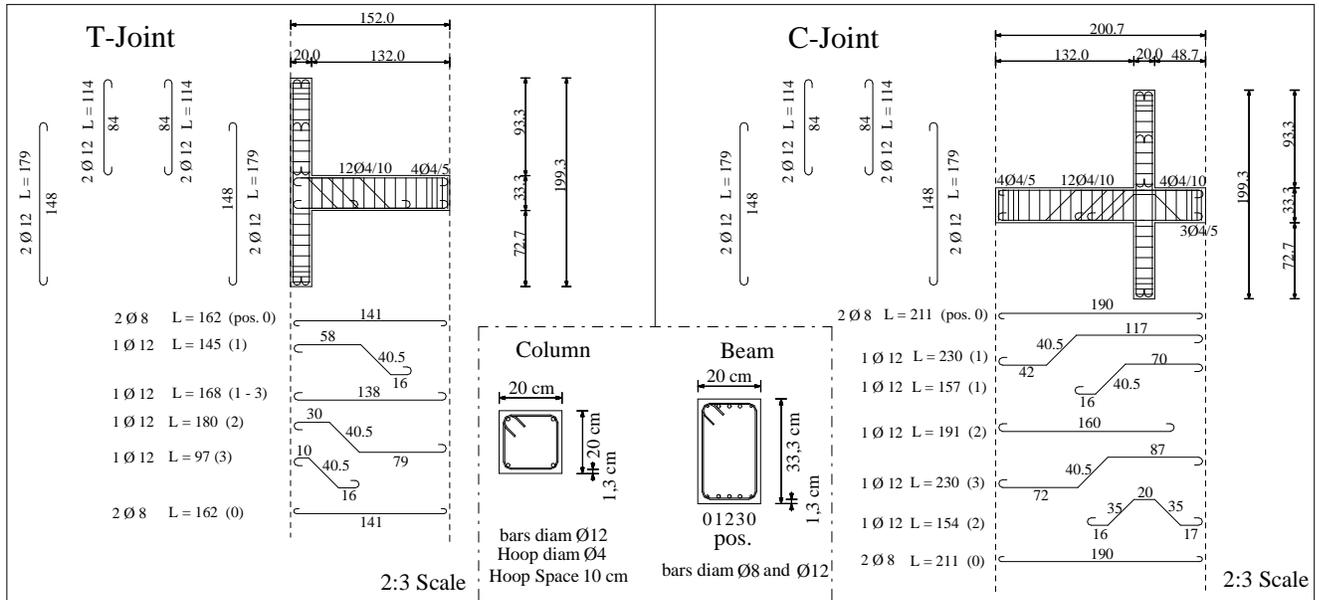
Fig. (2). External T-Joint and Internal C-Joint reinforcements (all dimensions are in cm and diameter of bars are in mm).

The beam-column specimens are named as follows: internal joints (C-Joints) as C11-1, C23-1 and C23-2 (two joints with the same details); and the external ones (T-Joint) as T23-1 (11 is the full scale and 23 represents the 2:3 scale). The specimens are reinforced with smooth bars whose diameters are 18 mm and 12 mm for the longitudinal reinforcements and 6 mm for the stirrups. These values are reduced to 12 mm, 8 mm and 4 mm in the case of 2:3 scale. The Fig. (2) shows the joint reinforcement details, while the Fig. (3) represents some steps of the manufacturing process, such as the preparation of the formwork, the reinforcement details and the concrete cast. As it is clearly visible from the figures, the specimens are built horizontally and monolithically, and this does not allow neither the effects evaluation of the construction of each joint nor the possible different concrete consolidation along the columns. On the other hand, this way of building up the specimens avoids the influence on the test of other secondary variables. The frame shows the same typical structural characteristics of the existing buildings designed only for gravity loads. They can be summarized as follows:

- 1) Inadequate confinement at the critical regions of the elements;
- 2) Lack of transverse reinforcement in the joint panel;
- 3) Inadequate longitudinal reinforcements of the columns;
- 4) Low quality of materials (such as concrete and steel) if one has to compare them with the properties required currently in seismic areas in particular:

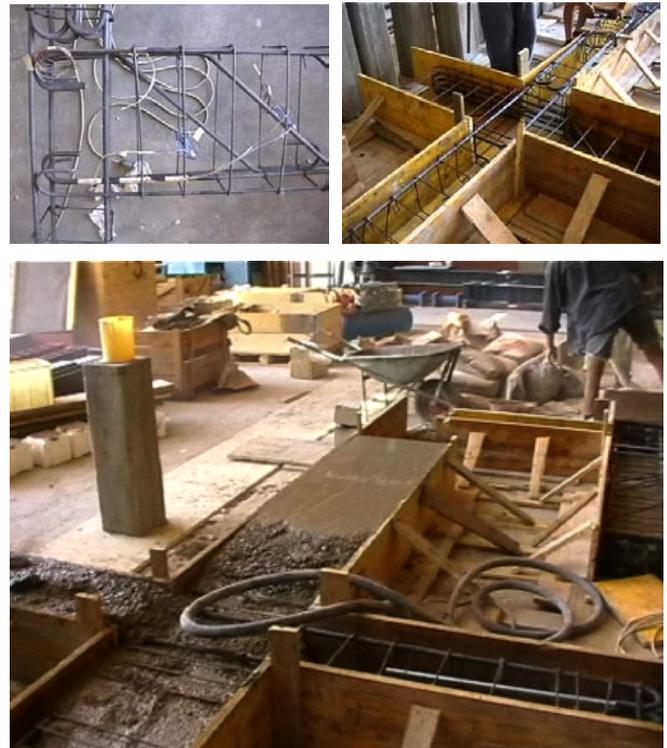
Fig. (3). Beam-column joints manufacturing process.

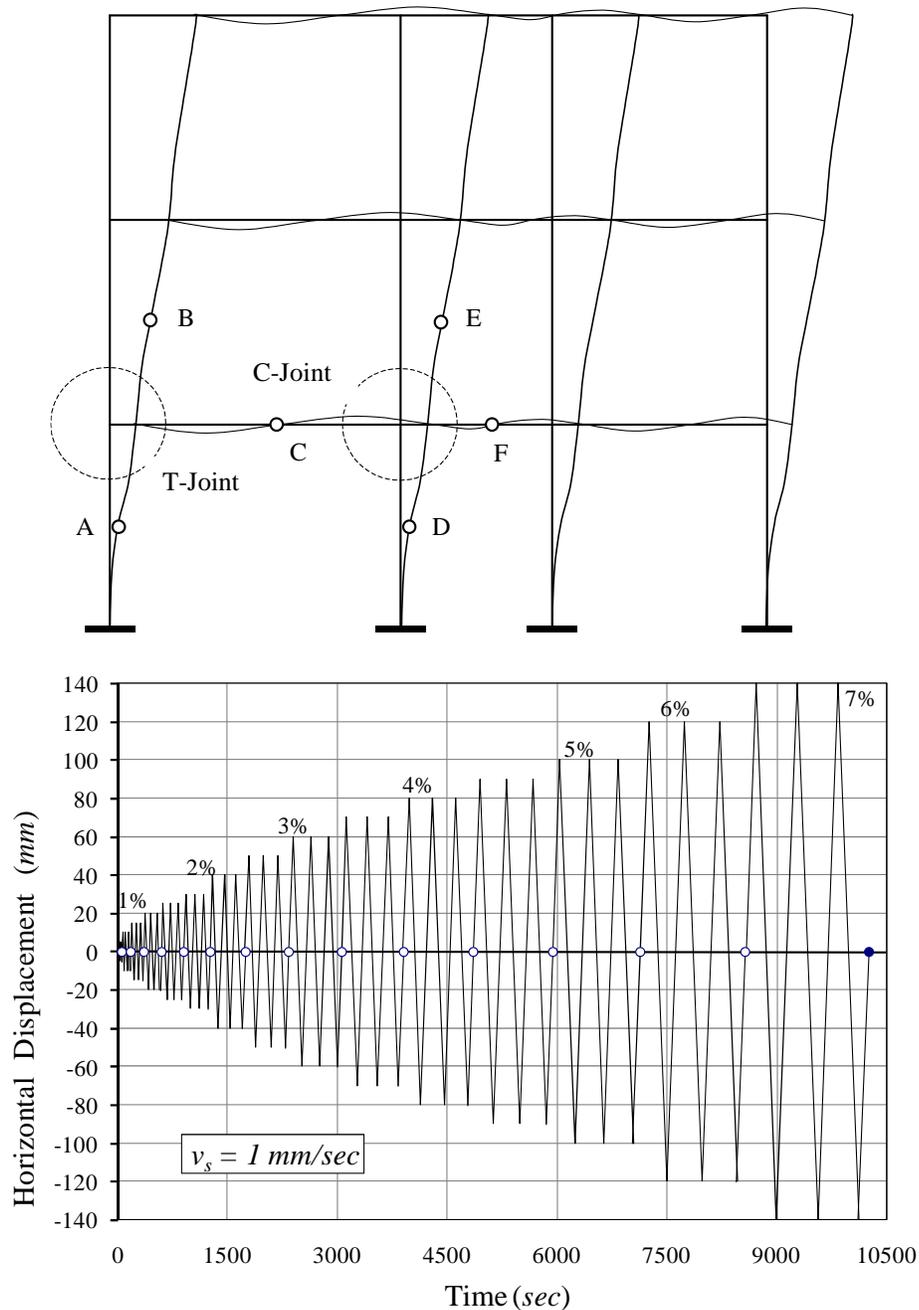
**Fig. (4).** Seismic deformation of prototype frame and displacement pattern applied to tested joints.

The way of carrying out this kind of tests, that is most commonly used, has the aim to reproduce, in the beam-column subset (ABC = T-Joint; CDEF = C-Joint), the same deformed shape that it would have in the whole structure under the effect of horizontal actions (Fig. 4).

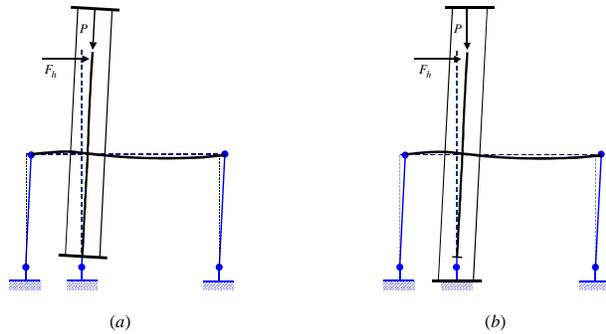
**Fig. (5).** C-Joints test setup: (a) (C23-1, C11-1) P axial; (b) (C23-2) P vertical ( $P\Delta$ ).

(Fig. 5): axially, for the C23-1 and C11-1 joints, as well as for the external T23-1 joint; and along the vertical one, for the C23-2 joint in order to simulate the  $P-\Delta$  effect Fig. (10) shows the test setup. The control on the horizontal displacements was performed using an actuator of +490 kN / -290 kN, connected to a R/C reaction wall and to the column head by hinges. The gravity load was applied using a jack with a capacity of 1500 kN. The system used to apply the gravity load is made of two steel plates and four bars behaving as ties. The system is internally self-equilibrated in case of gravity load axially applied. Therefore only the column shear is transmitted to the base hinge.

In the test with  $P-\Delta$ -effect, whereas, the basic hinge also absorbs the axial force of the column, while the contrast system acts as a hinged parallelogram. In order to gauge the significant strains of the beam-column joints, a system of linear transducers (LVDT) was used. It was arranged according to the Fig. (6) layout.

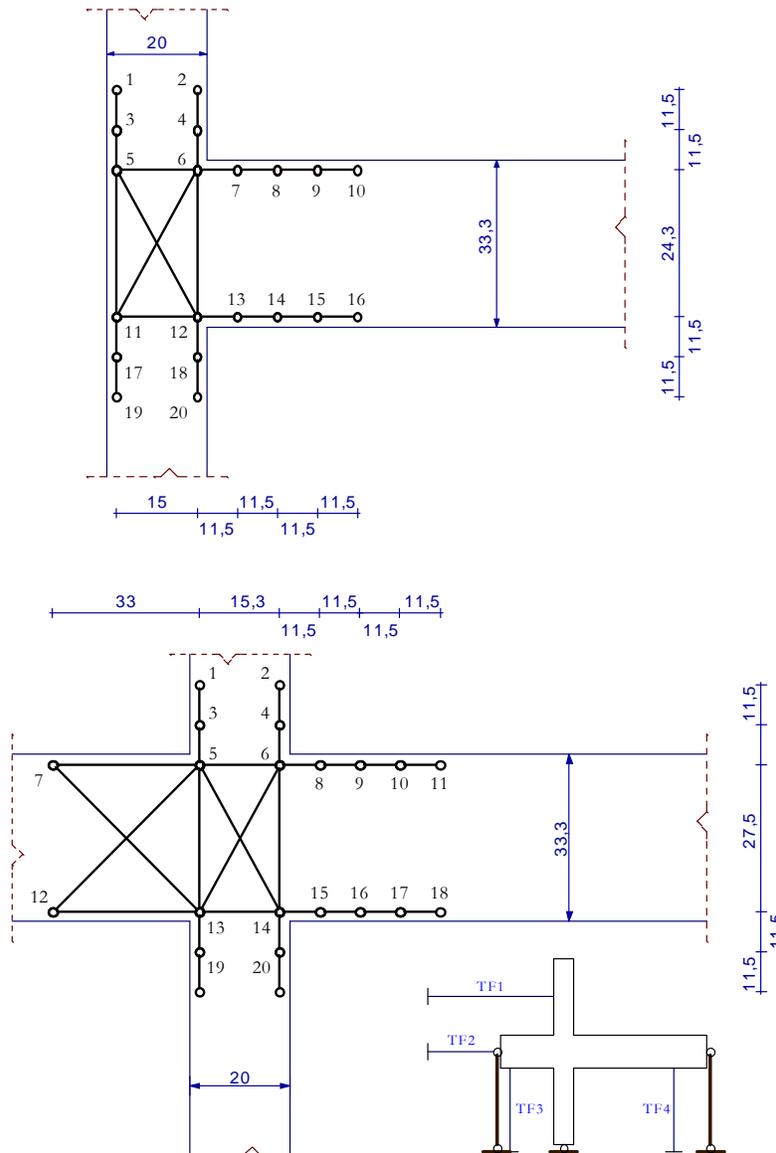
**Fig. (6).** Local and global displacement transducers (all dimensions are in cm).

The horizontal displacement at the top of the upper column was measured by a transducer with a stroke of 300 mm. The same kind of transducer was used to measure the horizontal and vertical displacements next to the steel rods. Six linear transducers of 25 mm and  $\pm 50$  mm were arranged on a side of the joint panel, in order to gauge any deformation due to diagonal cracks. At a distance of 35 mm from the upper and lower beam edges, starting from the joint panel, several linear transducers were arranged to quantify the flexural strains. Similarly, some transducers of  $\pm 10$  mm were arranged in the upper and lower columns to quantify the flexural strains.

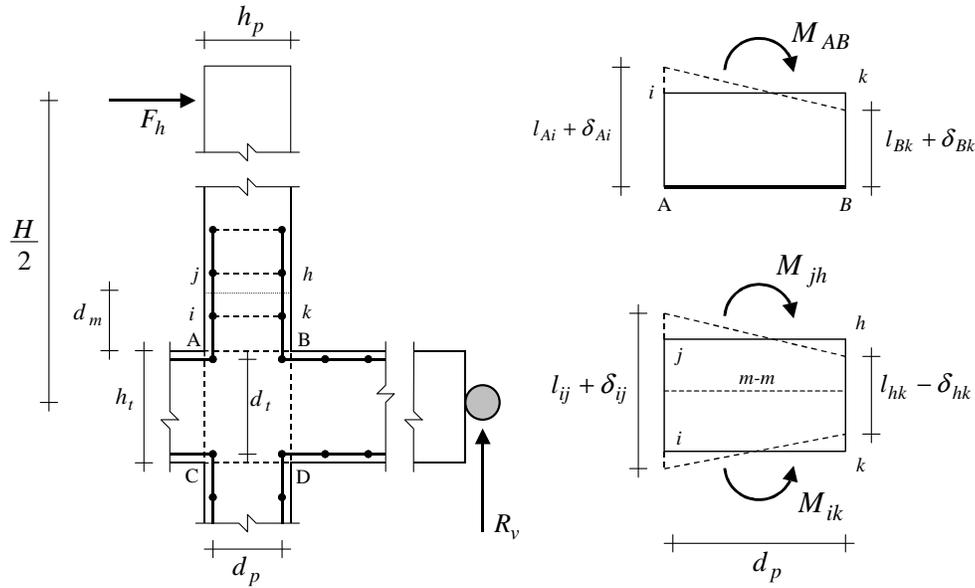
Fig. (7). Rotation and curvature measurements in the columns.

The rules adopted to evaluate rotations and curvatures are shown in Fig. (7). The clockwise joint rotation and the corresponding curvatures of the members (beams or columns) are assumed to be positive. The rotation between the ends (*ij* and *hk* faces) of the column element *ijhk* is given by the equation (1):

$$\varphi_c = \frac{\delta_{ij} - \delta_{hk}}{d_p} \quad (1)$$

where  $d_p$  is the distance between the left and the right transducers. The average curvature is given by the equation (2):

$$\chi_c = \frac{\varphi_c}{l_c} \quad (2)$$

where  $l_c$  is the length of the examined column block. Thus, the element average moment is referred to the midway section *m-m* between the ends. Just for the first element of the columns it was assumed to refer the moment to the AB section (Fig. 7). In order to control the axial load applied to the column and to quantify the rod reaction (shear in beams), load cells of  $\pm 200$  kN were used. One cell was located between the vertical jack and the top of the column, while the following two were located between the hinge and the steel rod, at the end of the beams. A cell of  $\pm 500$  kN was used to quantify the applied horizontal force (floor shear).

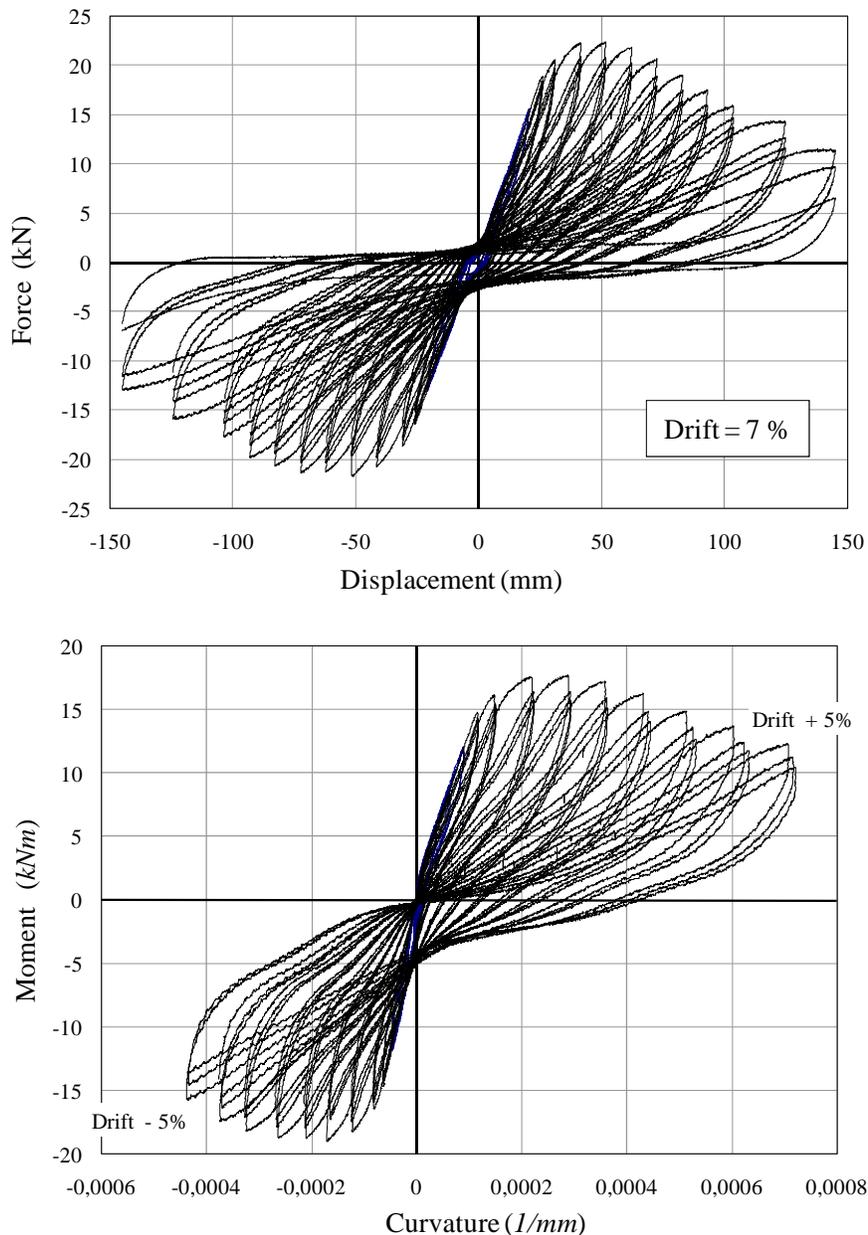
Fig. (8). C23-1 specimen: Force-Displacement experimental relationship and Moment-Curvature of the upper column.

Fig. (8) shows the experimental relation occurring between the imposed horizontal displacement and the force applied by the actuator to the C23-1 joint, and moment-curvature diagram at the base of the top column. All cracks in the beam-column joint occurred during the first three cycle groups (max inter-storey drift = 0.75%). The Fig. (9) shows the cracks pattern, specified as follows:

The presence of consistent slips is also confirmed by the limited number of the cracks and by their amplitude. The maximum strengths measured, in terms of horizontal force, are: 21.22 kN at the 2.5% drift, and 22.71 kN at the -2.5% drift. The maximum displacement reached during the test was equal to 140 mm (7% drift); at this displacement the strength was equal to 10 kN in the first cycle and 5.35 kN (≈25% of maximum strength) in the third cycle. From the force-displacement relationship can be observed that, except for the last group of the cycles, the strength reduction between one cycle and the following one tends to decrease. This fact highlights a trend towards the stabilization of the degrade mechanisms that is the source of the ductile

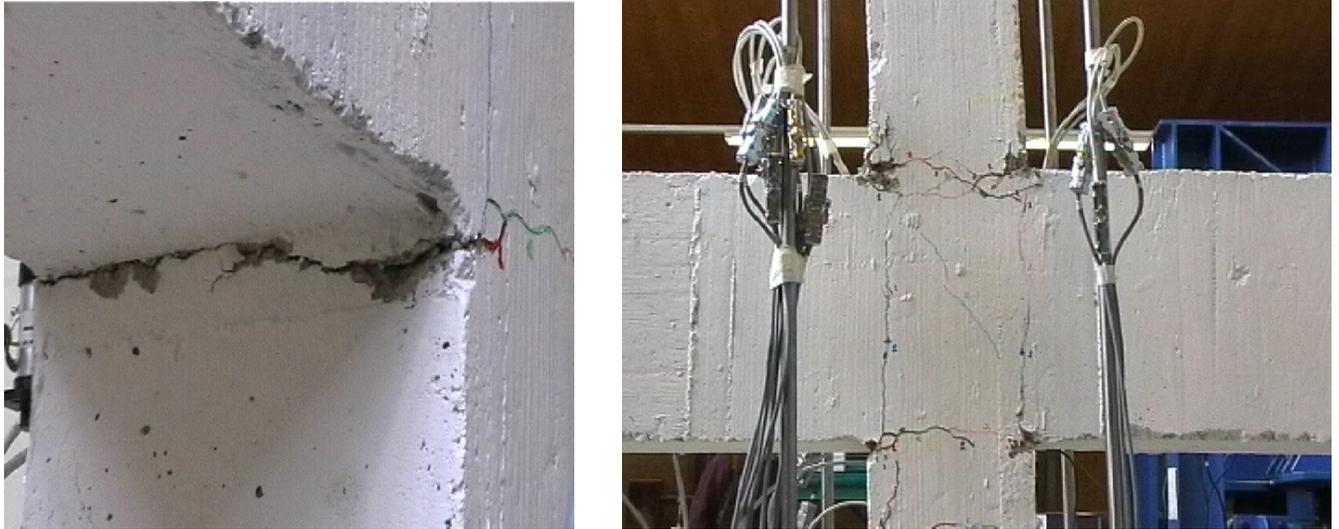
**Fig. (9).** Crack pattern of C23-1 specimen.

- diagonal micro-cracks within the joint panel;
- flexural cracking of the columns at the interface with the joint panel;
- flexural cracks in the columns at approximately 12 cm from the joint panel;
- flexural crack of the long beam at the interface with the joint panel;
- flexural crack of the long beam at the last longitudinal bar bend.

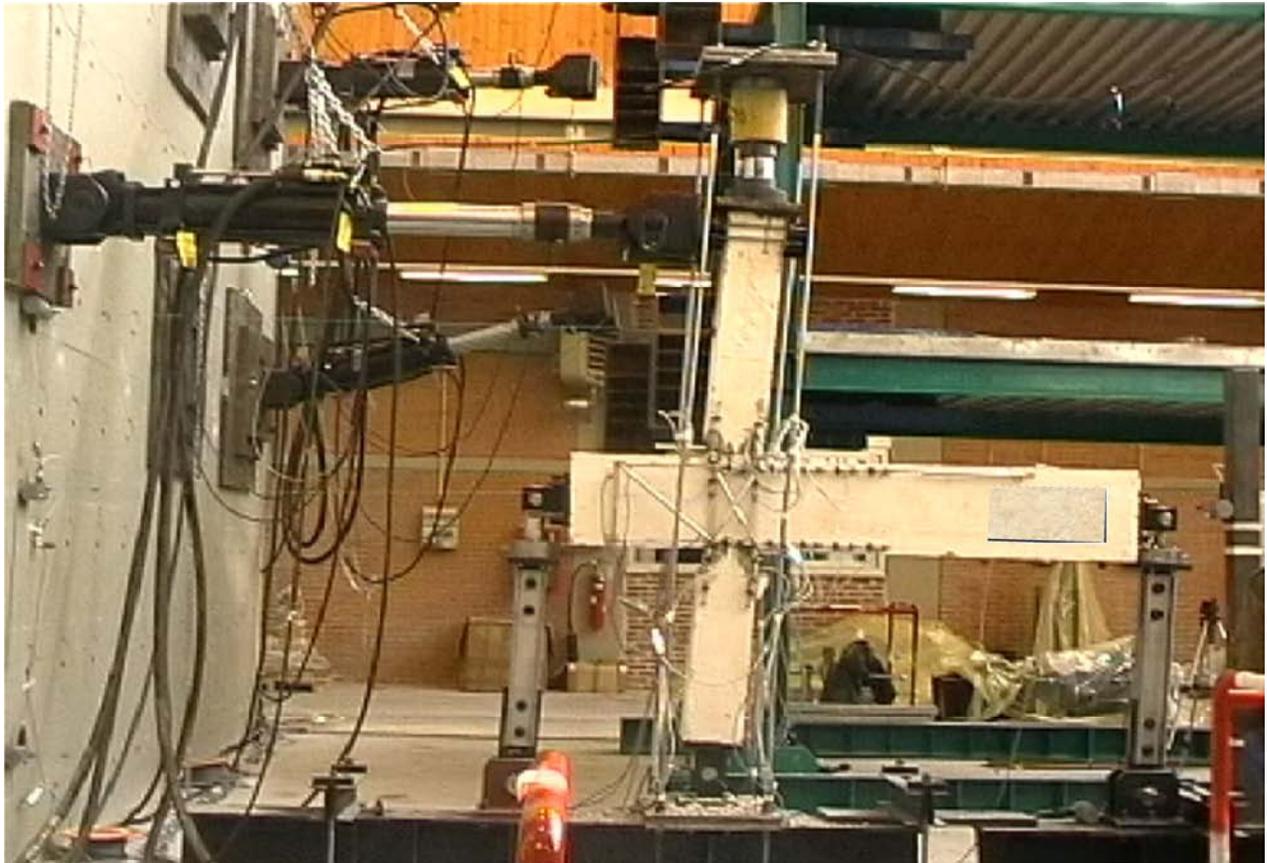
**Fig. (10).** C23-2 test.

The structural beam-column joint C23-2 (Fig. 10) has an initial behavior similar to the C23-1 joint.

where  $P$  is equal to the axial load applied to the upper column and the vertical component of the base hinge reaction for the lower column,  $\Delta$  is the drift of the upper column or of the lower column. Comparing the responses of the C23-1 and C23-2 joints (Fig. 12) it was observed a lower strength reduction to the horizontal action due to the P- $\Delta$  effect than the theoretically expected value (which was equal to the P- $\Delta$  moment divided by the column length). This is probably due to the non-perfectly-vertical jack axis, which occurred during the test and also visible with the naked eye (Fig. 10).

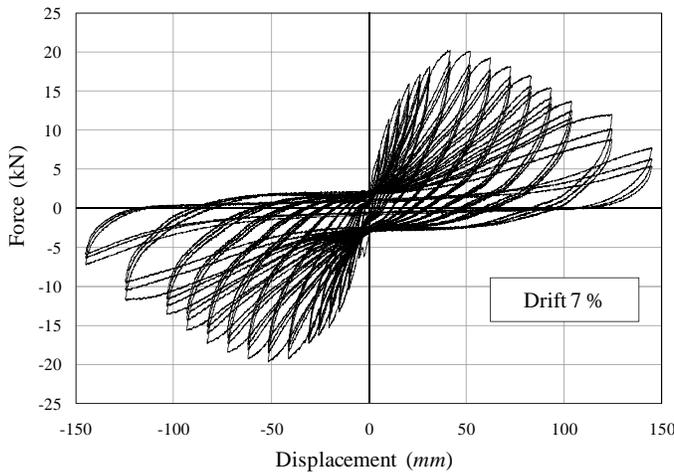
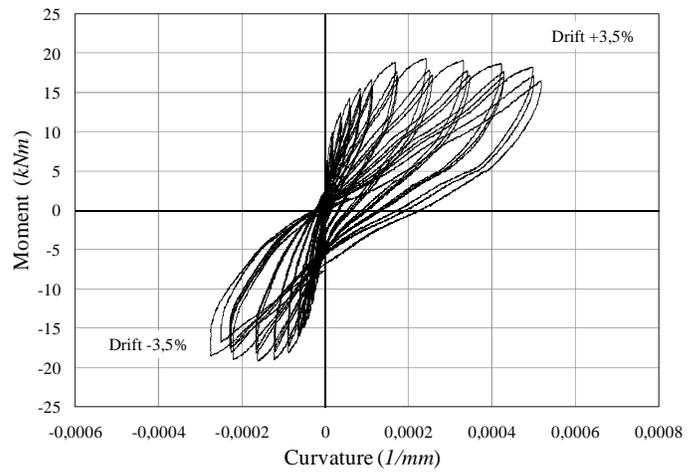
Fig. (11). C23-2 specimen: Force-Displacement experimental relation and Moment-Curvature of top column.

vertical load ( $P-\Delta$  effect) determines a significant stiffness and strength reduction (Fig. 11).

For the C23-2 joint the curvatures were measured by using the displacement values of the 3-5 and 4-6 transducers for the upper column (Fig. 11), and the displacement values of the 13-19 and 14-20 transducers for the lower column.

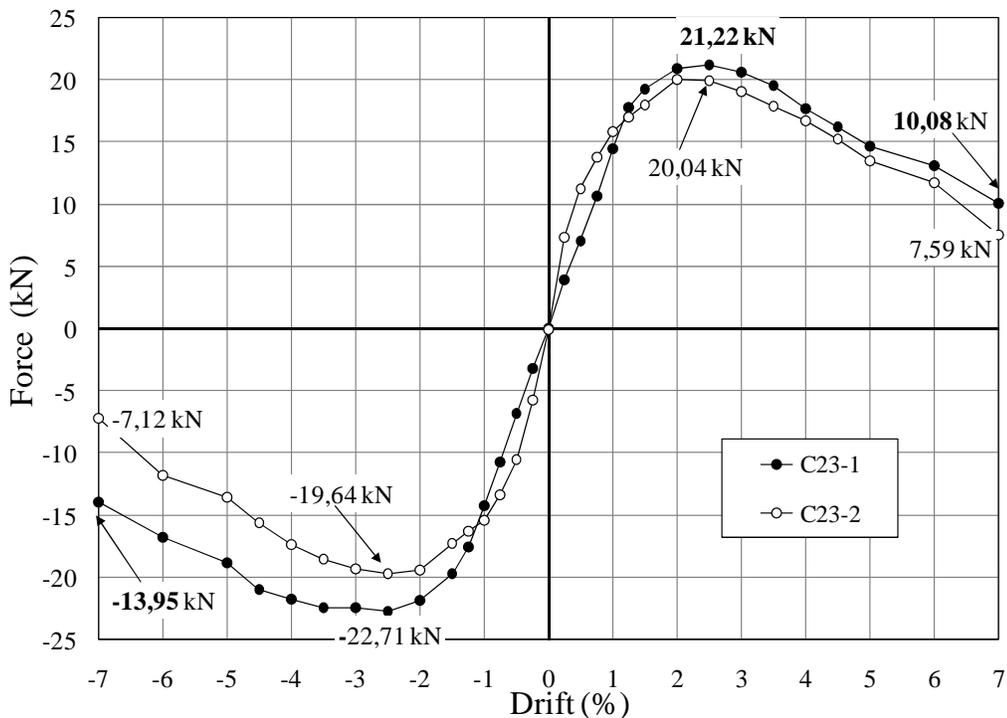
Fig. (12). Force-Displacement envelope curves of C23-1 and C23-2 joints.

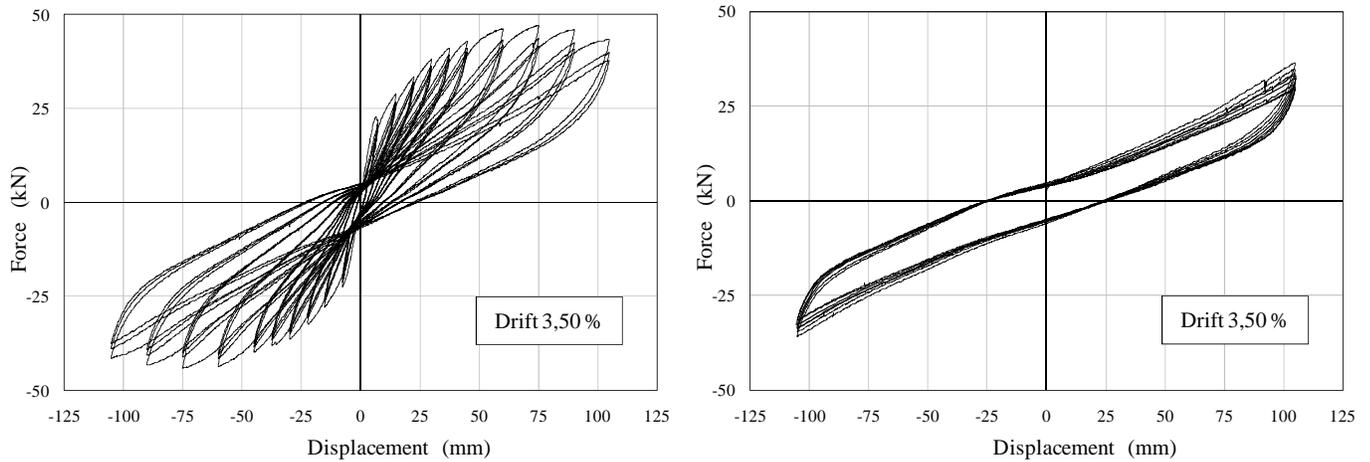
**Fig. (13).** C11-1 specimen: Force-Displacement experimental relationship and Additional groups of cycles (Drift: 3, 50%).

Fig. (13) shows the experimental relation between the force applied by the actuator and the imposed horizontal displacement, which was observed during the test carried out on the C11-1 joint. The first diagonal micro-cracks within the specimen already appeared during the first cycle (0.25% drift), as well as a flexural crack at the fix-end of the beam. During the first cycle of the second group (0.50% drift), the lower column began to show flexural cracking.

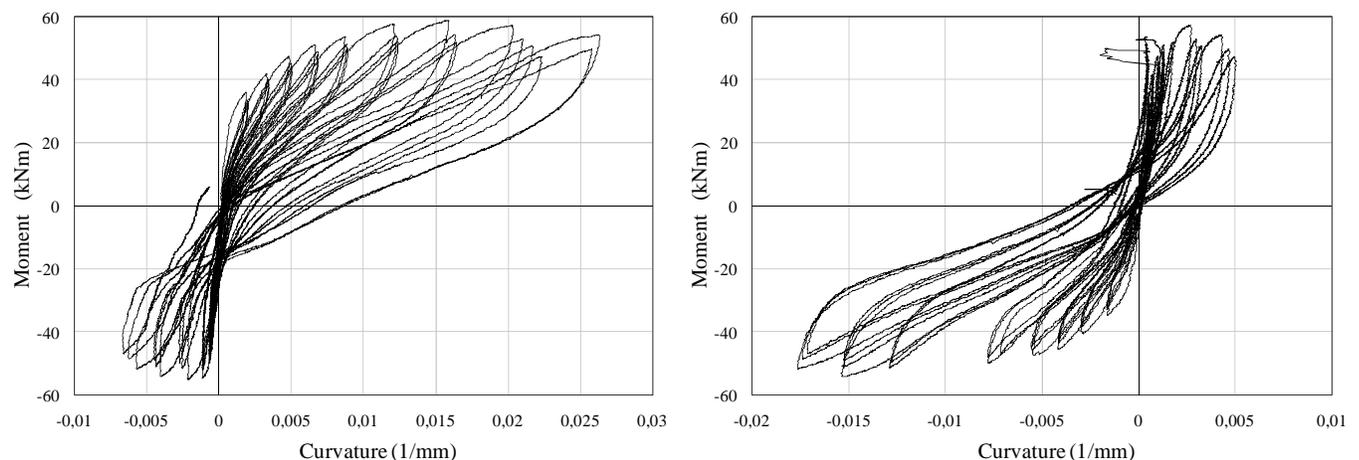
**Fig. (14).** C11-1 specimen: Moment-Curvature relation of top and bottom columns.

Fig. (14) shows the experimental moment-curvatures diagrams of the upper and lower columns, respectively, at the interface of the joint panel. It is important to outline that for the positive horizontal displacements the upper column curvature is higher than the one of the lower column. On the contrary, for the negative horizontal displacements the upper column curvature is less than the one of the lower column. The examined mechanism is due to the changing axial load applied to the lower column. As described in Fig. (15), when the horizontal force is positive, the reaction of the right rod (long beam) goes up while the reaction of the left rod (short beam) goes down. From the equilibrium derives an increasing axial force acting on the lower column and, consequently, greater flexural stiffness of the lower column in comparison with the upper one. Similarly, when the floor

shear is negative, a reduction of the axial force acting on the lower column occurs, causing an increase of the curvature at the interface with the joint panel. A critical issue, related to the slip of the bars, is the possible decay of the bond and the consequent reduction of the section flexural strength. This is mainly due to the cracking induced by the bar slip on the surrounding concrete, especially in presence of deformed bars. Accordingly with previous results, the failure flexural mechanisms, ruled by the smooth bar slip, put into evidence a minor strength decay of the force-displacement curve in the softening branch, mainly due to the progressive loss of the concrete cover followed by a reduction of the distance between the inner forces. Unlike the normal behavior of the members subjected to flexure and axial load with enhanced bond bars (deformed bars), the first two tests highlight a reduced decay of the cyclic response. This is further confirmed by the test performed on the C11-1 joint. At the 3.5% drift eight cycles in addition to the three programmed ones were imposed to the specimen (Fig. 14). Among the eight cycles, the two central ones (the fourth and fifth) were carried out at a displacement speed of 15 mm/sec, equal to ten times the speed used for the other cycles. In the groups of cycles at 3,5% drift, it can be observed that the reduction of strength is more evident between the first cycle and the

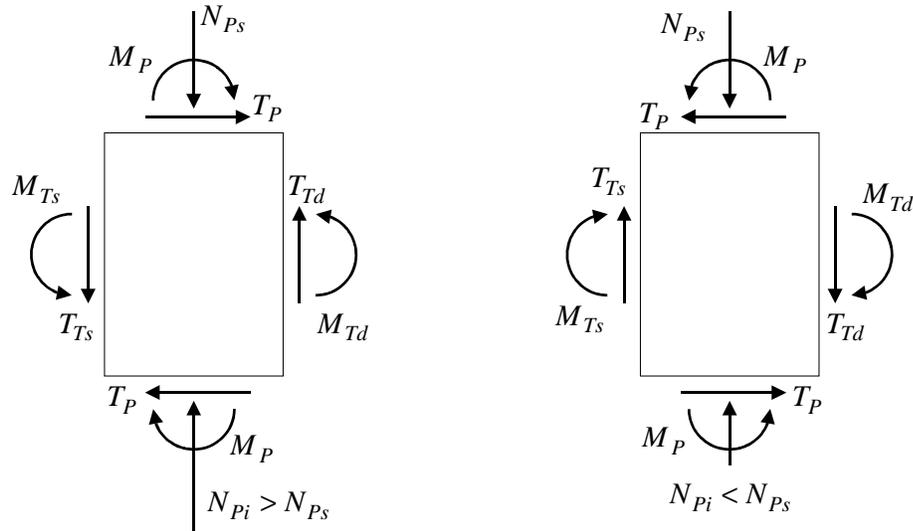
Fig. (15). C-Joint panel equilibrating forces.

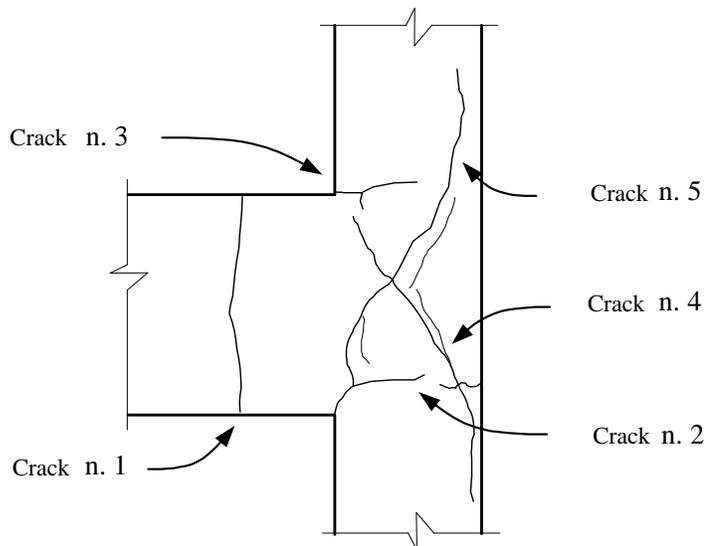
Fig. (16). T23-1 specimen: evolution of cracks pattern.

Evolution of cracks both in the joint panel and the beam is represented in Fig. (16), as highlighted by the test. Fig. (17) represents the experimental relation between floor shear and horizontal displacement and the beam moment-curvature diagram. The analysis of the hysteresis loops and the related cracking frame allows a more detailed description of the mechanisms mentioned above. The first group of cycles (0.25% drift) underlines a significant stiffness reduction for positive displacement, due to the concrete cracking at the beam intrados. During the second group of cycles, (0.5% drift), the beam cracked at the extrados, for negative displacement. The first yielding of the lower steel bars of the

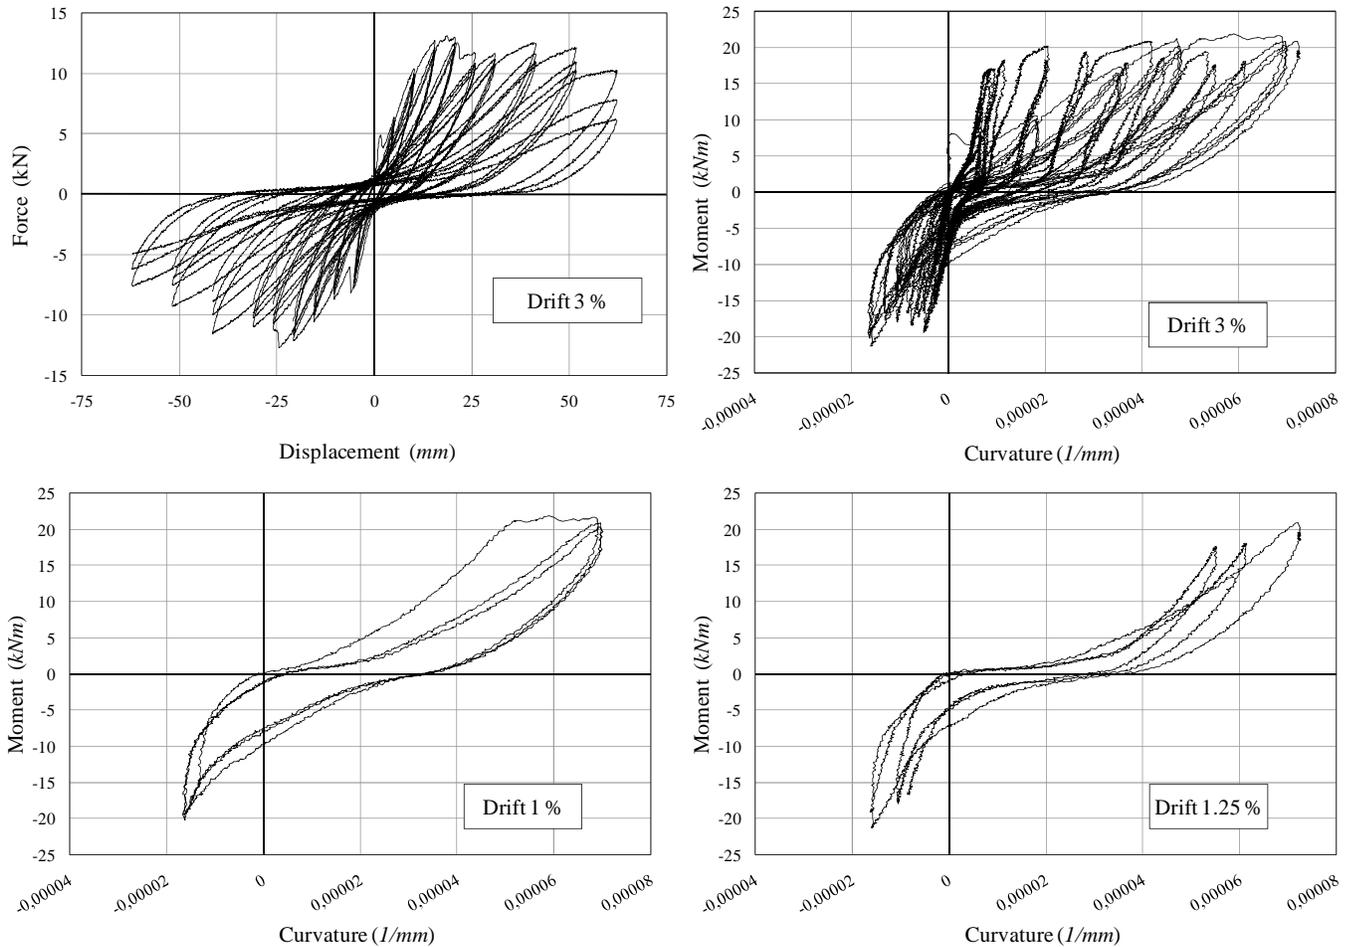
**Fig. (17).** T23-1 specimen: Force-Displacement experimental relation (max inter-storey drift = 3%) and Beam Moment-curvature relation.

beam takes place in the fourth group of cycles (1% drift). The value of the maximum force applied is, approximately, equal to 13 kN. During the first cycle of the fifth group, joint shear cracking began to occur causing a whole sharp reduction of strength and stiffness. Diagonal cracks in the joint panel appeared in both directions during the first cycle

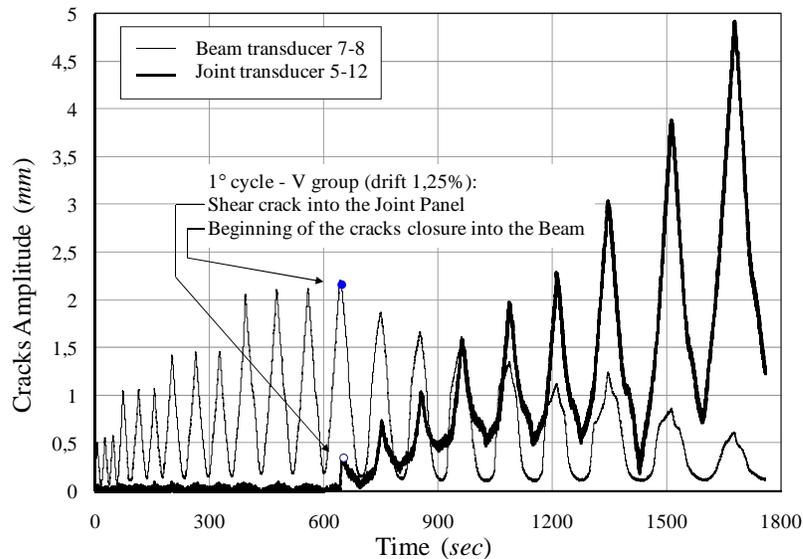
**Fig. (18).** Cracks Amplitude in the beam and in the joint panel.

The hysteresis loops tend to become tighter in the central area (pinching) and show a minor joint dissipative capability. At the end of the ninth group of cycles (3% drift) joint strength appeared to be more than halved. The cracking therefore involved the beam in the first place at the joint panel interface, creating a yield hinge. Then cracks had origin in the beam sections in which the upper bars bends were placed. Afterwards, cracking involved the lower and upper columns at the joint panel interface; finally diagonal cracks took place in the joint panel, allowing to flexural cracks of the beam to heal (Fig. 18).

Fig. (18) shows, in detail, that starting from the second cycle of the fifth group (1.25% drift), the beam cracks began

to heal because of the cracking in the joint panel. This is highlighted by the increasing diagonal cracks that reached a maximum width of 20 mm at the end of the test. It can be observed that joint shear cracking progressively occurred, while it amplified quickly during the last 3 cycles (3% drift). The moment-curvature diagram of the beam can appropriately describe the above mentioned mechanisms and gives the relation between flexural and shear failure. It can be noted the stiffness reduction, due to the beam cracking, that occurred during the first cycle. Fig. (17) shows the most significant group of cycles. In particular, the moment-curvature diagram of the fourth group (1% drift) clearly shows the steel yielding point and the following yielding branch. The healing of flexural cracks in the beam is explained by the moment-curvature diagram, starting from the fifth group (1.25% drift), where can be observed a moment reduction switching from one cycle to another with the same drift. A progressive pinching, which implies a lower energy dissipation related to beam flexural cracking, can also be observed. The pictures of the various steps in the test allows the check of both the qualitative descriptions and numerical results.

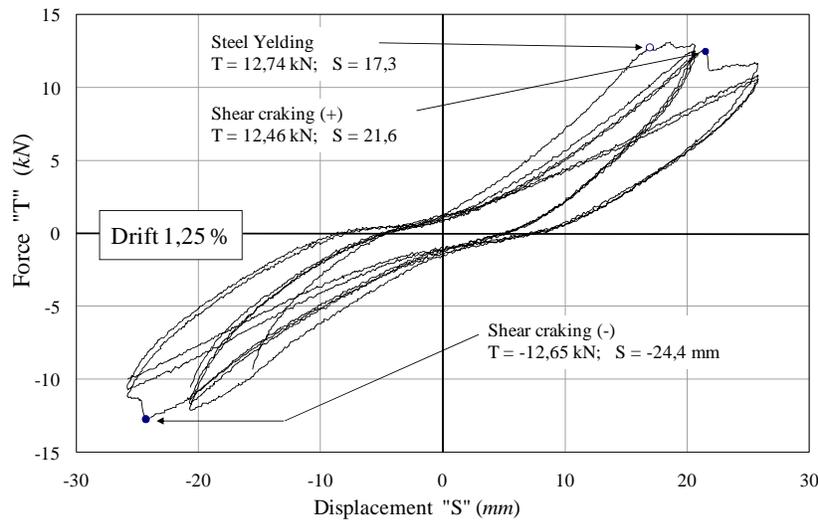
**Fig. (19).** T-Joint specimen: IV (drift 1%) and V (drift 1,25%) groups of Force-Displacement cycles.

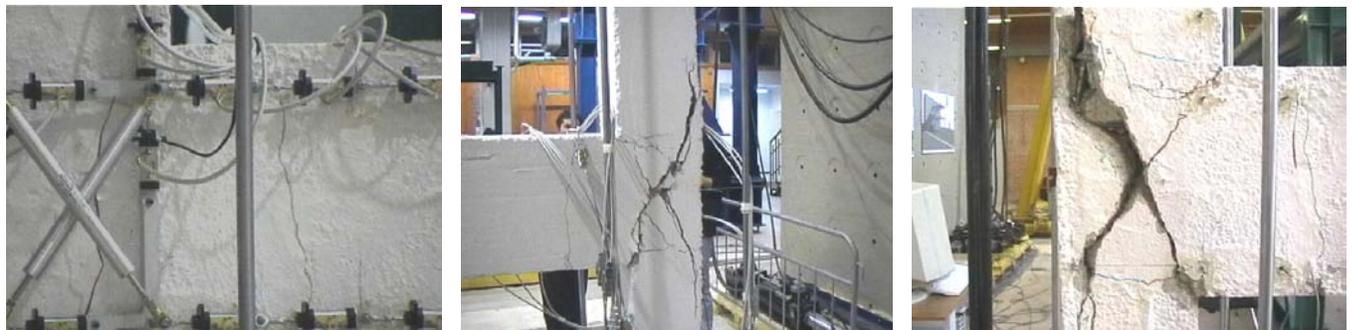
**Fig. (20).** T-Joint specimen: Beam and joint panel cracks pattern at failure.

In particular, Fig. (20) shows the cracking trend in the beam and in the joint panel. First cracks in the span of the beam and the one close to the column are clear, and the following opening of the diagonal cracks in the joint panel. The two mechanisms show similar level of yielding strength and yet, as the joint panel mechanism is more brittle, it

It must be pointed out that the tests carried out did not highlight any significant slip of the hook either outwards or inwards. As a consequence the ejection of the above-mentioned block cannot be considered as an effect of the hook slip, which, however, remains inside the internal concrete section as it is shown in the last picture of the Fig. (20).

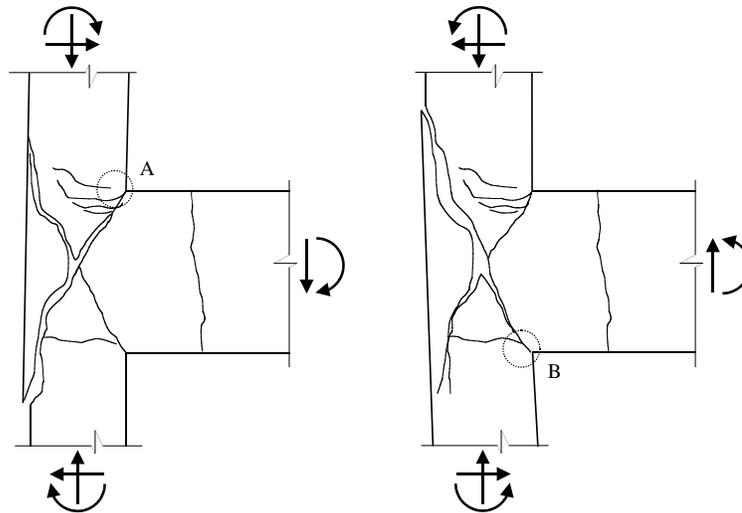
Fig. (21). T-Joint specimen: Observed failure mechanism.

In Fig. (21), the two rigid body mechanisms are described in the case of a positive displacement (left to right) and of a negative displacement. These two mechanisms are characterized by the rotation around the compressed zone of the column on the beam side: the A area for positive displacements, and the lower B area for negative displacements. The above mentioned mechanisms determine the cracking spreading towards the columns and the inflection of the external longitudinal bars of the columns passing the joint panel. These bars, being not linked by transverse reinforce-

ments in the joint, push the concrete triangular block outwards.

The rigid body mechanism observed during the external T-joint specimens tests (Fig. 21) is characterized by the rotation around the compressed zone of the column on the beam side and by the traction-inflexion of the external longitudinal bars of the columns. Also in this case the bond-

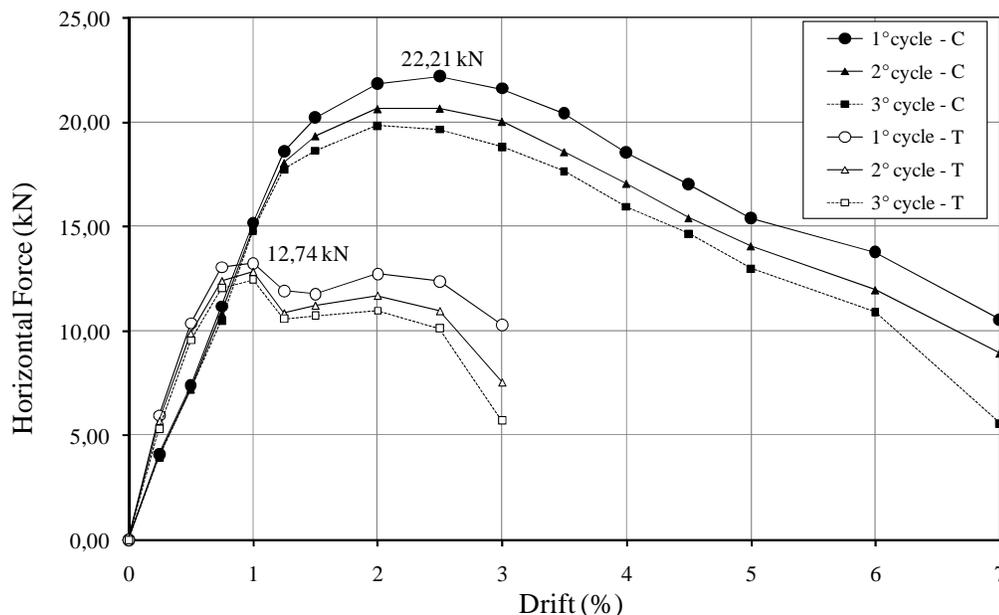
Fig. (22). Force-Displacement envelope curves of T23-1 and C23-1 joints.

One of the objectives of the tests carried out on sub-assemblages of the prototype frame is to establish relations between the response of the whole structure and the one of the two kinds of beam-column joints: the internal joint (C-Joint) and the external one (T-Joint). From this point of view, it is interesting to compare the response of the T23-1 joint with the C23-1 joint (Fig. 22).

It must be underlined that the same displacements and the same axial load were applied on both joints. It can also be observed that the comparison becomes significant from the characteristics of the failures shown by the two joints. Even though the geometry and the stiffness ratio between the elements determine the kind of failure, the comparison between the two structural sub-assemblages is not related to their geometry. From the two tests it is possible, in fact, to deduce the comparison between the different failure mechanisms ruling the response to lateral actions. In Fig. (22), the experimental envelope diagrams of the hysteresis loops in the two joints are shown. Firstly, it can be observed the difference between the maximum lateral strength values related to the two failure mechanisms. For the C-joint, the maximum value of the floor shear is 22.21 kN, while for the T-joint, the value is 12.74 kN. The drift levels corresponding to these strength values are 2.5% and 1%, respectively. The

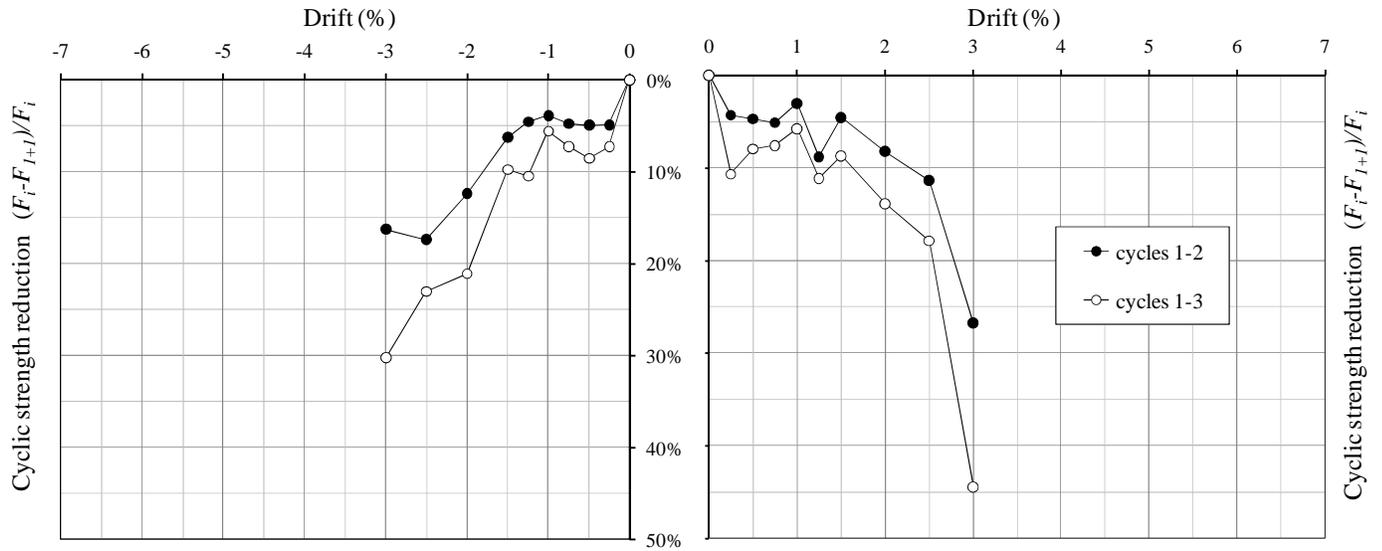
Fig. (23). T23-1 specimen: Cyclic strength reduction (drift max = 3%).

drift level where the two tests were stopped is equal to 7% in the C-joint and to 3% in the T-joint and, as measured at the end of the test (third cycle), the corresponding strength values were, respectively, equal to 25% and 45% of the maximum strength. At the end of the test, the external joint showed a more noticeable loss of integrity in comparison with the internal joint, even though the test were stopped at a much lower drift level (3% against 7%) and the remaining percentage strength was higher than the internal joint. Nevertheless the percentage level of the remaining strength (in the first cycle at the test end) was higher in the T-joint than in the C-joint, the former showed a more marked loss of integrity with a significant cyclic reduction of strength (Fig. 23) than the internal joint (Fig. 24).

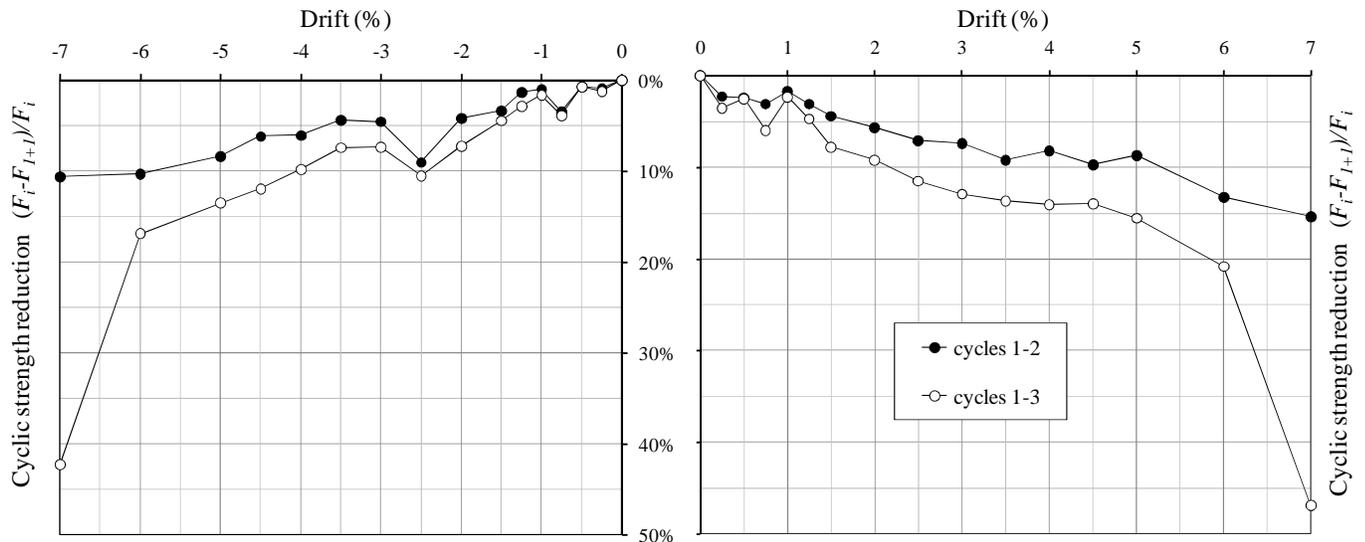
Fig. (24). C23-1 specimen: Cyclic strength reduction (drift max = 7%).

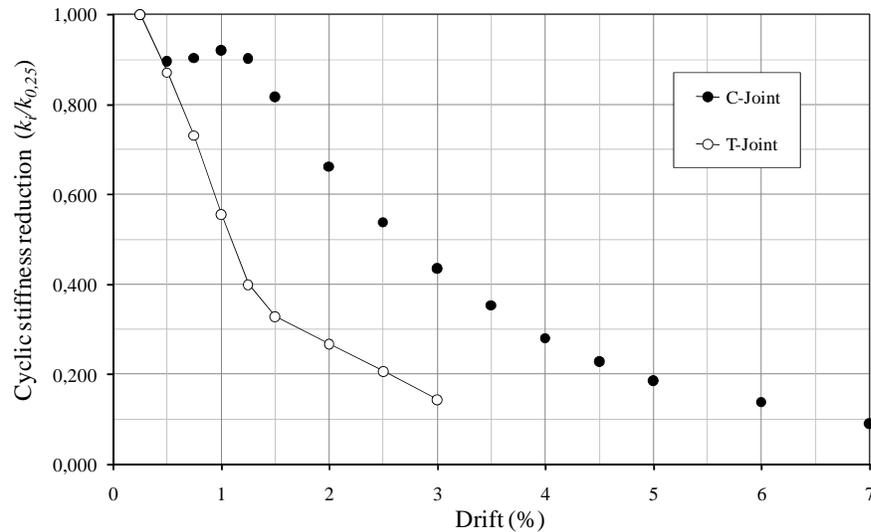
**Fig. (25).** Cyclic stiffness reduction of T23-1 and C23-1 joints.

both joints. The main difference was that it was reached more quickly in the T-joint. Fig. (25), illustrates the comparison between the two joints in terms of variation in the secant stiffness evaluated at the second and at the third cycles, in relation with the one evaluated at the first cycle, as the drift increases. While the C-joint stiffness remained basically unchanged in comparison with the initial stiffness up to a drift level of 1.25%, in the T-joint it decreased to 40% at the same drift. With a drift level equal to 3% the T-joint secant stiffness was equal to 14.4% of the initial value, whereas the C-joint stiffness was still equal to 43.7%.
