A. Guida ¹     ² , F. Fatiguso ²     ² , A. Pagliuca ²   ²
¹ University of Basilicata   ⁵ , Potenza [Italy]
² Polytechnical University of Bari   ⁹ , Bari [Italy]
humidity, civil engineering, Building, stone, condition monitoring, comfort indoor

THE CASE STUDY: THE "SASSO BARISANO" IN MATERA

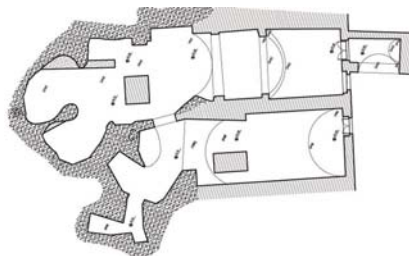
Figure 1 – The case study

The case of study (Fig. 1) includes the terraced valley that develops in the direction of West, in "Sasso Barisano", at the bottom of the cliff, called "Civita", and involves two lines of the expansion of the original medieval core of the city: the "Casale Vetere " and the "Casale". The original landscape morphology was more articulated and complex than the present one; over time has been transformed into a series of enclosures that depart from the main routes to the rock ridge of "Civita".

The area is located in a strategic position between "Sasso Barisano" and "Sasso Caveoso" and behind "via dei Fiorentini", and grow on 6 levels with a surface of about 1000 mq each one. Having identified some homes - both recovered and currently inhabited - it proceeded to the

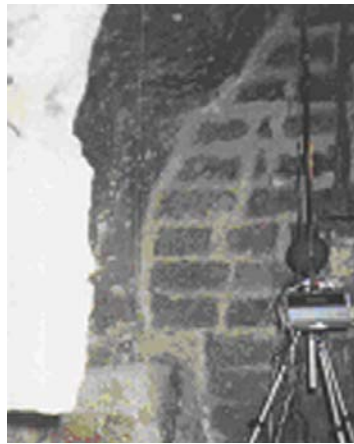
Figure 2 – BABUC

The measurements were made using an instrument called BABUC (fig. 2) in an enough deep underground structure and they were collected in five days (in the last week of April). The data acquisition occurred in continuously, every 10 minutes. The sampling period was chosen on the environment conditions; in environments where variables detected remain largely constant in the day, as in this case, it is enough a measure of 10 - 15 minutes for each “homogeneous” area. The areas could be considered "homogeneous" if, at an given moment, the air temperature, the average radiant temperature, the air speed and the relative humidity can be considered uniform.

The unit BABUC was positioned at the center of the room, with sensors placed at 1,5 m on the floor, away by transient or not relevant to the assessment factors. The diagram show a relative stability of values; the comparison between the various measurements point out that the relative value and the average temperature is consistently contained within the set of values (20-25 ° C), that are considered optimal from the norm UNI EN ISO 7730 1997, "Moderate thermal environments.

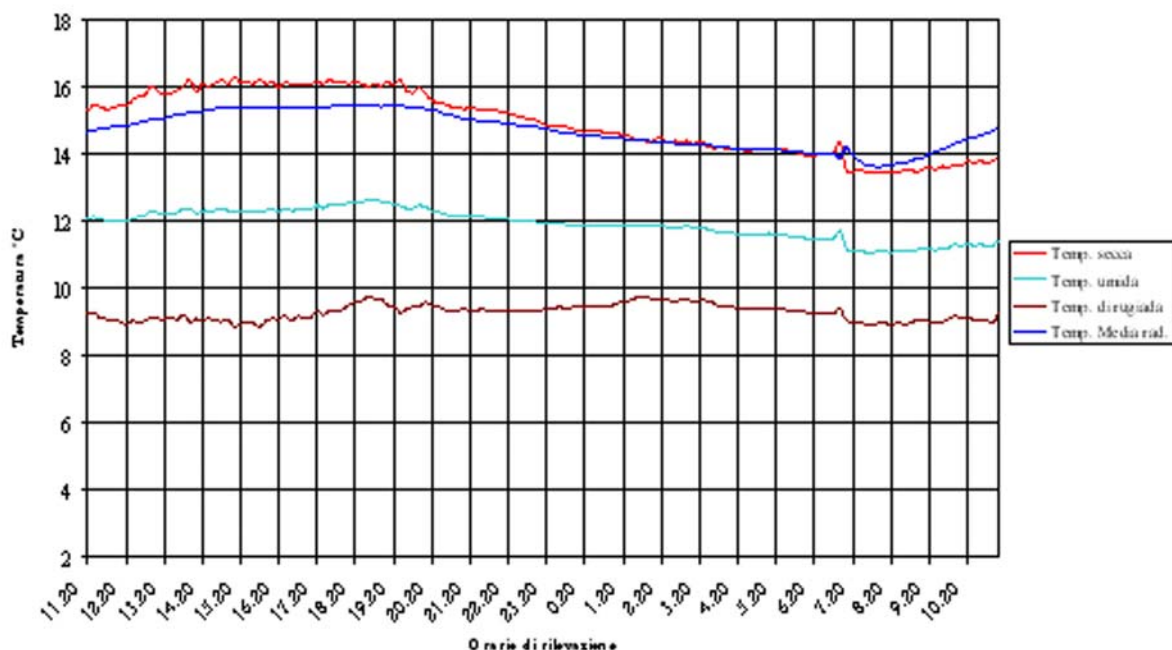
Determination index PMV and PPD and specific conditions thermal wellbeing" and the more recent UNI EN ISO 7726, 2002, "Ergonomics of thermal environments - Tools for measuring physical quantities".

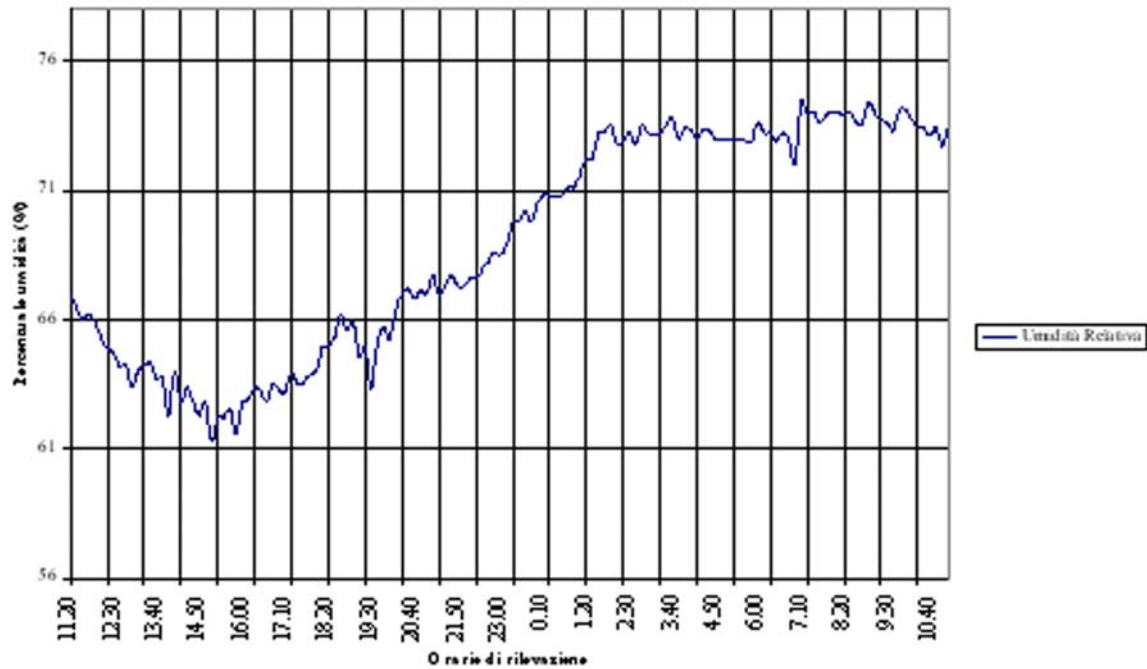
Tables B

The results, reported in Tables A and B, indicate that both the temperature and the relative humidity of the air in the room where the test is carried out, they seems to guarantee the indoor wellbeing. Additional measurements, made in other environments and in different climatic conditions [1] [2], seem to point out the same characteristic. This information shall be confirmed and "systematized" by further measurements campaigns.

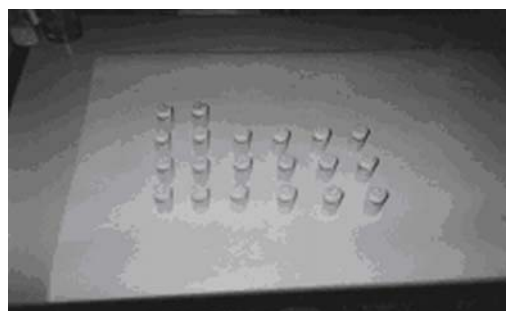
Figure 3 - Detector PACKARD PICO-RAD

In the same environment, it has been tested the measuring to verified the presence of gas radon. It is a gas produced by the decay of the uranium and is everywhere in soil and rocks, particularly those of volcanic origin in granites, in sandstone, in "tufo", all used as building materials. The radioactivity associated with each type of material or environment is measured in bequerels (Bq). The monitoring of radon is carried out through the use of passive detectors with baskets to activated charcoal, with a detector PACKARD PICO-RAD (fig. 3), which is a preliminary inspection device for measuring the radon concentration in inner part of a building.

The methodology followed in this tests consisted, as in the previous case, in direct survey concentration of radon in the building through the arrangement of detectors at various levels. The test follows the directives of the Agency for the Environment of the United States (EPA), about their employment procedures, maintaining, for example, the external doors and windows closed and placing at least two detectors next to each other.
