8th International Symposium
on the Conservation of Monuments
in the Mediterranean Basin

**Monument Damage Hazards
& Rehabilitation Technologies**

STATIC REQUIREMENT AND TYPE'S COMPLEXITY IN THE DIAGNOSTICS PHASE

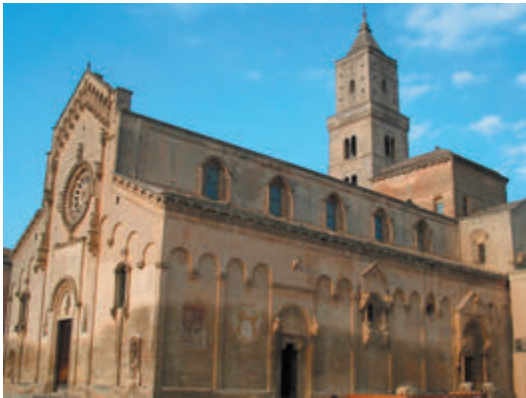
Figure 1: The Matera Cathedral

This research focus upon the Cathedral of Matera - a little city in the southern part of Italy (Figure 1), a massive architectural structure, built at the end of the XIII century.

In Apulian Romanesque style, it keeps its formal and architectonic connotations almost unchanged outside, even though some interventions have substantially changed the inside style. It does not show any plain deterioration signs of its static structure, but it is plain a pathology outside.

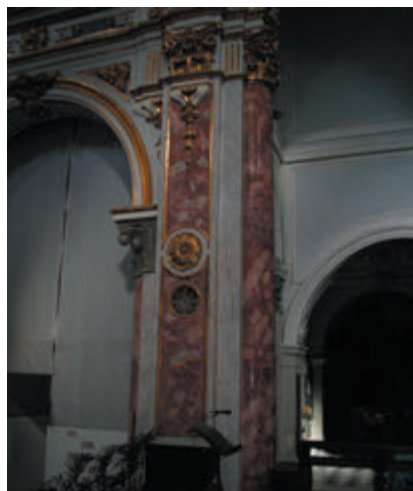
The study focuses on the analysis of the restoration intervention on two trilobate pillars (Figure 2) that separate the central space from the presbytery.

Figure 2: The trilobate pillars

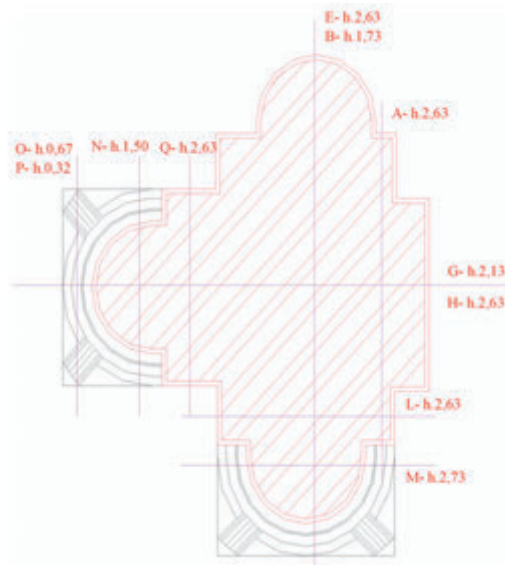
The test was performed on the above said columns, identifying different directions (Figure 3 and Figure 4) - at different heights - in order to cover the largest part of the surface; these directions would also consider the different materials connections, related to the particular shape of the pillars. Certainly this complexity became an important element to evaluate in order to operate a correct and precise evaluation of the investigations project.

Figure 3: Sonic directions of investigations carried out on the left trilobate pillar

From the observation of results, it is possible to note that lower values are not recorded along the longest paths - such as those linking the two semi-columns or the semi-column with the pilaster - but along the shortest paths within the elliptical shape. This leads us to assume a more widespread damage, also visible on the surface of the pillars.

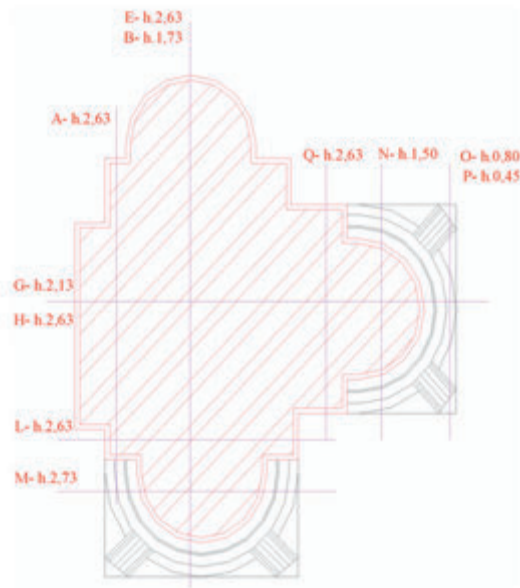
Figure 4: Sonic directions of investigations carried out on the right trilobate pillar

While, the investigations on the right pillar (Tab. 2) highlight of values between 1450 m/s and 1850 m/s at different levels and in the range 1.50-2.73, which usually characterize those walls not strongly degraded and presence of voids. Even the pillar right, by the observation of partial results show that higher values are recorded along the longer trajectories (as above said), the lowest (about 1400 m/s) along the shortest paths within the elliptical shape. This leads us to do the same considerations of the left pillar.

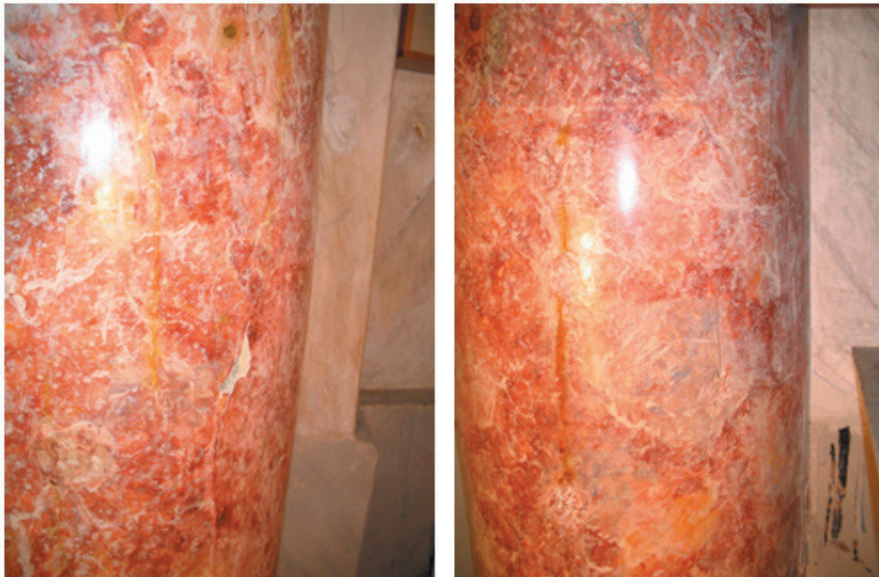
Figure 5: Damage visible on the surface of the pillars
