## 1 PATHOLOGY - 1.4 Diagnostic Techniques

### “QUALIFICATION” METHOD FOR THE REINFORCED CONCRETE STRUCTURE

### IV. THE CASE OF STUDY: THE “ANNUNZIATA” BRICKWORK IN MATERA

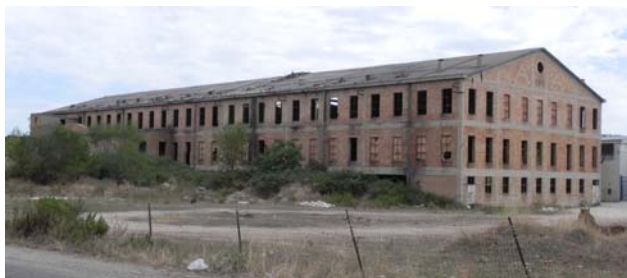
Plate 1 - Brickwork “Annunziata”

The case study is the Brickwork “Arcangelo Annunziata” (Plate. 1) in Matera (Italy). The building was built in the years '50 and for 25 years has represented the most important industrial factory in Matera. The interest in the re-discovery of the cultural and architectonic values of “Industrial Archaeology” has developed simultaneously with that

landscape. The Brickwork “Annunziata” is an important “monument” of Industrial Heritage in Matera. It - in which there was a “Hoffmann”<sup>9</sup> kiln for bricks, now destroyed – was realized in various building, built using different shape, materials and technologies.

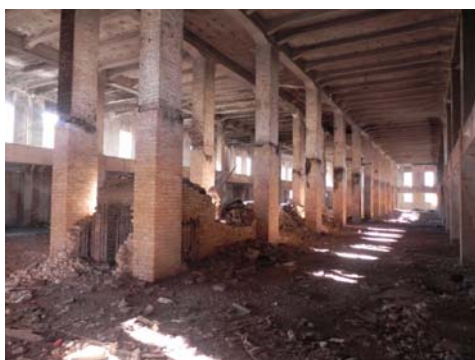
**Plate 2** - The central nave

The main building was built in a concrete structure; it is 74 metres in length, has a sequence of 15 spans and three floors. The external envelope was a brickworks with a series of windows regularly organized. The bearing structure is formed by reinforced concrete beams and pillars that divides the interior space into five naves: the central one (Plate. 2) appears with a double-height pillars, covered with firebricks (in fact there was a kiln, as witnessed by the ruins still present). The side naves, close for the central one, develop a height twice the perimeter naves; the perimeter naves have a “margherita”<sup>10</sup> floor at an height of 3,40 m from the ground floor. The horizontal structure on the second floor is at an height of 7, 20 m from the ground floor; the reinforced-concrete slab has holes to drop the hot air coming from the kiln to the third floor. Here, there are the pillars that support the roof trusses. The chimney, that through the building from the kiln on ground floor up to the roof, is collapsed. Now the

Brickwork is abandoned and in an evident state of deterioration caused largely by the presence of meteoric water. In fact, one of the most important causes of degradation is the meteoric water (that generates the crystallization of salts, which catalyzes in many chemical degradation processes (carbonation, sulphation, salts) and makes possible the growth of biological organisms). The reinforced concrete structure, among the consequences of the roof collapse, shows a high level of surface carbonation of pillars and beams; it is evident the separation of iron coverage due to the oxidation of the bars in the concrete. The signs of degradation have different causes due to chemical, physical or mechanical components; except for biological and man-made “aggressions”, the signs are related to the conglomerate porosity: as much it’s greater the concrete porosity as it’s greater the probability that take place anomalies.
