1st International Symposium on Building Pathology

Conference Proceedings

8.15 — Recovery and enhancement of modern architectures: the case of cinema Ariston in Potenza (Italy)	
Antonella Guida, Ippolita Mecca, Silvia Michela Scavone	651

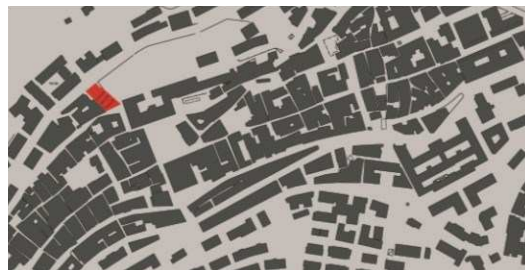
Figure 1. Site Plan.

Cinema Ariston is located in the center of Potenza, borders on the Prefect's Palace and an aristocratic mansion near Pretoria street, the path on which has developed the urban core. It was built in the 50s and it is one of the first examples of modern architecture in reinforced concrete of the town, in which the testing of materials and techniques describe the uniqueness of shapes.

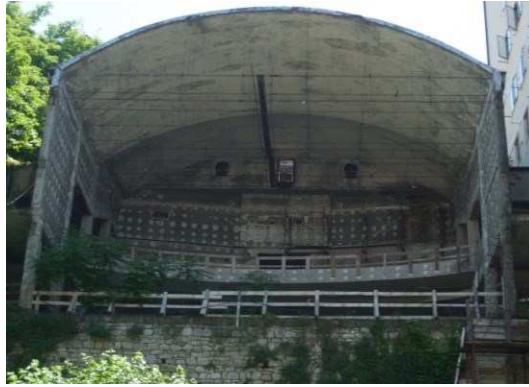
Figure 2. The North-West Facade.

The facade on the north-west, in Via Mazzini, is completely absent after the demolition carried out over the years because of the vulnerability of structural elements; on this side the Cinema is completely stripped and it allows to see what remains of its structures. The atrium structure has reinforced concrete pillars and beams and it is different from the structure of the stall area characterized by beams in longitudinal, transverse and oblique directions which identify a regular grid of pillars. From them, at the level of the stall area and the gallery, it can identify different reinforced concrete shelves on which they rest the reinforced concrete roofs, in order to derive the floor of the gallery realized with twice reinforced concrete vaults.

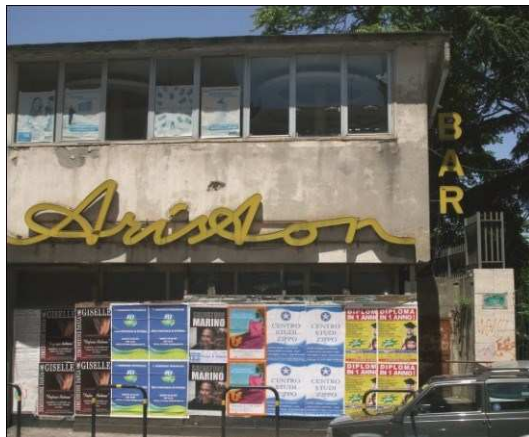
The Cinema is located on a natural slope and has a rectangular planimetric shape as opposed to the profile facades, where there is co-penetration of volumes that define unique shape. The extension of the Cinema made possible to preserve the natural characters of the site, reflecting both in plan and section, the morphology of the place. The main facade is characterized by glass surfaces, now partly walled, and by the sign of yellow color that characterizes the original entrance.

Figure 3. The Main Facade.

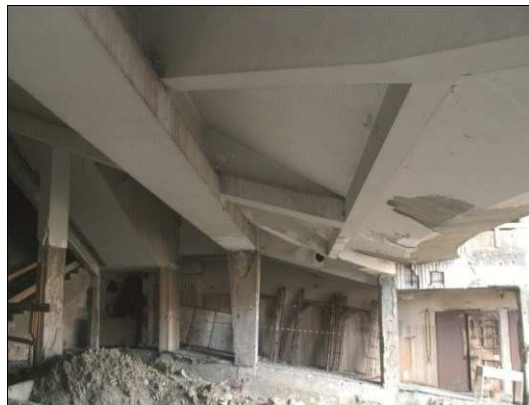
From the pathological and decay point of view, the building has several alterations due to atmospheric, chemical and biological agents. There are stains, patinas and efflorescence on the

surfaces of the materials, the rubble and vegetation cover most of the walk areas, instead gaps and the demolitions were caused by human intervention. Therefore, the re-use will ensure the absence of these causes and the preservation of the building.

Figure 4. The Stall Area view.

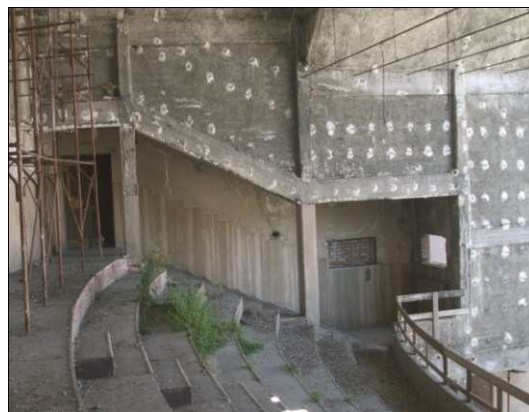
Figure 5. The Gallery view.
