European Geosciences Union General Assembly 2014, EGU 2014

The influence of indoor microclimate on thermal comfort and conservation of artworks: the case study of the Cathedral of Matera (South Italy)

Tiziana Cardinale*, Gianluca Rospi, Nicola Cardinale

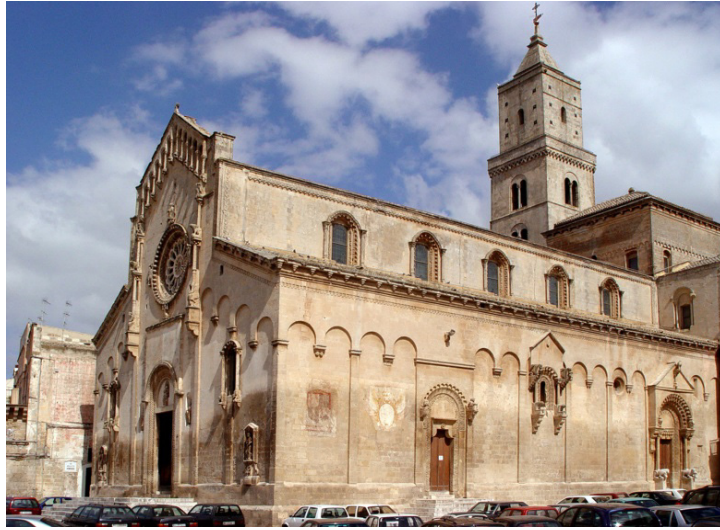
The architect is unknown, but the church is characterized by a “salient façade” typical of Apulian Romanesque style. The main facade is directed to the west towards the valley of the *Sasso Barisano* and presents the main door surrounded by delicate floral decoration and a magnificent rose window with sixteen rays consisting of 16 columns in the middle and small arches, with a circumference surrounded by two ornate frames (Fig.1).

Fig. 1. The Matera Cathedral (exterior)

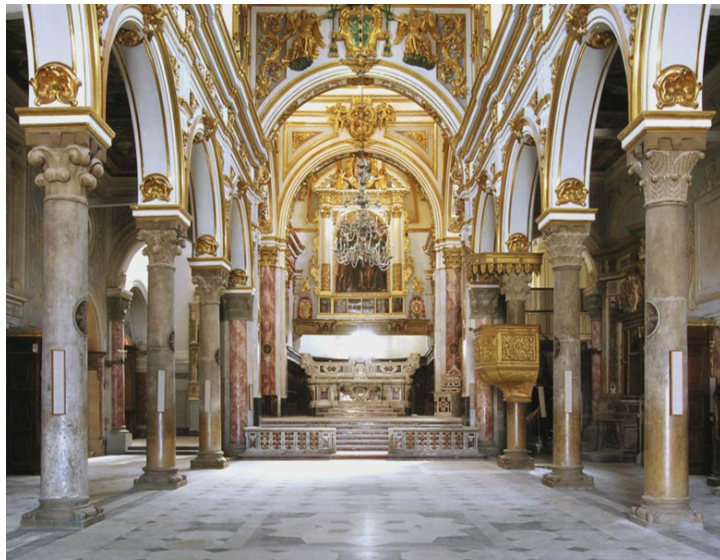
Entering the Cathedral of Matera there is an evident contrast with the exterior styling and the interior one, composed by three naves, typical of a Latin cross church (Fig.2). In the 17th century were added anywhere stucco decorations which were then covered with a golden patina in the 18th century. The original ceiling was covered in 1719 with a wooden false ceiling, on which in the 19th century were inserted three paintings by Battista Santoro, important for the culture of Matera: St. John of Matera and S. Eustace in the medallions and “The Visitation of the Virgin” at the centre. Inside the cathedral we find several frescoes and paintings by Anselm Palmieri, Domitius Persius, Carlo Rosa and Antonio Conversi, representing life and stories of Saints painting between 1500 and 1650. Of great importance is the high altar, coming from Montescaglioso Abbey, made of fine white marble and dominated by the “Big Cona”, made by Fabrizio Santafede and purchased in Naples in 1580. It represents, in the central part, the Virgin surrounded by Saints John the Baptist, John the Evangelist, Biagio, Donato, Peter and Paul, and in the oval at the top, the Holy Trinity. Below, in the boxes, scenes from the Gospel. Behind the high altar a Wooden Choir is situated. The cathedral consists of 3 other altars, one dedicated to Saint Anna, with a beautiful

Fig. 2. The Matera Cathedral (interior)
