International Journal of  
**A** Heritage  
rchitecture  
STUDIES, REPAIRS AND MAINTENANCE

This issue comprises selected papers on Studies, Repairs and Maintenance of Heritage Architecture topics that are becoming increasingly important in modern society.

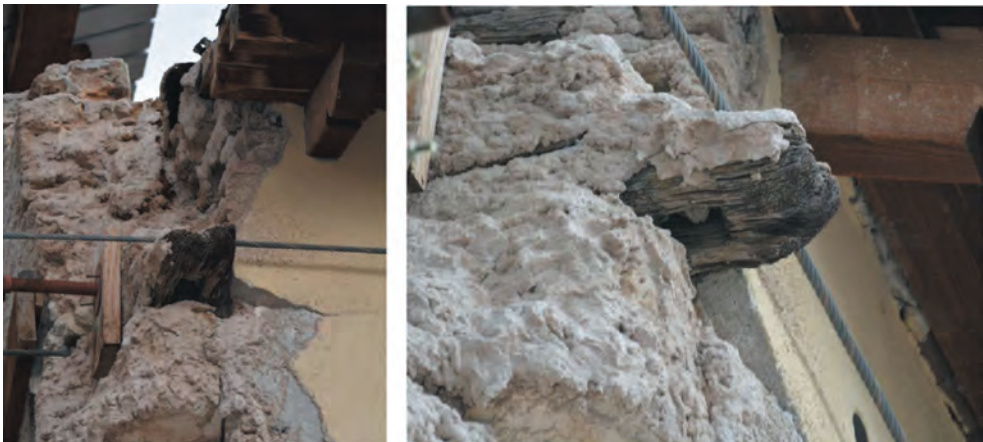
With the same purpose, the systematic placement of roots in the masonry structure generates spiral reinforcements, placed at different heights in relation to the size of the building and its vertical structure; the wooden beams, properly steamed by simple riveting or 'Jupiter dart-pin' connections, intersect near the angled and end outside the cantonal with metallic anchor bolts studded on the head of the beams and retaining bolted-end-plates, according to different shapes that, in the High Renaissance, are characterized by floral and animal motifs.

Figure 1: Wooden chains placed inside the wall. Building in Piazza San Domenico.

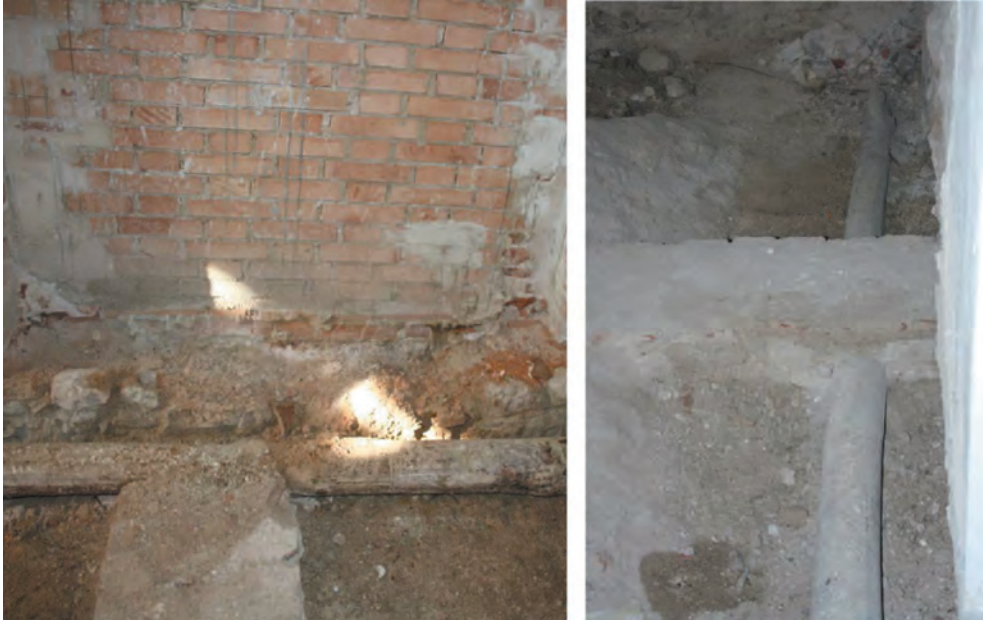
Figure 2: Wooden chains placed outside the wall of Palazzo Zuzi.

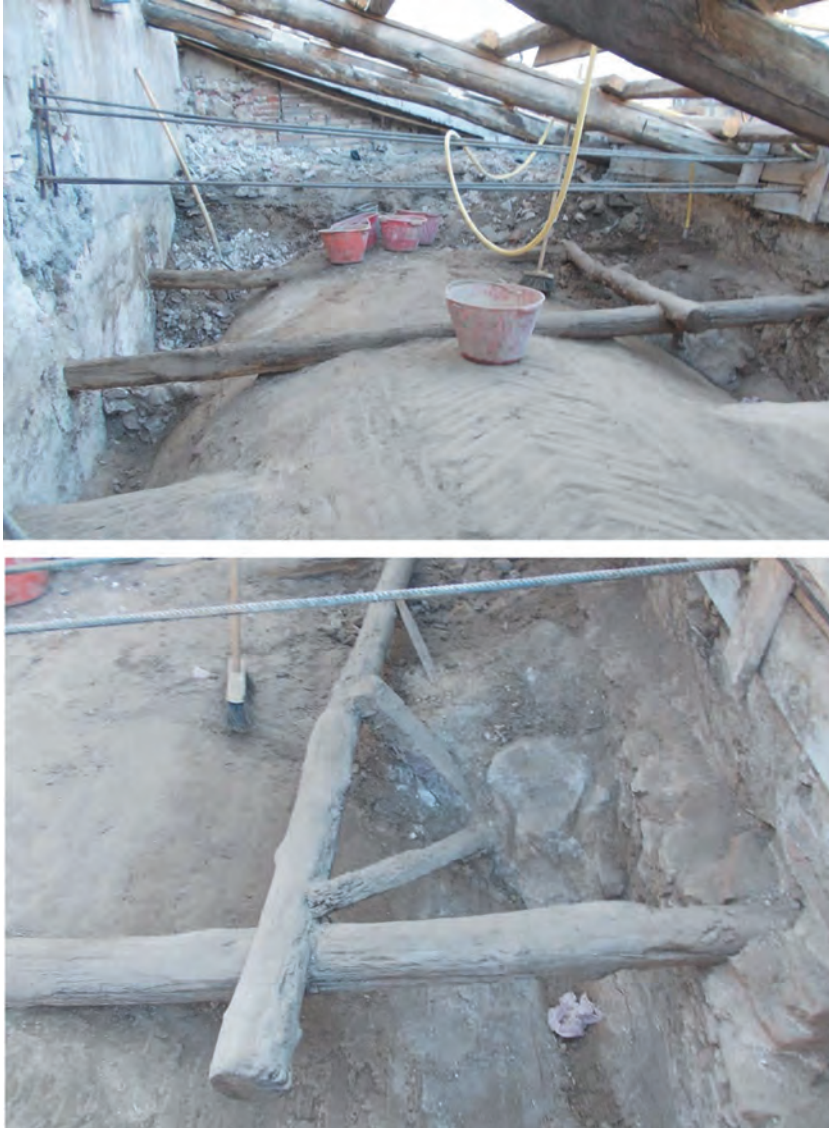
In the case of barrel vaults with longitudinal structure, the wooden beams are placed transversely to the generatrix, partially embedded into the upper part of the element, free or leaning against the steering cables and connected to the exterior wall, thanks to concealed or exposed retention systems. The chain can be integrated with other wooden elements, just like the ‘sling chains’ described by Valadier [9], or according to more complex structures in which the transverse chains are longitudinally contrasted by rafters where retaining elements, embedded in the abutment, are connected (Fig. 3). Conversely, in the case of ‘intersected’ vaults (e.g. rib vaults), the roots are placed parallel to the generators and integrated inside the bricks to about a third of the rise. The beams are placed on the four sides of the vault; they intersect and connect near the corner, and then bound to the exterior walls. Mainly on the longest sides of the vault, the beams can be supplemented with other retention wooden elements that reconnect them to the perimeter walls.

Figure 3: Palazzo Gualtieri. The transverse chains are longitudinally contrasted by rafters where retaining elements, embedded in the abutment, are connected.

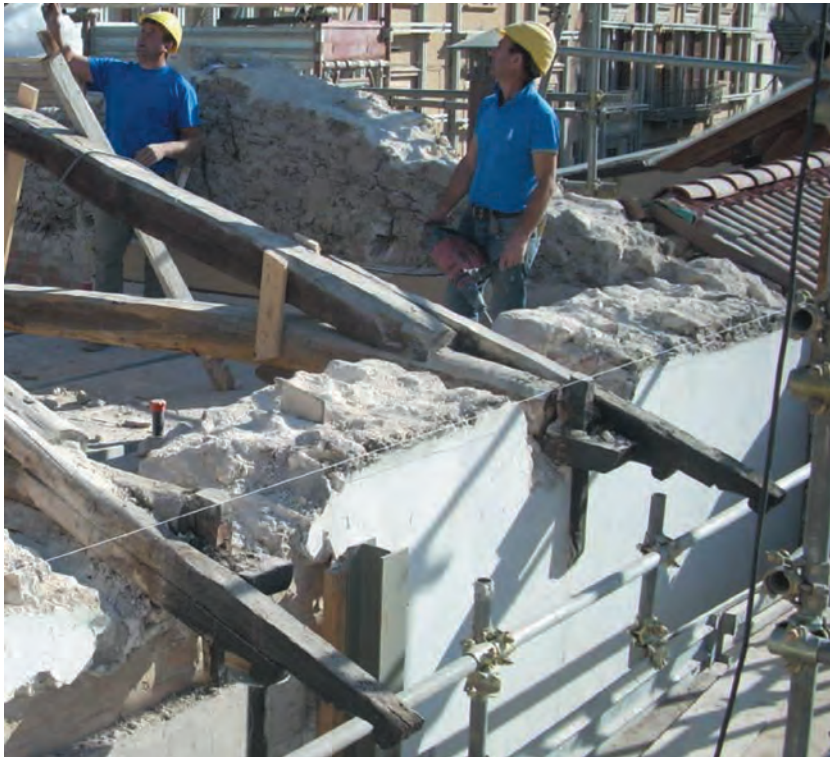
Figure 4: The typical example of the staked trusses applied in Palazzo Farinosi.

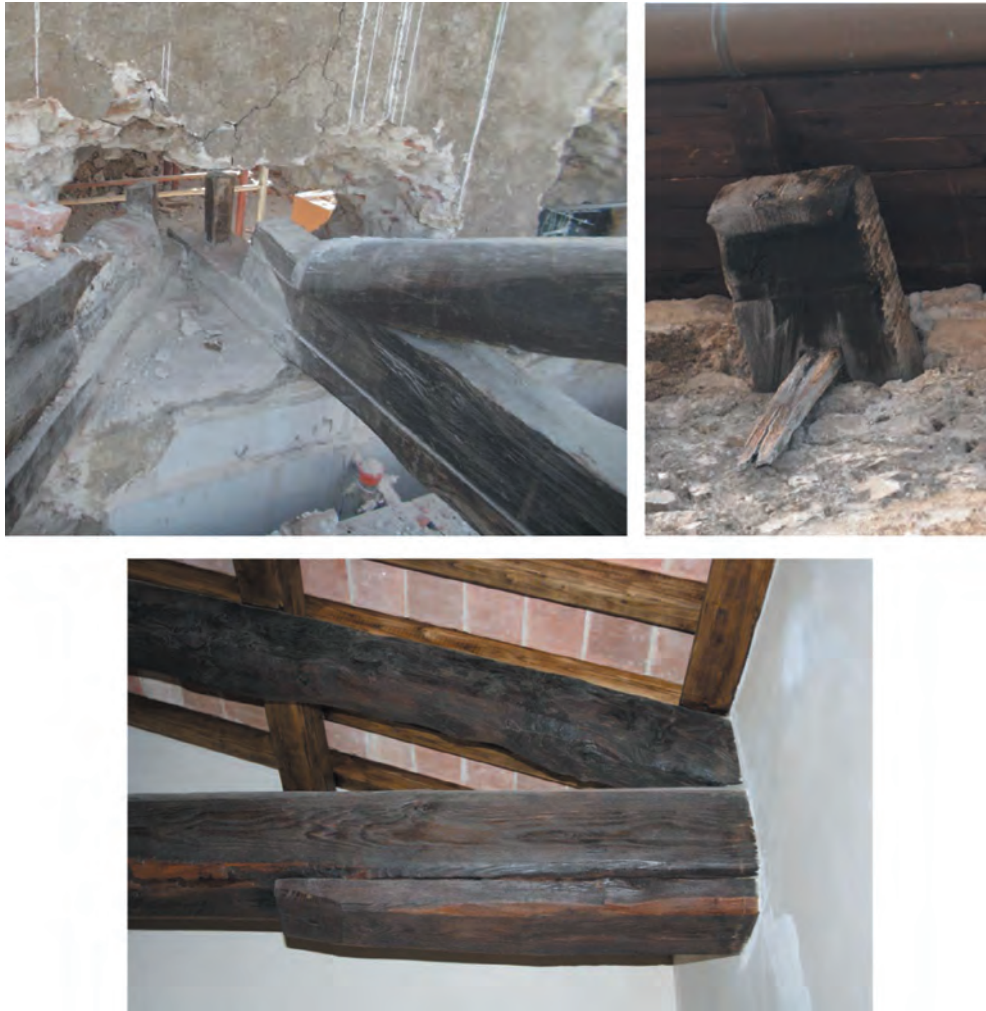
The same construction knot can also be complemented with further wooden element, a tilted beam called 'polza', which is nailed and paired with the rafter and the cushion while extending itself outside so as to create the warping of the eaves.

Figure 5: Details of the support knot solution in Palazzo Farinosi.

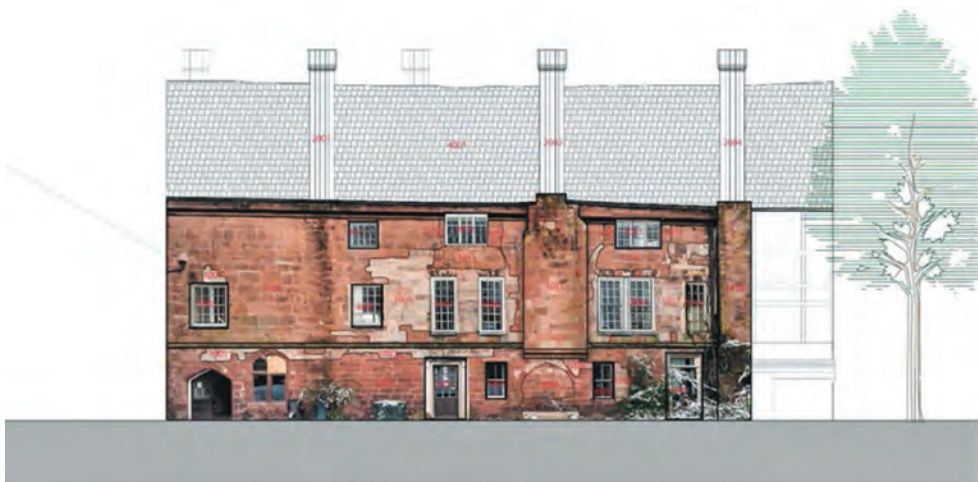
Figure 10: Stratigraphic analysis.

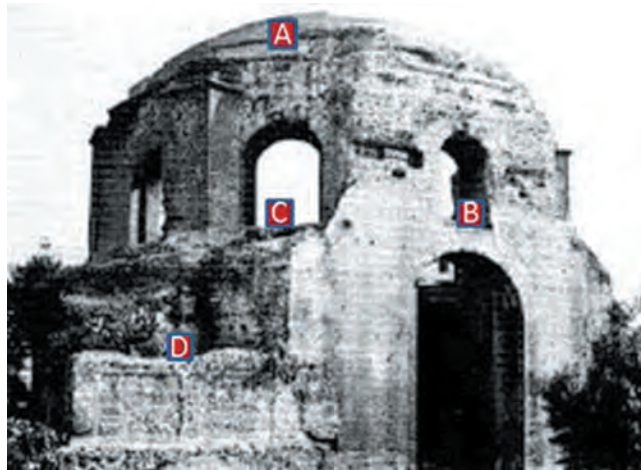
Figure 4: Measurement points on the façade.

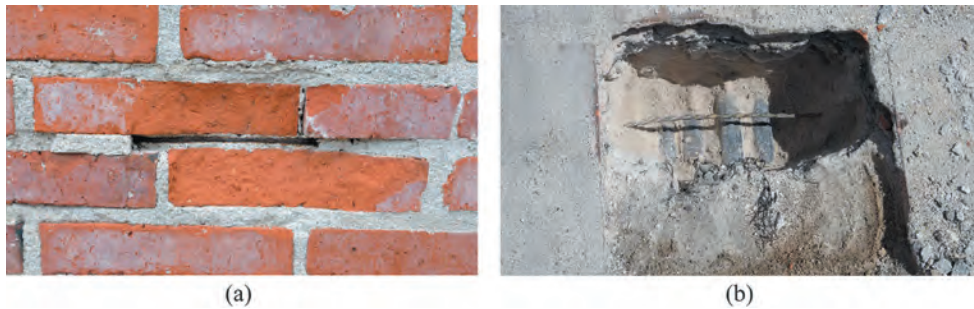
Figure 5: (a) Corrosion with exposed rebar and mortar detachment in the church building and (b) actual state of tie rods in the roof's valleys.

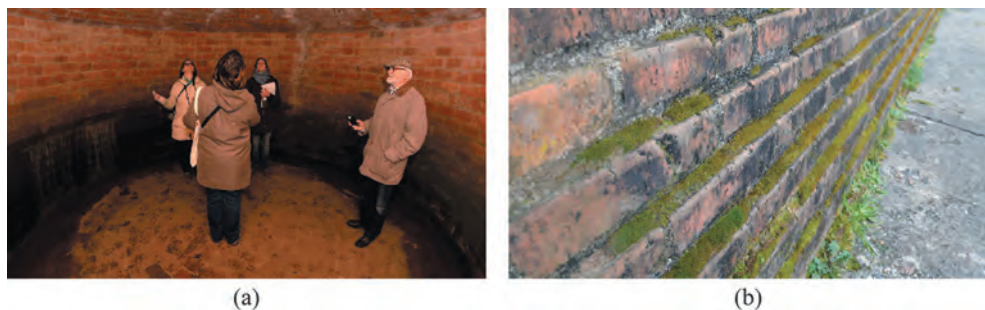
Figure 6: (a) Ponding at some parts of the baptistery's floor and (b) biological colonization and deterioration of mortars by phototropic organisms.

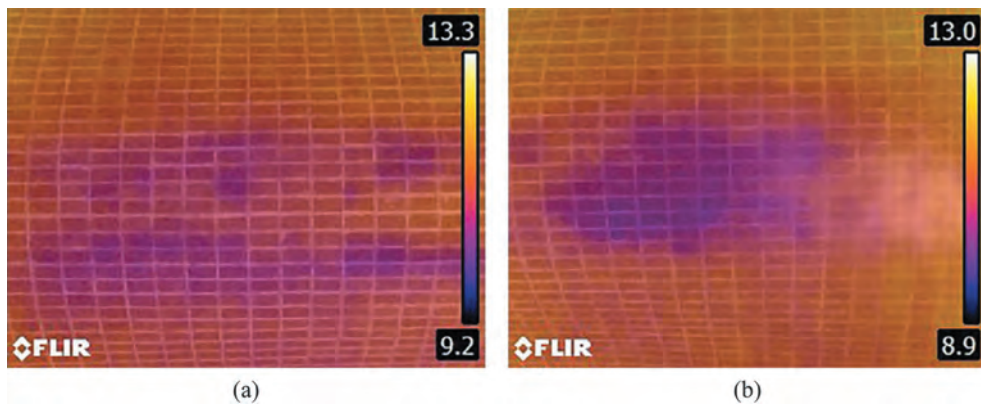
Figure 7: Presence of moisture in the valleys of the church's ceiling.

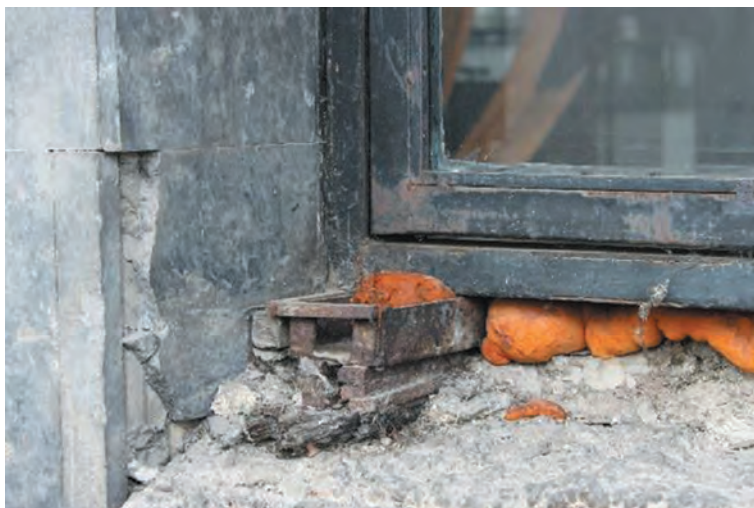
Figure 2: Ground floor openings that show improvised repairs.

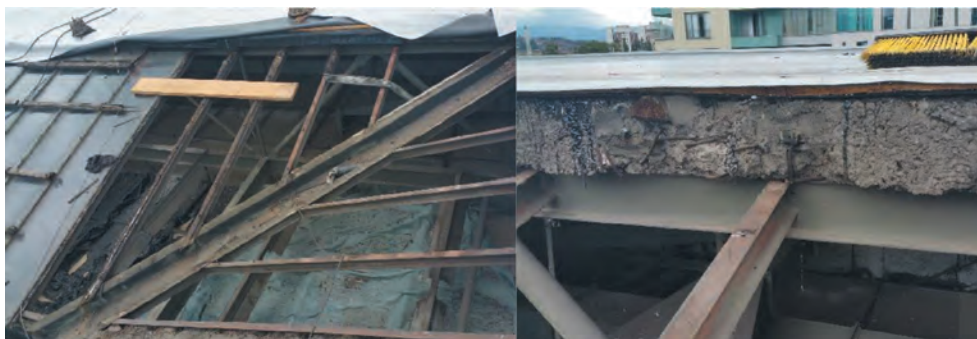
Figure 6: Degraded state of sheet metal and insulation under glass.

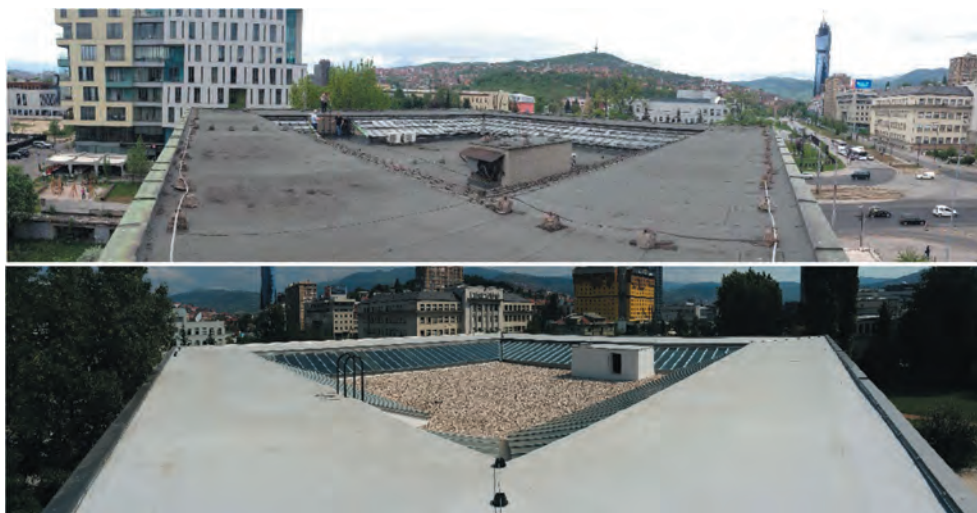
Figure 9: Condition of the roof (before and after).

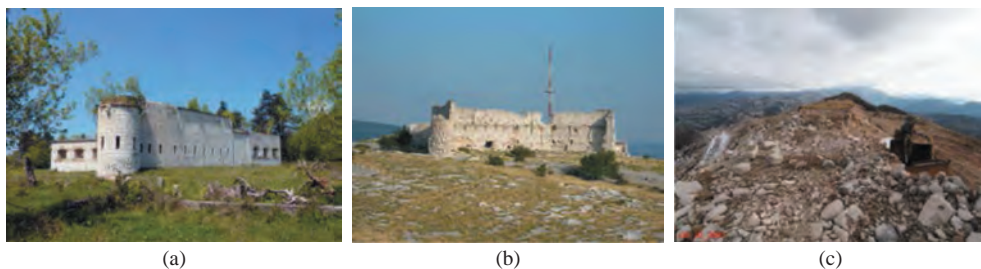
Figure 7: Different examples regarding the state of preservation: ‘good’ – ‘damaged’ – ‘destroyed’. (a) Fort IV Pasin brdo, Sarajevo (2011). (b) Fort 6, Mostar (2015). (c) Guardhouse Goli Vrh, Krivošije (2008).
