9TH INTERNATIONAL SYMPOSIUM ON THE CONSERVATION OF MONUMENTS IN THE MEDITERRANEAN BASIN

REFURBISHMENT BETWEEN TRADITION AND INNOVATION. THE CHURCH OF “PIO MONTE DEI MORTI” IN POMARICO (ITALY)

ABSTRACT

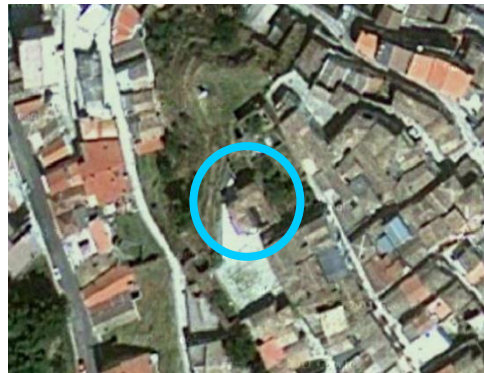
The church of “*Pio Monte dei Morti*” is located in the city centre of Pomarico (a little town in the southern part of Italy) [16], close to the old church (now destroyed) of “*San Michele Arcangelo*” and near the ruins of the ancient castle as well; it is in an urban fabric strongly articulated and characterized (Figure 1) by narrow streets, according to the usual typology of the historical centres of the area.

Figure 1. Area characterization

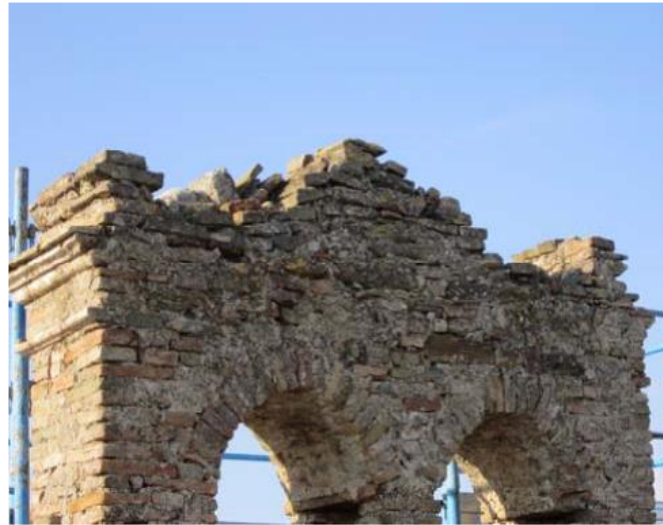
Figure 4. Bell gable of the church - Particular

The church was built using masonry load-bearing in local stone very irregular (according to the traditional local construction systems) [15]. The main facade is onto a small, narrow urban street (Figure 3). The entrance is constituted by a mail door, which does not have decorations, but that is defined by simple sequence of clay bricks to form the architrave and door jamb; above the main door, there is a large window that is the natural light point for the nave; the facade ends with a double sequences of arches, that form the bell gable of the church (Figure 4).

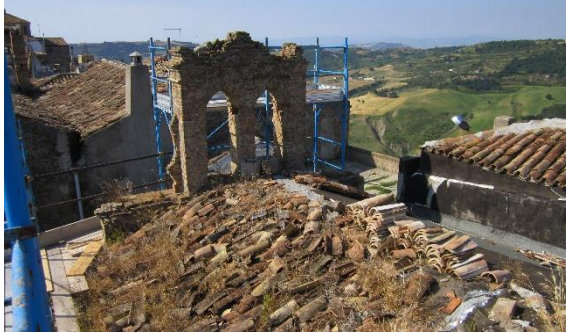
the causes that have generated them; this analysis makes it possible to highlight the qualitative and quantitative characteristics of the building to determine the evolution of the damage over the time (Figure 7). However, this analysis is only the first element to identify the causes of damage and to determine the security status of the building; in fact, it is necessary to integrate that analysis studying the geological situation as well the foundation system, through tests of *in situ* monitoring. The church has a very important pathological condition that affects all the part and elements of the building. In fact, because of the total disconnection of the brick tiles on the roof and of the absence of a system for the draining of meteoric water, the vaults and the walls have undergone a process of pathological aging rather accelerated (Figure 6).

Figure 6. Church cover state of conservation **Figure 7.** Kinematic mechanism of damage

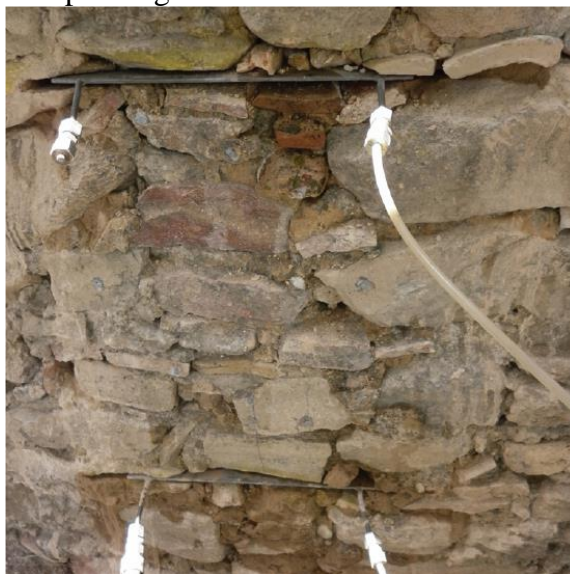
Figure 12. Double jack - Particular

At the end of the intervention were compared to the results deriving from the tests *in situ* using single and double jack (Figure 12) to evaluate the performance of the masonry of the church before and after the intervention, according to the Italian regulations for seismic verification (DM 14/01/2008). From the verification *ante operam*, the structure was not verified if subjected to seismic actions (also very modest); while it was verified only for the static condition, according to the operating loads.
