II Fabre Conference – Existing bridges, viaducts and tunnels: research, innovation and applications (FABRE24)

Defects detection of pier and abutments foundations: an overview of a recent experience in Basilicata (Southern Italy)

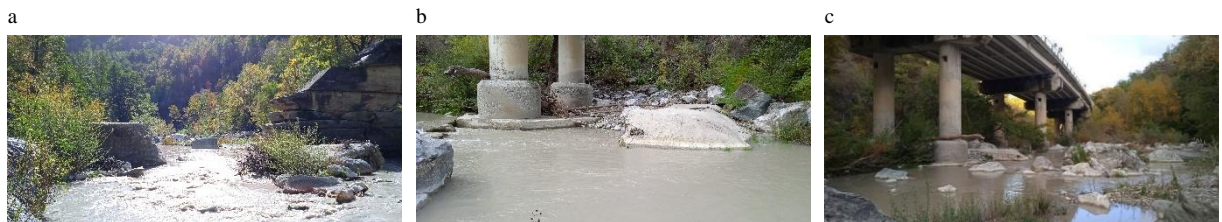
The loss of efficiency and functionality of transversal hydraulic structures, which stabilize the topographic longitudinal profile of the river bed, can lead to significant morphological changes due to general scour (Wang et al., 2020). This situation was observed on Viaduct I, where the weirs failure (Fig. 2a and Fig. 2b), induced a progressive lowering of the river bed highlighting pier foundations and large boulders along the river reach (Fig. 2c). Foundation exposure resulted in a significant increase in the water impact surface area on the bridge (Fig. 3a), producing the obstruction of the channel due to floating materials and debris (Fig. 3b). This determined local scour processes due to secondary currents and fields of swirling and turbulent flow along the path.

Fig. 2. Viaduct I: (a) Remaining of the wing walls of weir damaged; (b) broken submerged weir placed at the downstream reach; (c) presence of large boulders along the river reach.

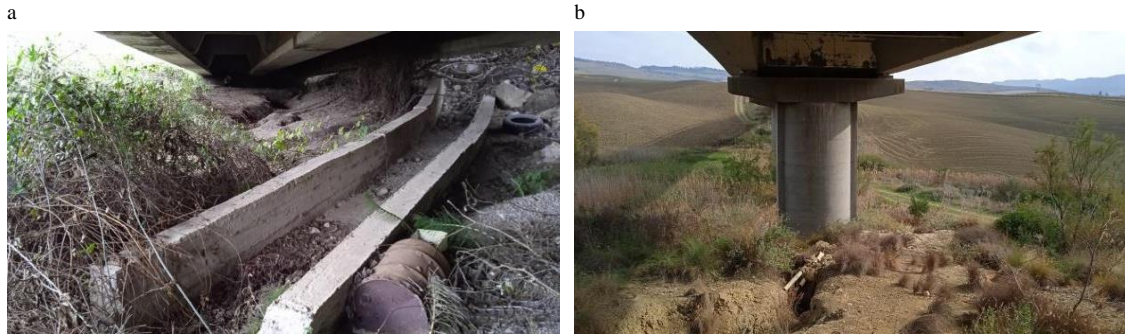
A relevant issue, often not adequately evaluated, is related to the increasing of erosion risk due to the inadequate stormwater management systems. In two specific cases, it was observed that the damage of the canalization system and the uncontrolled stormwater runoff produced local scour phenomena around piers and abutments. As for the Viaduct III, the failure of stormwater canalization induced a deep river bed incision (Fig. 6a) directing stormwater runoff toward one pier Fig. 7a. In the case of Viaduct IV, a deep river bed incision directed close to the pier (Fig. 6b) induced scour condition and damage of the right abutment (Fig. 7b and Fig. 7c).

Fig. 6. (a) Viaduct III: pronounced incisions almost parallel to the broken stormwater channel; (b) Viaduct IV: river bed incision close to the bed pier.

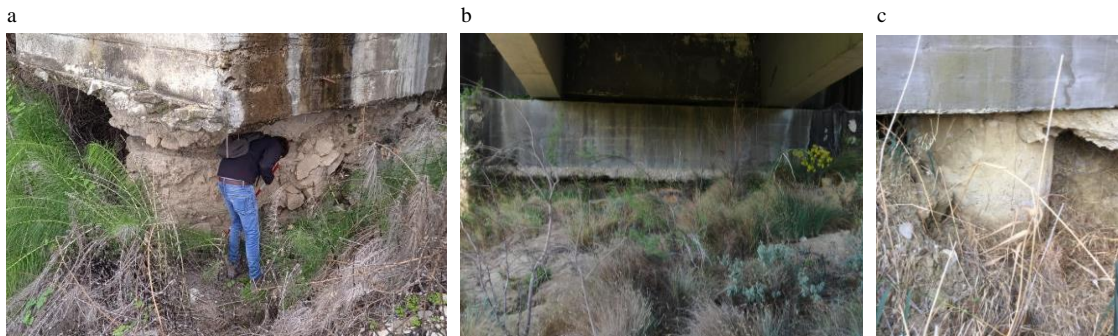
Fig. 7. (a) Viaduct III: foundation exposure of the pier interested by storm water runoff; (b) and (c) Viaduct IV: abutment foundation exposure.

From a structural point of view, Viaduct III and Viaduct IV reported similar condition and geographical context, despite not being close each other. Specifically, during the inspections, scouring was recorded at the foundations of one pier in the case of Viaduct III and both abutments in the case of Viaduct IV. Viaduct IV abutment no.1 presented scouring defect intensity coefficient $K2 = 0.2$ (Fig. 7b), while as for abutment no.2 the defect reached $K2 = 0.5$ (Fig. 7c). The latest coefficient was registered also in the case of Viaduct III pier no.1 (Fig. 7a), having the pile the height of 1 m at the most exposed part. This G5 gravity defect, according to (MIT, 2020), represents a critical element of the abutments and piers of the two bridges for SF-CoA, that is evaluated High for this reason. As previously stated, in these cases the Overall Class of Attention (O-CoA) is automatically conducted in High, independently of the assessments on the other risk classes (S-CoA, L-CoA and H-CoA). As for the S-CoA, seismic defect level is assumed to be Medium-High, since scouring on these elements is considered to be affecting the overall bridge behavior toward seismic actions. Nevertheless, the seismic vulnerability is assigned High because of span length, static scheme, and bridge material. Ultimately, in these cases the S-CoA is High.
