A simplified procedure for risk assessment of cultural heritage: definition and application to case studies

Abstract: Nowadays comprehensive management plans are needed for conserving and protecting the immovable cultural heritage in high natural risks-prone areas.

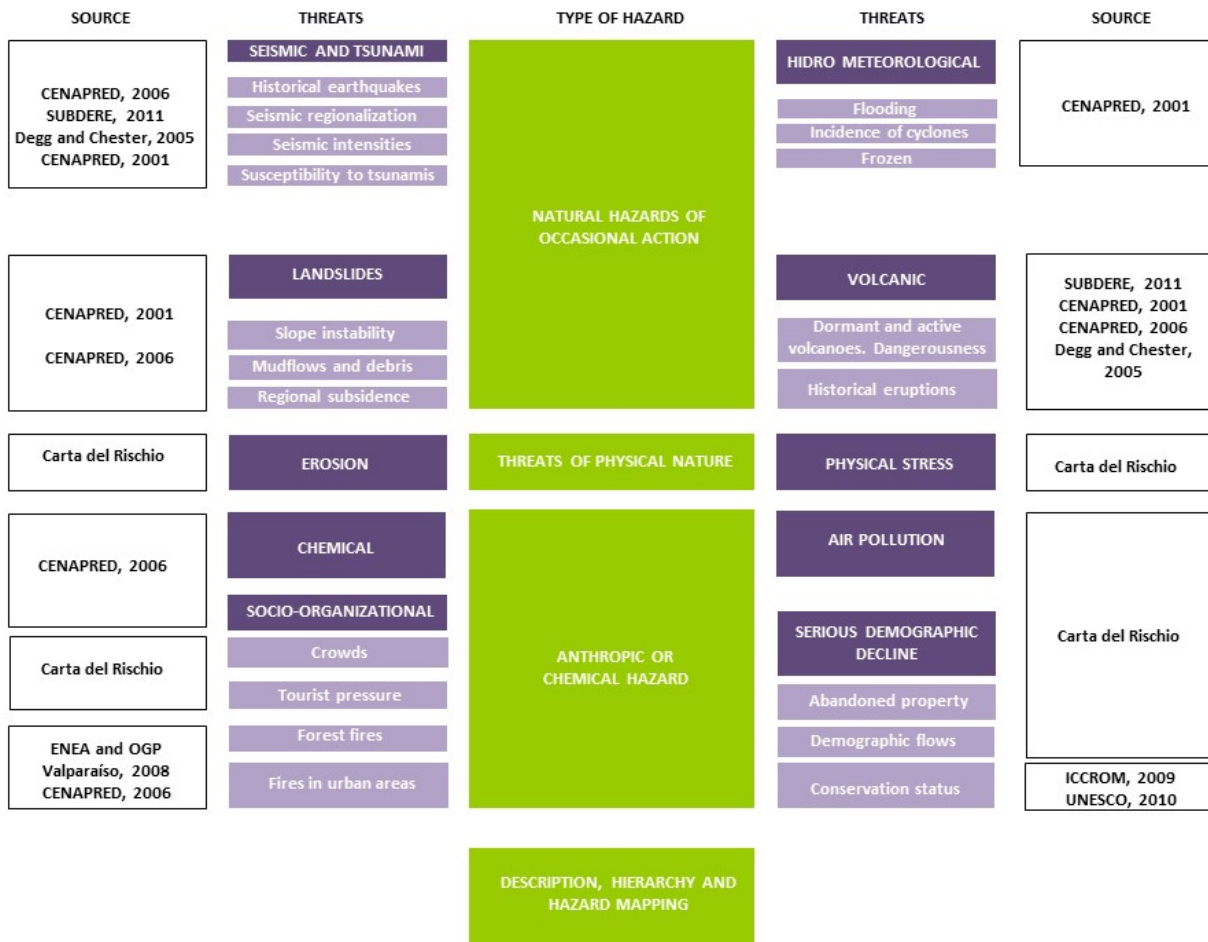
The diagram in Fig. 2 shows the classification of the threats into three main groups (in green): natural hazards of occasional action; threats of physical nature; and man-made and chemical hazards. In both sides of the main column the parameters related to the main group are shown (in purple), and the source or reference (in white) is shown next to each parameter.

Figure 2 – Structure of Tool 2: Description, hierarchy and hazard mapping (Díaz 2015)
