A State-of-the-Art Report on Building Pathology

CIB – W086
BUILDING PATHOLOGY

EDITED BY
VASCO PEIXOTO DE FREITAS

2013

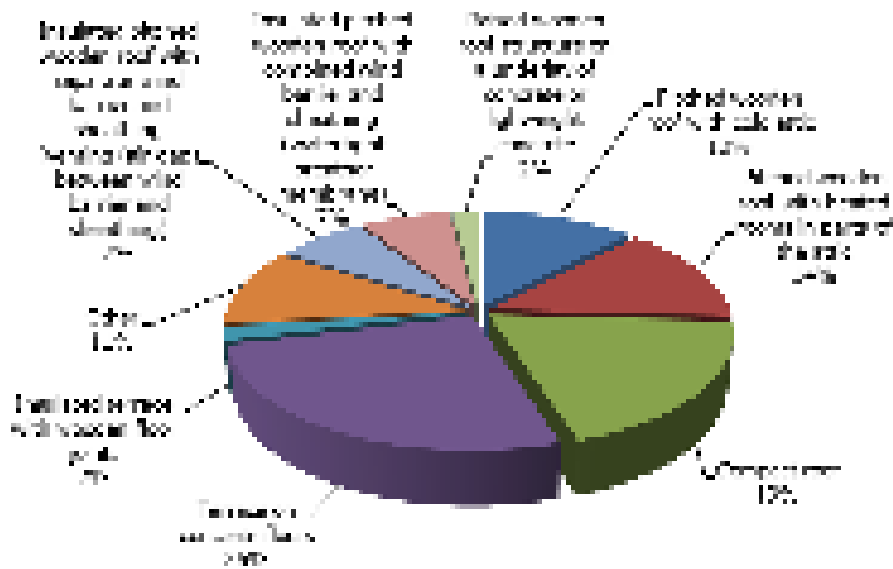
Figure 9 – Distribution of process-induced building defects between 1993 and 2002, according to the type of roof – NBRI

In Norway, construction elements located in the building envelope account for almost two thirds of all observed defects (figure 7). Figures 8 and 9 shows the building defects according to type of external wall and to type of roof, between 1993 and 2002, respectively. In France, the building envelope elements such as façades, roofs and terraces, account for approximately 35% of reported defects between 1995 and 2009 (Figure 10)

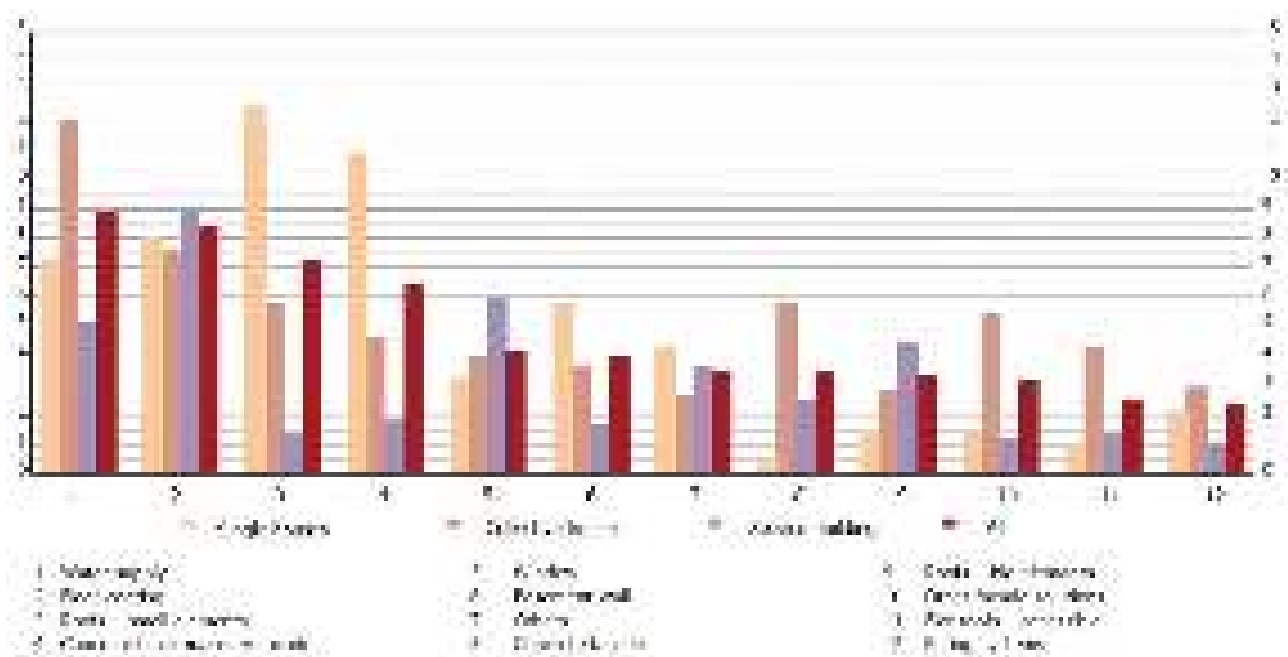
Figure 10 – Hierarchy (%) of the nature of building defects, considering several types of buildings - Sycodès.

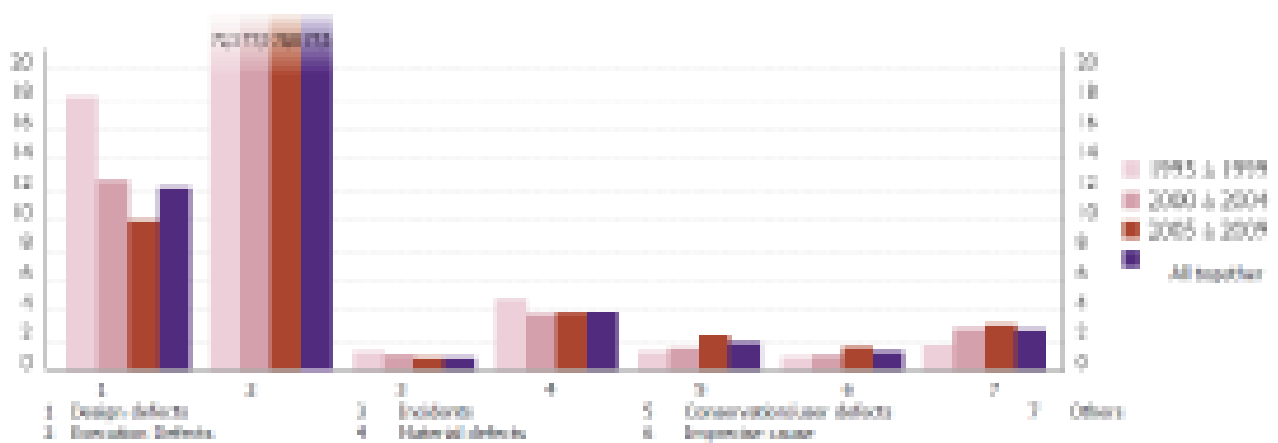
Figure 13 – Distribution (%) of building defects, according to the intervenients in building process – Sycodès.

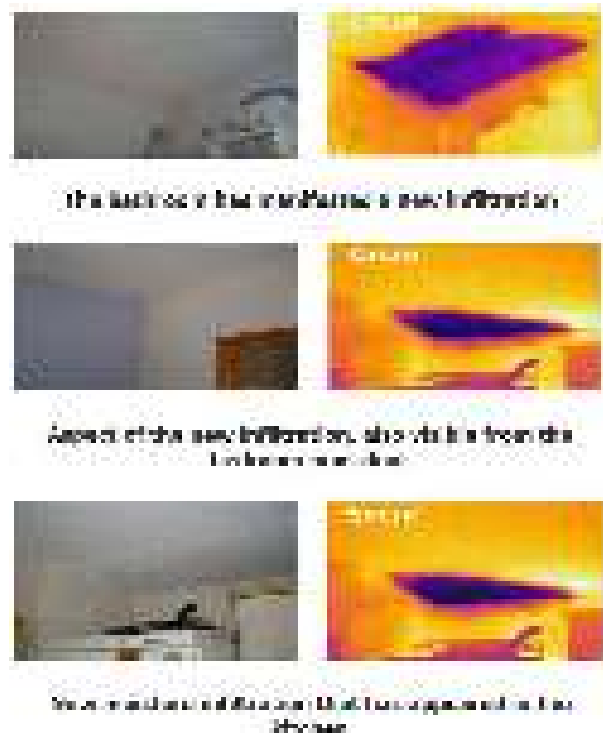
Figure 20 – Thermographic and visible photography points of infiltration of rainwater under the roof of an apartment building

- Synchronous: all of the defects are recorded in a short period of time, with their most relevant descriptive parameters (photographs, dimensions and description) as well as their position (x,y,z) in the geometry of the building (Figures 16, 17 and 18);
- Diachronic: all the defects must be recorded at different stages to assess their evolution over time. They may get worse (increase in the size or severity of the problem) or stay the same. In some cases, a diachronic record should be used to assess whether or not a repair has been successful (Figures 19 and 20).

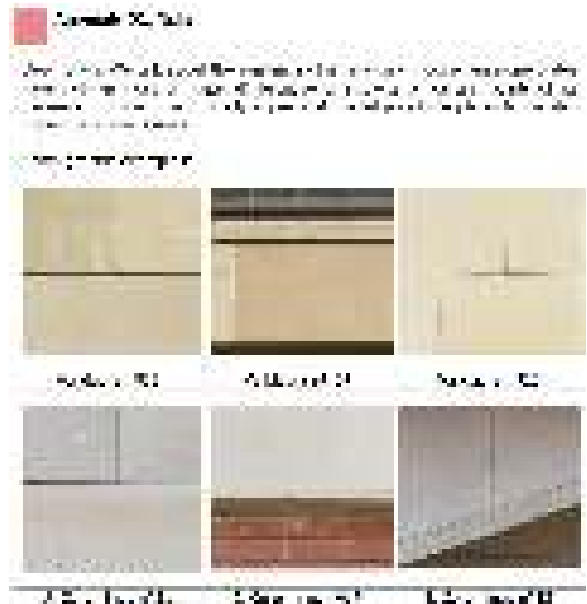
- 01. NICKS
- 02. EFFLORESCENCES
- 03. SCRATCHES
- 04. BREAKAGES
- 05. STAINS
- 06. REPAIRS
- 07. DISCOLORATIONS
- 08. IMPACTS

Figure 24 – Proposal for classification of the anomalies detected in the natural stone façade placated by a group of single houses

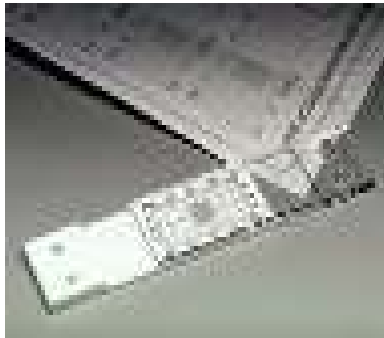
Figure 29 – Fissuremeter by Durham Geo

Fissuremeters (figure 29) measure horizontal and vertical displacements between two base points, with 10E-1mm accuracy. They are composed of two overlapped transparent plastic plates. The top plate shows two orthogonal axes. The bottom plate has a grid divided into millimetres as a graph paper. Before monitoring, the two plates are stuck to each other with adhesive tape to rule out small movements due to the installation. Specifically, when the gauge is set up, the origin of the two axes above should correspond to the centre of the grid below. Each plate is connected with one of the two measurement bases. Then, the adhesive tape is removed and the two plates can move freely according to the movement of the two points of the structure they are connected to. Readings can be taken manually.

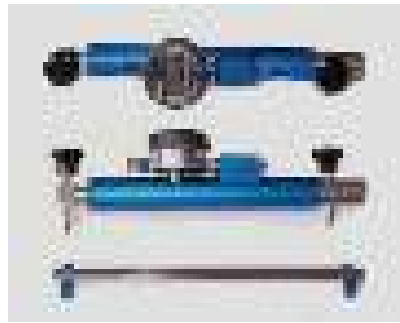
Figure 30 – Deformeter by Huggenberger

Deformeters or Mechanical Extensometers (figure 30) measure the displacement between two base points with 10E-3mm accuracy. They are composed of a metallic tube made out of invar steel, in order to reduce the thermic expansion of the gauge, which may affect the results. Two tapered pins are mounted at the tips of the tube. One pin is fixed; the other can move along the tube, up to ± 5 mm. Displacement value and direction are detected by a comparator and transmitted to a reading unit that can

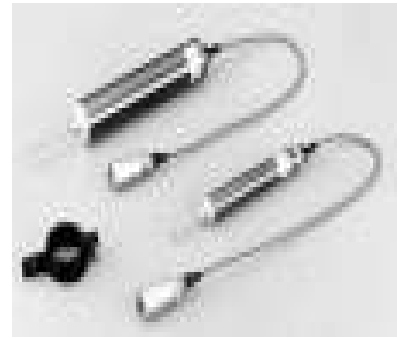
Figure 31 – LVDT's by Bestech Australia

LVDT's (Linear variable differential transformers) (figure 31) are sensing devices that produce an output voltage proportional to the mechanical displacement of a magnetic core. They are composed of a metallic hollow cylinder, where a primary and two secondary coils are symmetrically arranged, and by a nickel-iron core, supported by a nonmagnetic push rod. The metallic cylinder is fixed to the structure by suitable pins, while the magnetic core may move axially within the cylinder in response to mechanical displacement of the probe tip that is also connected to the structure. With excitation of the primary coil, induced voltages will appear in the secondary coils. Because of the symmetry of magnetic coupling to the primary, these secondary induced voltages are equal when the core is in the central position.

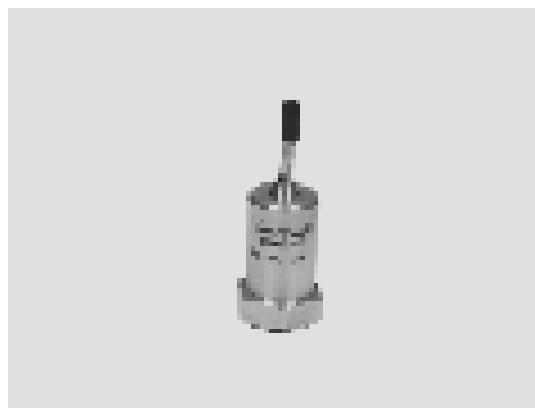
Figure 33 – Standard accelerometer by Honeywell

Accelerometers (figure 33) measure accelerations. They consist of a mass connected to a spring and a sensing element, hosted in a metallic box that can be bonded to the structure by epoxy resin. The mass produces a force if it is accelerated ($F=ma$, Newton's law) and the force produces a deflection in the spring ($F=kx$, Hooke's law). By measuring the deflection, the acceleration can be calculated ($a=kx/m$), if m (mass) and k (spring elastic constant) are known. Different accelerometers are available according to the physical principle and the sensing element to determine the spring deflection. The described system is a single axis accelerometer, as it only responds to accelerations along the length of the spring. In order to measure multiple axes of acceleration, the system needs to be duplicated along each of the required axes.

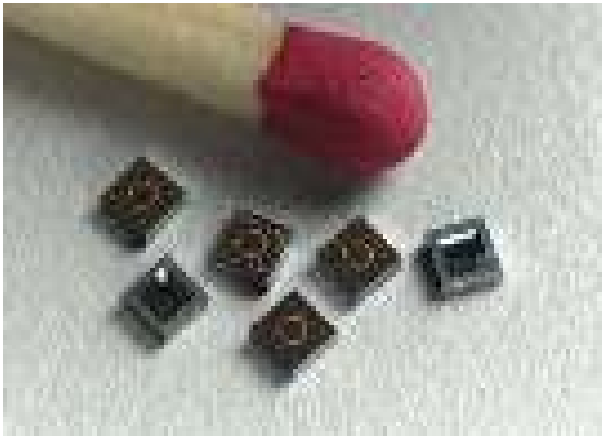
Figure 34 – Example of MEMS

MEMS (figure 34) are microelectromechanical devices that generally comprise micro sensors, signal processing units and micro actuators integrated on a single small size silicon chip by means of the so called micromachining process. They can be bonded onto the structures and integrated into materials.

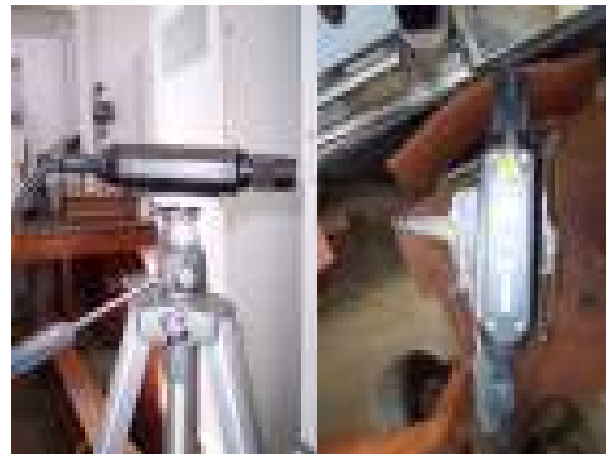
Figure 35 – Single Point Laser Vibrometer by Polytech

Laser vibrometers (figure 35) are innovative devices, which many studies and experimentations are focused upon, also with reference to building materials and structures [Copparoni et al. 2003 & Agnani et al. 2005]. Specifically, laser vibrometers allow for detecting the velocity of a moving point focused by a laser beam. The device measures the frequency shift

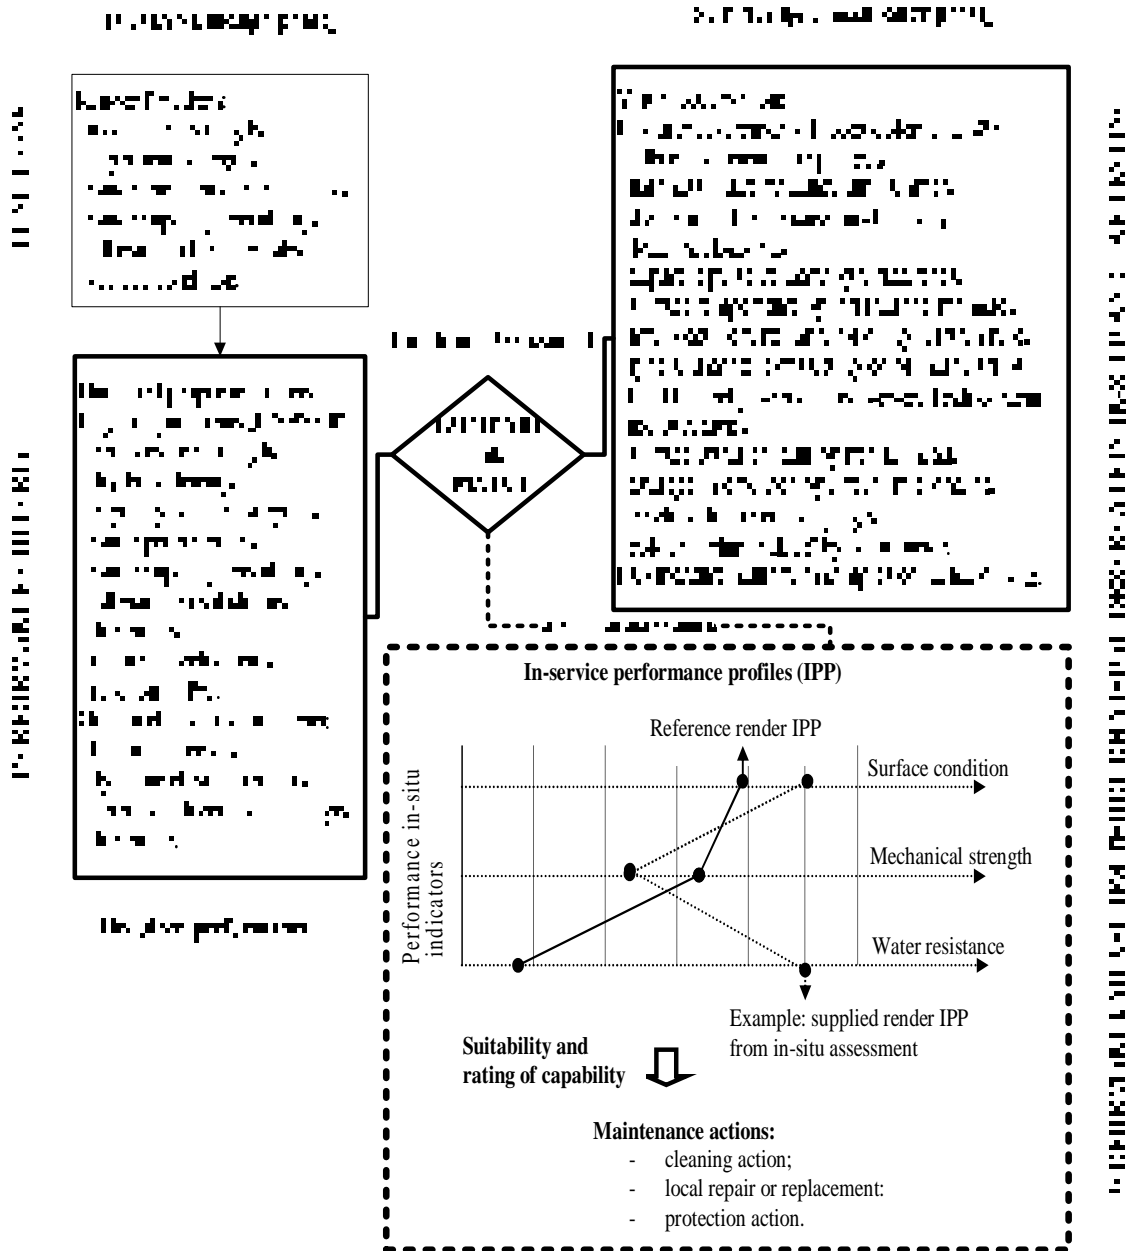
In this methodology the application of in-service performance profiles (IPP) are recommend. The IPP include in-service performance indicators and reference values of properties measured on-site (reference IPP); in figure 36 three performance categories are exemplified: surface condition, mechanical strength and water resistance for condition assessment in current area of rendering façade. Conditioned maintenance should be applied when the supplied in-service performance level (at least in one of the three previous categories) is not acceptable, through cleaning, repair, replacement and protection actions. For example, using mechanical strength indicators, the use of an in-service performance profile (IPP) in serviceability assessment is possible with the identification of a reference IPP that considers two groups of renders (A and B), taking reference values (as shown in figure 37; in this example, the ready-mixed mortars PL belongs to group A and PP to group B). This profile allows the integrated study of more than one on-site property and therefore it can increase the reliability of the assessment.

Figure 36 – Methodology for condition assessment of rendering (Flores-Colen, et al., 2008b).

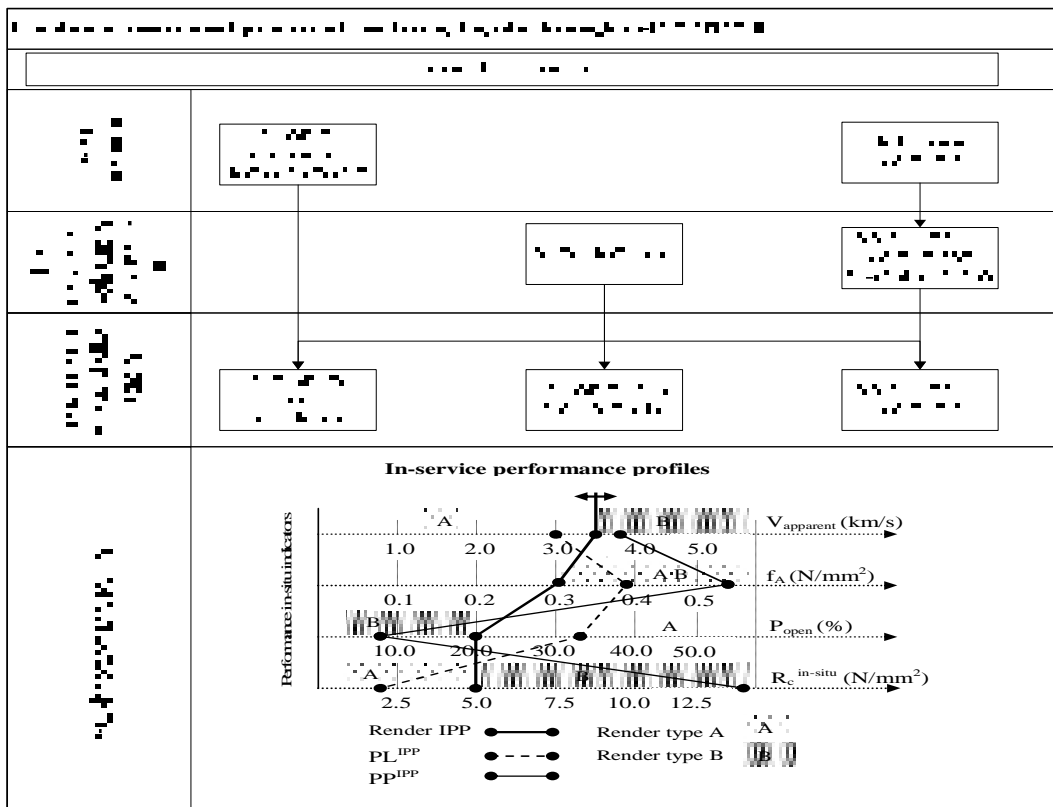
Figure 37 – Example of condition assessment of rendering through hierarchy on-site mechanical strength indicators.

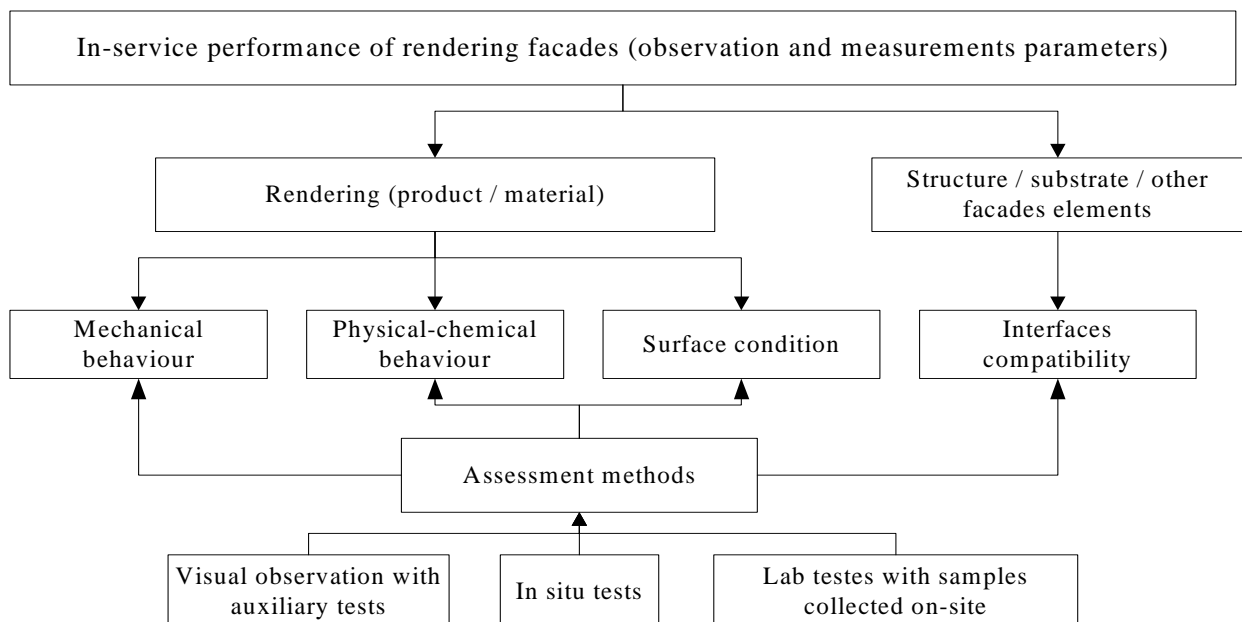
Figure 38 – Performance criteria and methods of assessment (Flores-Colen, et al., 2010)

The proposed methodology includes four types of performance criteria assessment (multi-performance approach): 1) condition of the rendering surface (in terms of anomalies and inner heterogeneities); 2) compatibility of interfaces (identification of problems in render with the other elements of façades, such as wall, structure, finishing layer, copings, sills, among others); 3 and 4) mechanical and physical-chemical behaviour of render. The assessment methods proposed in the methodology include visual observation, auxiliary methods, in-situ and lab testing (in this type of assessment samples are collected on-site), figure 38.

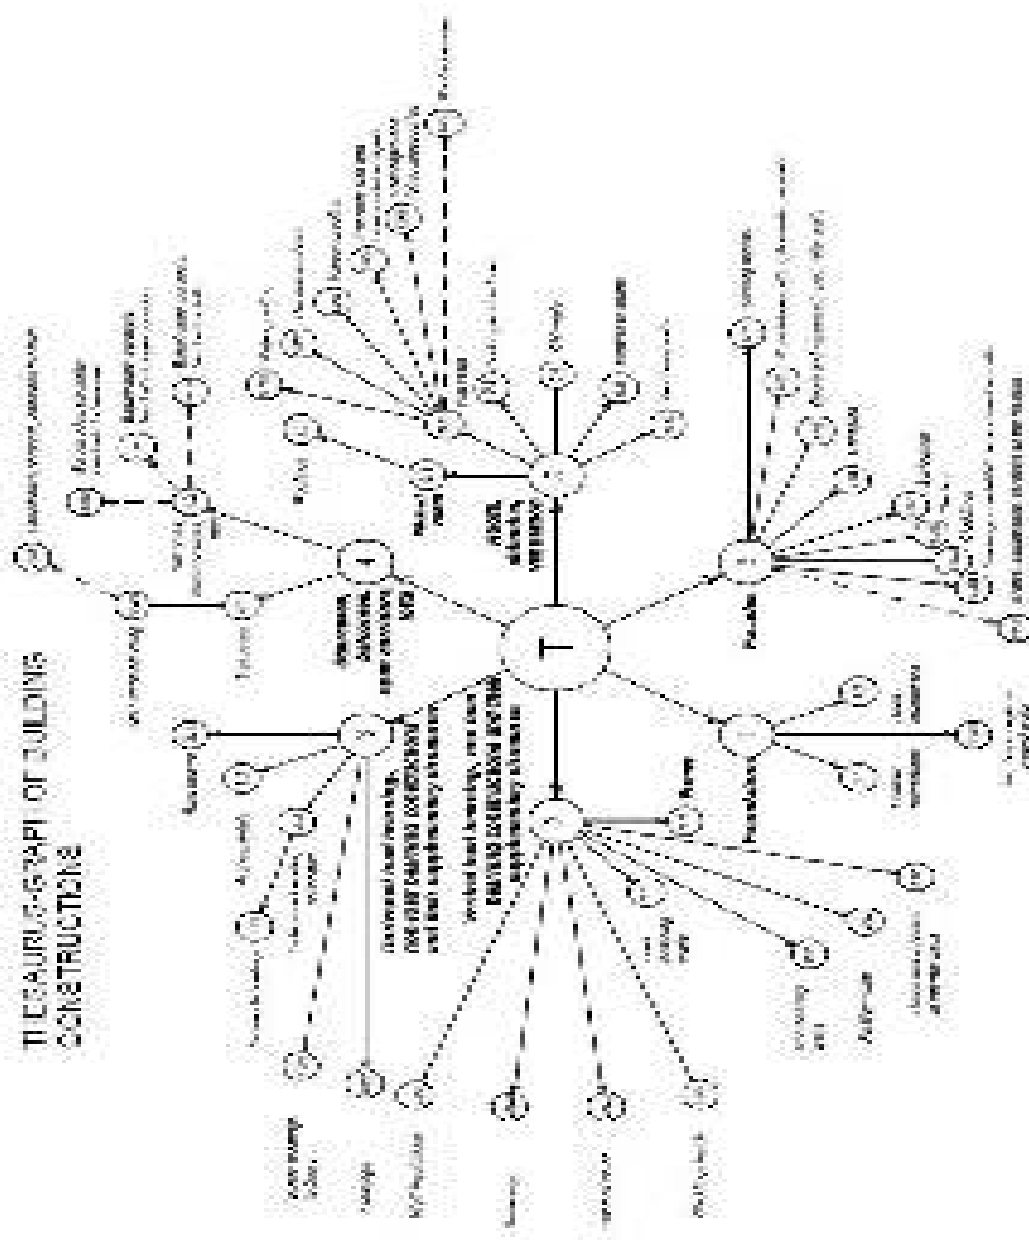
The main task of our thesaurus (graph-version) is to help the visual survey. It can be very useful to understand the hierarchy and the connections in the field of building constructions (figure 40). The thesaurus is not only necessary to the easy surveillance of the system, but also to exclude the usage of

Figure 40 – Thesaurus Graph

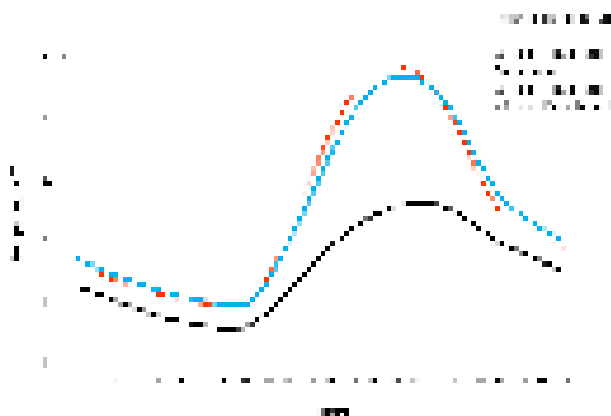
Defects are identified by differences in surface temperature between areas with and without pathologies (Rao 2008). Detachment creates an air layer and thermal resistance to heat flows, which enables the temperature differential to be assessed. This surface temperature variation changes over the course of the day, as can be seen in the numerical simulation results with WUFI software (WUFI 2009) (figure 44).

Figure 44 – Changes in surface temperature in a southward-facing façade with and without detachment over the course of one October day obtained by numerical simulation, using the WUFI calculation programme

Figure 44 shows that, without radiation on the façade, the temperature difference between the zones with and without defects is negligible. As the exterior surface temperature increases, due to the effect of radiation, the temperature of the detachment zone increases more rapidly than zone without the defect, because of the thermal resistance provided by the air space. At around 3 pm the solar radiation on the façade causes the detachment zone to reach maximum temperature. When sunlight stops falling on the façade, the surface temperature of the detachment decreases more rapidly than that of the zone without the defect, where there is no thermal resistance from the air layer. The surface temperature of the façade continues to drop, with the zone without detachment cooling more slowly than the defective zone.

The results presented were obtained with the climate file generated by Meteororm (METEOTEST 2007) for one October day in Porto, Portugal. The simulated configuration involved fine polymeric render (0.004 m), an air layer (considered only for the case with a detachment of 0.003 m), cement plaster rendering (0.02 m), brick masonry (0.3 m), an air layer (0.02 m), extruded polystyrene (0.05 m) and gypsum board (0.015 m).

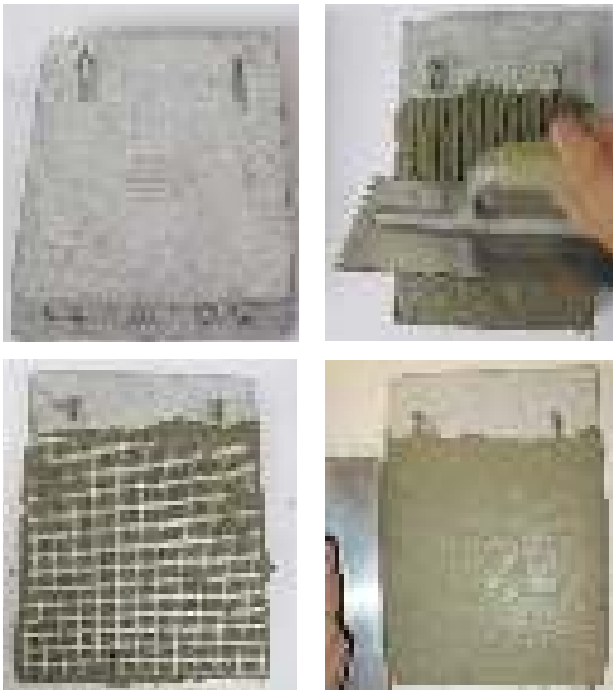
Figure 47 – Preparation of the samples – creation of the detachment

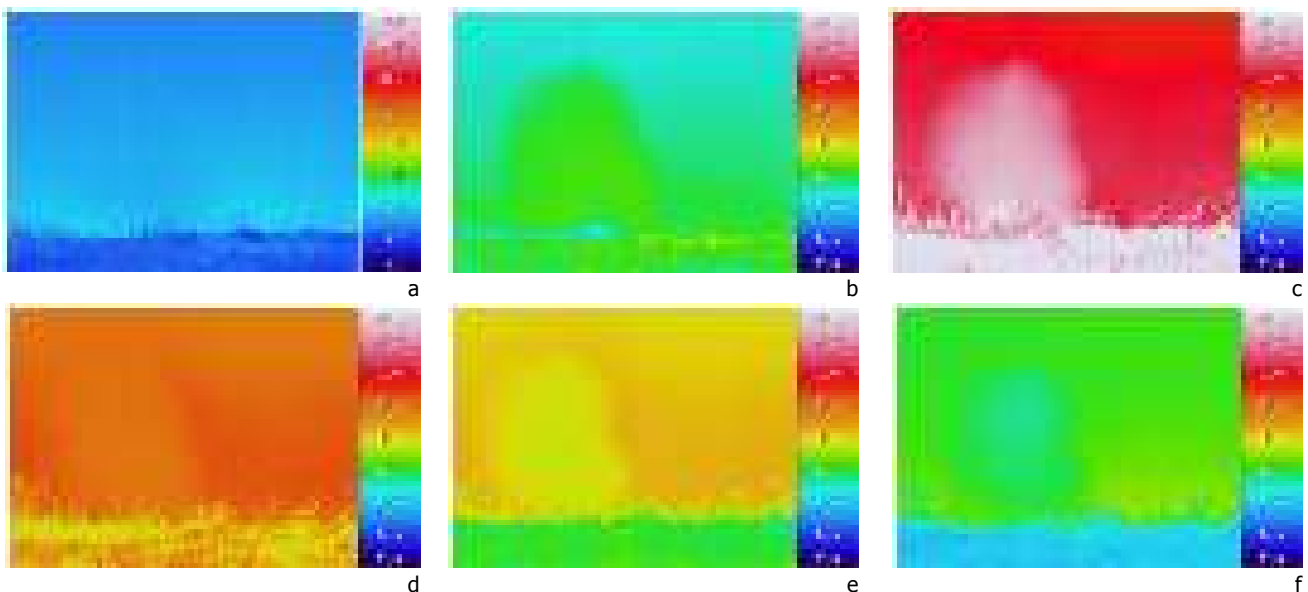
Figure 54 – Thermograms taken *in situ* through an October day: a) 9.30 am, b) 12.30 pm, c) 4.30 pm, d) 5.30 pm, e) 6.30 pm, f) 11.30 pm

Figure 54 shows the thermograms obtained over the course of a sunny day in October. Tests were also performed on cloudy days with similar results.

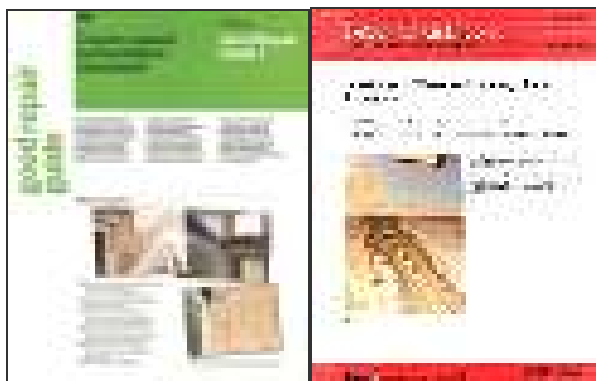
Figure 57 – Examples of a BRE "Defect Action Sheet" and Good Repair Guide.

Between May 1982 and March 1990, 144 pathology records or reports, collectively entitled the "Defect Action Sheet – DAS", were prepared and published by the Housing Defects Prevention Unit of the Building Research Establishment (BRE), a British organization specialising in buildings (Figure 57).

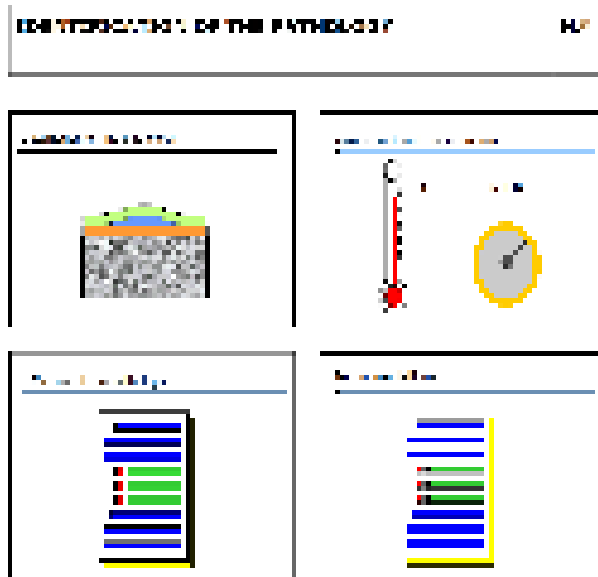
Figure 64 – Standard model of a Pathology Report.

The information is organized according the figure 64.

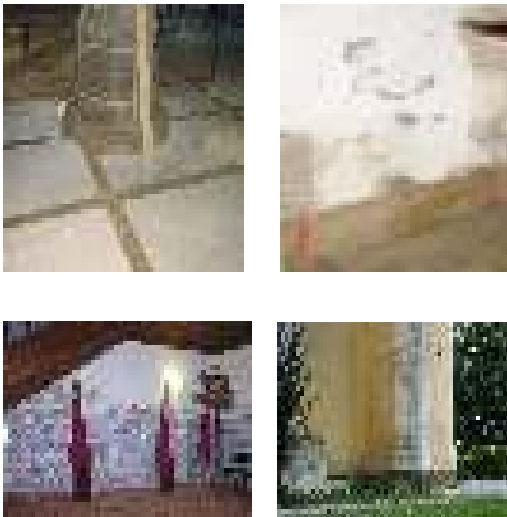
The coating of the interior walls presented moisture and degradation of renders and stone due to salts cristalization (wetting and drying process) stains on its base.

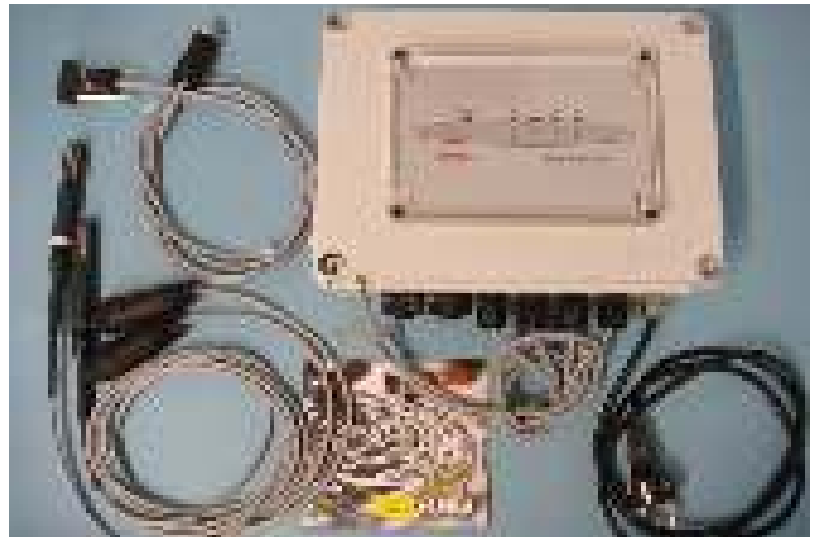
The tests conducted to identify the wall's constitution revealed granite masonry construction, with rendered and painted surface. Measurements were taken to determine the ambiances hygrothermal conditions (temperature and superficial moisture content of the wall).

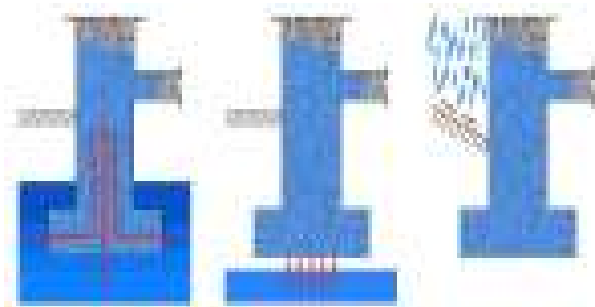
The moisture stains on the base of the wall resulted from rising capillarity. Rising damp occurs when walls made of high capillarity materials and with no hydric break are in contact with water or moist soil. Rising capillarity continues until a balance between evaporation and capillarity is achieved. The drying flow (g) depends on the vapor concentration gradient of the air (Ca) and surface of the wall (Cs).

$$g = \beta (Cs - Ca) \text{ [kg/(m}^2\cdot\text{s)]}$$

The absence of an adequate hydric break may have been the main cause of the problem.

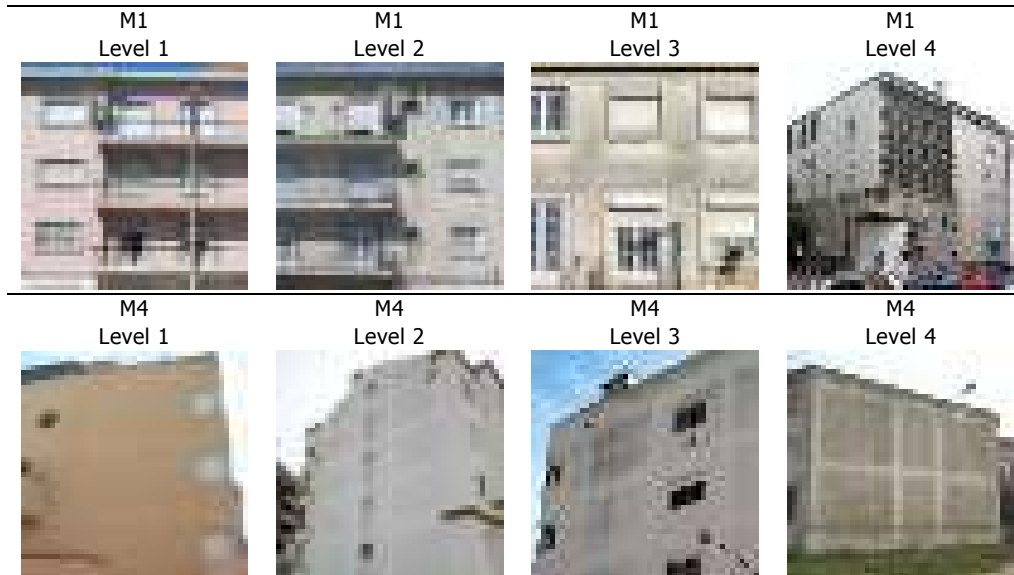
Table 5 – Examples of different condition levels for staining defects M1 and M4, from level 1 (less severe) to level 4 (most severe)

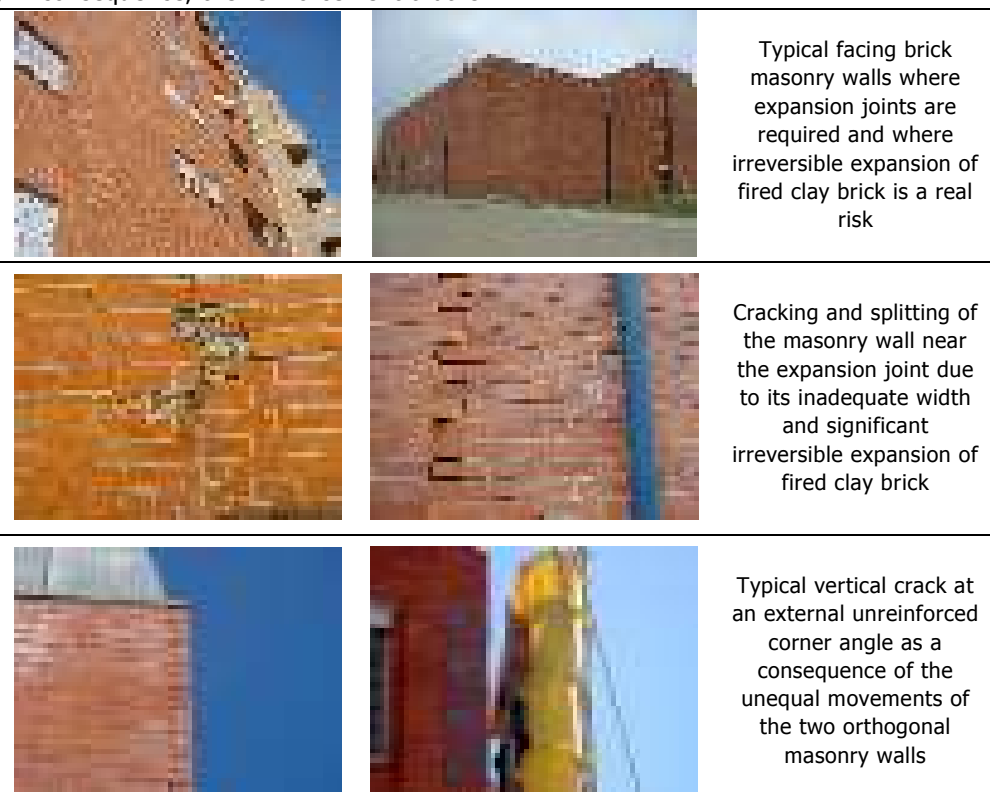
Figure 66 – Examples of defects on clay brick external masonry walls, resulting from natural movements and inadequate reinforcement or free movement joints

For long time, clay brick masonry walls were built inside concrete structural frames and, in consequence, the natural movements of materials produced by humidity and temperature change along the time imposed local stresses with limited consequences. The increasing use of non-restrained external walls leads to increasing defects resulting from natural movements, because the expansion is, theoretical, free. However, at singular points of the walls and in extensive walls, these movements generate high local tensions and consequent cracks (see Figure 66).

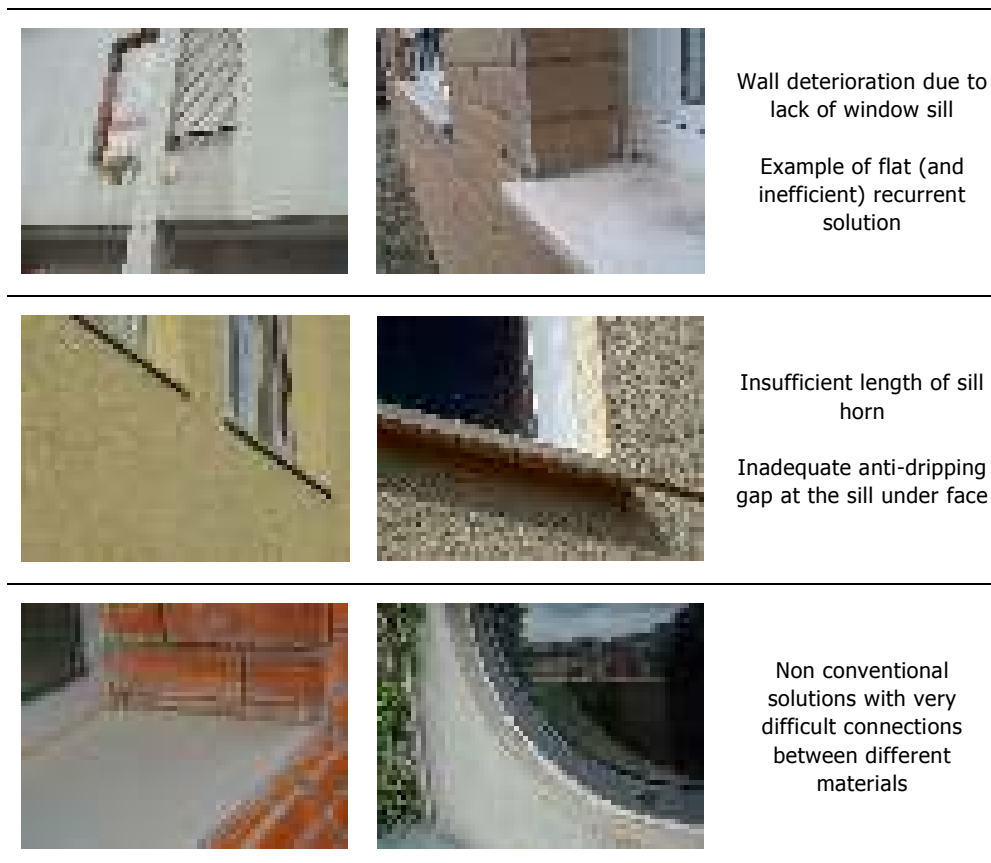
Figure 67 – Examples of window sills with different shapes and materials, which functional performance is somehow compromise

Unfortunately, in ordinary construction, many non-innovative solutions – already well described in technical documents that are frequently neglected – are designed and executed with basic workmanship errors and defects that limit the expectation of their more elementary performance (see Figure 67).

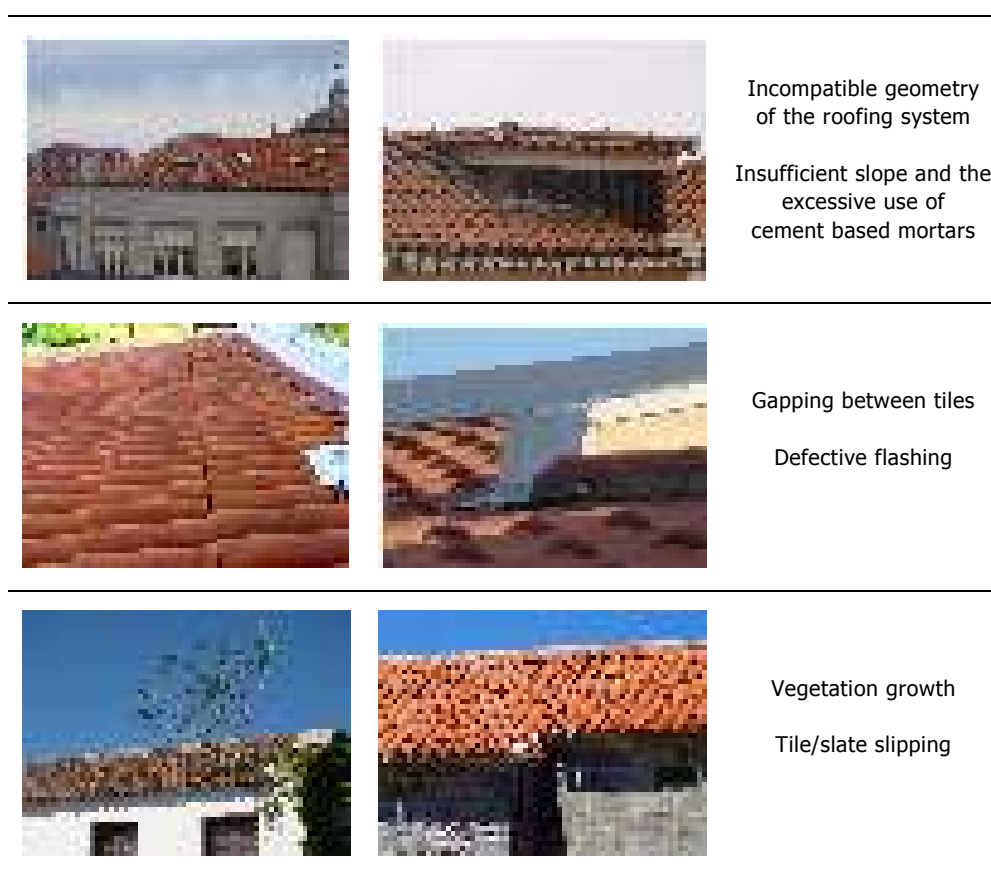
Figure 68 – Examples of defects for pitched roofs

In figure 68 are presented some cases of common defects observed in recent and old buildings with pitched.

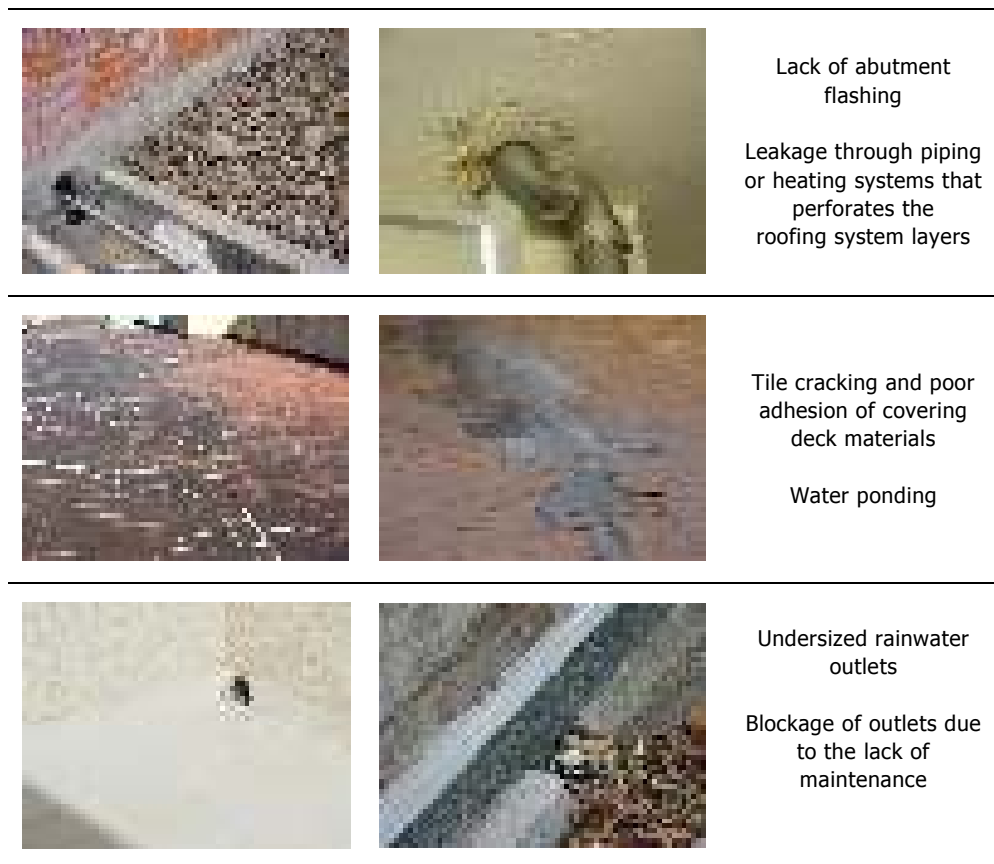
Figure 69 – Examples of defects for flat roofs related to the inefficiency of their draining system

In figure 69 are presented some cases of common defects observed in flat roofing systems with the focus on inefficiency of draining systems.

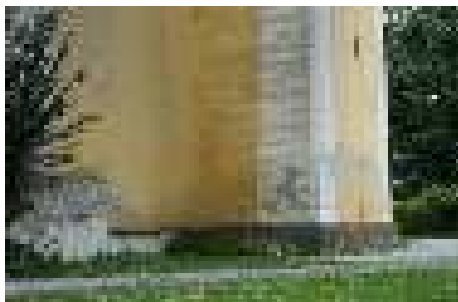
Figure 136 - Rising Damp

Rising damp is one of the main causes of deterioration in old buildings and historic monuments (figure 136).

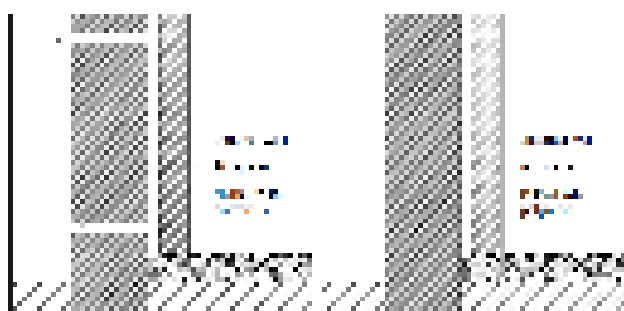
This method does not treat the causes of the problem but rather aims to disguise it. It involves placing a thin layer of cladding on the inside, some 10 cm from the wall, so that there is no physical point of contact. The air space between the wall and the cladding should be ventilated to the exterior through orifices at different levels. The base of the wall should be impermeable so that there is no moisture continuity (figure 141). It is not advisable for the air space ventilation to be directed towards the inside of the building.

Figure 141 - Interior cladding

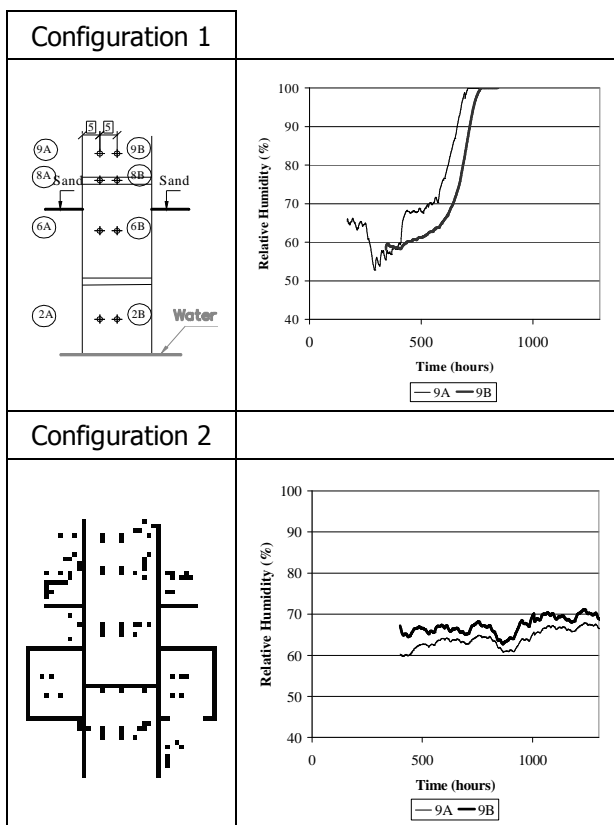
Figure 147 – Results obtained for Configurations 1 and 2 at Level 9

The variation in relative humidity at a particular level enabled us to determine the moment when the rising damp front, generated by capillary action, reached the level of the sensors. Figure 147 shows the position of the sensors. Type B sensors were located in the middle of the wall thickness, while Type A ones are located 5 cm from the surface. Level 9 corresponds to the third row of stones 61.5 cm from the base.

The laboratory tests showed that, for Configuration 1 (i.e. without the wall base ventilation system), the sensors recorded 100% humidity after a given period of time, which means that the damp front had reached that level. On the other hand, in Configuration 2 (with the ventilation system installed), the relative humidity remained constant and less than 70%, even after a longer period of time, since there was no rising damp (figure 147).

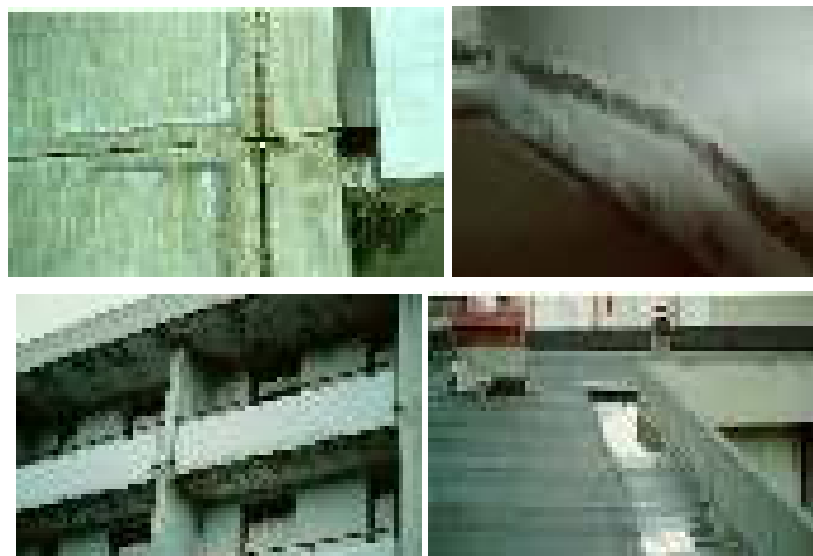
Figure 156 – An example of the lack of attention in the assembling and junction of components in a building made with load bearing great prefabricated panels. Some of them present breaches and most joints are not adequately sealed. It is inevitable that there is leakage of water and infiltration of air inside the habitable rooms, in addition to thermal bridges. It is also an example of the wrong design of water piping and collecting system, which leads to leakage of water caused by stagnation, cracks, lack of cohesion of concrete and to stains on external surfaces.

The analysis confirms that this kind of pathologies can be linked once again to mistakes in design and execution (see figure 156), but also to mistakes in conducting the heating system and the “wrong use” of the building.

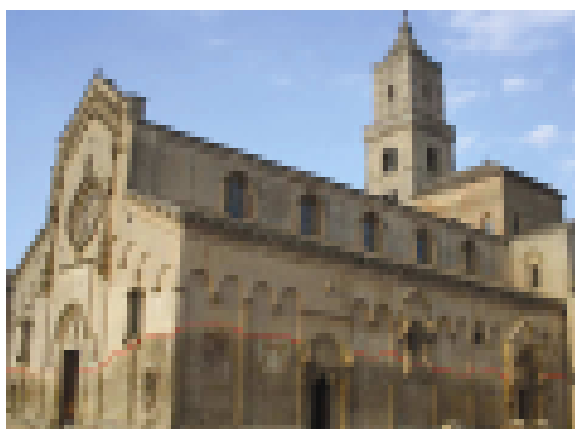
Figure 157 – The big dark spot on the external wall of the Cathedral

A big dark spot (figure 157) affects the whole building along its perimeter. It seems to be caused by a deep phreatic rise, which could have resulted in rising damp pathologies on the whole building, even though the spot's height is makes it doubtful, since it rarely reaches such heights. This kind of humidity rises from the subsoil and may be fed either by dispersed water or by an underground water table [Croce S. 1994]. The first one is usually the result of local - and limited - causes, such as insufficient collecting of rain-waters, leakage from wells or water pipes; all these causes may produce local imbibition of the soil touching the foundations. They often affect just one side of the building, and can be solved through suitable means.. On the contrary, underground water tables are neither removable, nor controlled. They affect the building uniformly from the basis; showing maximum rise height on North/North-East façades and minimum rise height on the sunniest areas; it is widely spread to every building in the area and does not show any changes in the re-ascending height.

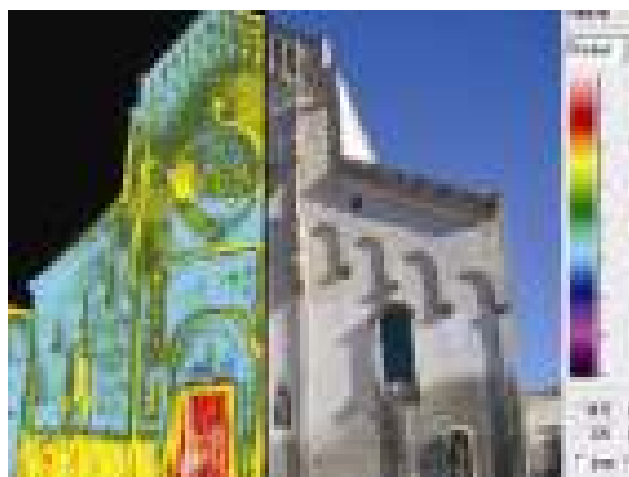
Figure 158 – The thermographic survey of the Cathedral's façade

nor hollows which could allow the underground backwater. However, some hydrogeological surveys carried out in this area, have shown that there has never been any underground water tables, either now or in the past. After excluding this possibility, a thermographic analysis (figure 158) of the whole building was conducted, in order to understand the dark spot's nature.

The analysis was carried out in March 9th 2007. The outer temperature was 8°C and the air's relative humidity was at 53%. An unusual result was attained by the analysis of the achieved thermographic pictures: the lighter areas, corresponding to the dark spot on the façade, are actually hotter rather than colder, as it would have been expected if there had been rising damp [Massa S., 1987]. This result showed that the masonry was actually dry, and the fact that it was hotter in the whole building's lower areas - even though at different heights - was probably justified by a different behaviour of the stone when absorbing solar radiation, which probably led to variations in the material's emission capacity. The big dark spot would seem to absorb more sunlight than the rest of the building, which has a lighter color, typical of the local stone, called "tufa". The physical mechanism that is responsible for this process is the irradiation that transfers the heat in the form of electromagnetic waves, in this specific case, directly from masonry irradiated by sunlight. For this reason, the spot is hotter than the rest of the building. However, further tests on physical-chemical properties of the material, and more detailed petrographic analysis are today being implemented to determine the exact nature of the phenomenon.

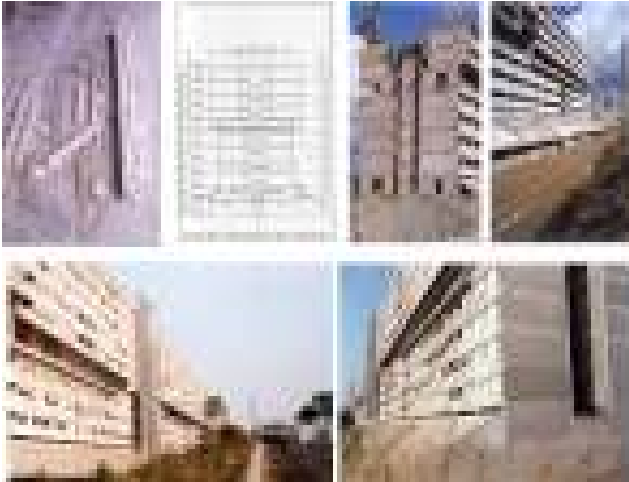
Figure 159 - Roma, Corviale North and South, n.1.080 flats of subsidized buildings realized with large bearing panels system

This is the case of an eleven-floor building which width is divided in three parts, the overall length being approximately one kilometer; it contains 1080 dwellings of subsidized construction, a "street" on the seventh floor, with (prevised, but never realized) offices and shops, meeting halls, and at the ground floor and first floor, garages, storerooms and so on (see figure 159).
