A State-of-the-Art Report on Building Pathology

CIB – W086
BUILDING PATHOLOGY

EDITED BY
VASCO PEIXOTO DE FREITAS

2013

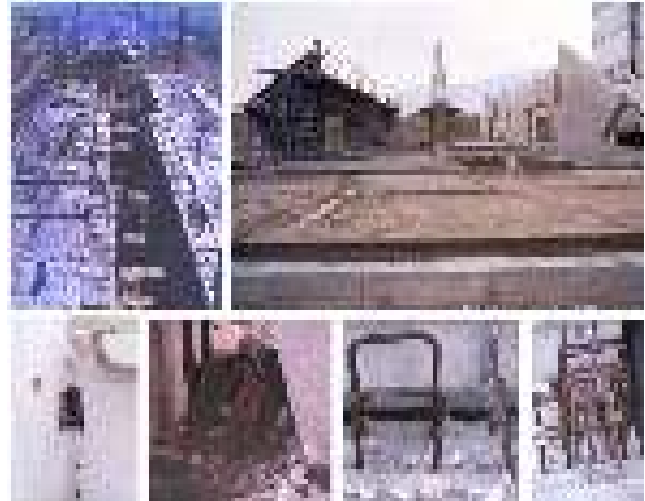
Figure 160 - Roma, Corviale North and South, characteristics of the industrialized building system

It was necessary to employ an enormous quantity of steel bars for pillars in the panels (four to six in each), with a very small cover, because of the reduced thickness (16 cm) of the panels. As a matter of fact, the damaging effects of carbonation were not considered at all, thanks to the structural Standards, which allow the designer to consider very small dimensions for the cover (see figure 160).

most hydrophilic material possible, such as gypsum plaster lath bricks or expanded clay. The same problem about thermal bridges is also true for internal loggias, galleries and cavaediums (see figure 160).

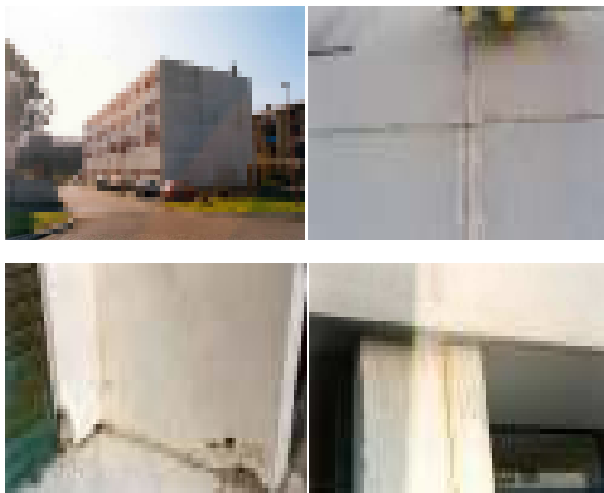
Figure 161 - Pozzuoli (Napoli), Monterusciello n. 148 flats of subsidized buildings realized with large bearing panels

In most part of the construction with large prefabricated panels (see figure 161), they used one layer of multitubular panels, interiorly isolated with a light insulating panel and inner lining in plaster. That produces pathologies of condensation near the thermic dispersions, and vertical widespread cracks at the joint of the panels, due to the thermal shock of Summer-Winter cycles to which the structures are subjected.

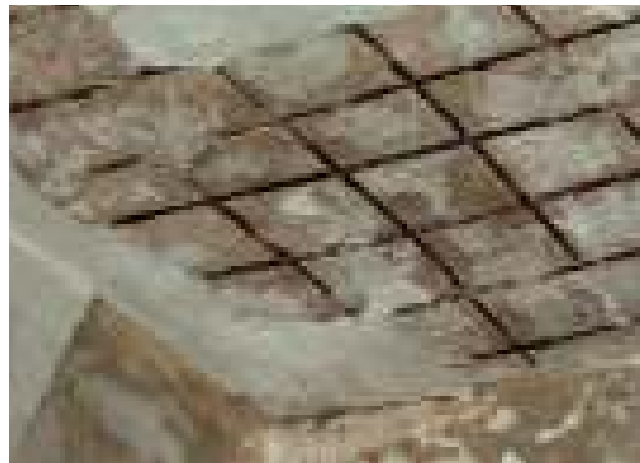
Figure 164 - Type C1 concrete slab. Decay of concrete under the reinforcement bars

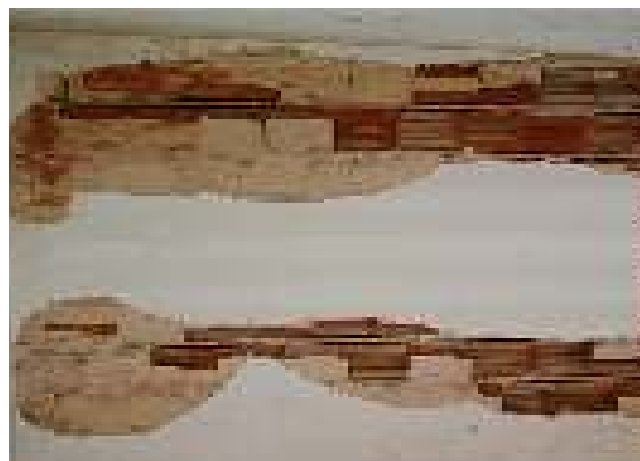
Figure 165 - Type C1 concrete slab. Brick blocks falling down

As far as type C slabs (concrete beams and plain concrete slab/ brick blocs) are concerned, it should be observed that intrados surface decay and stains, as well as swelling, detachment and cracking of intrados plaster (figure 163) are quite common. Possible causes are poor mechanical, chemical and physical compatibility between different materials and inadequate maintenance. Further pathology patterns concern the decay of concrete under the reinforcement bars (lack, mouldering...); cracking and detachment of concrete elements (figure 164). They might be due to construction defects; ineffective hardening of concrete; overloads; deficient iron beam bearing section; iron corrosion. For type C2, those factors might also cause the brick blocks to fall down (figure 165).

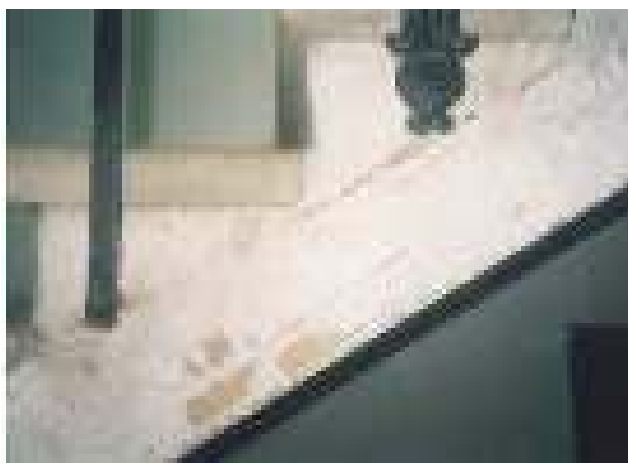
Figure 166 - Type B1c staircase. Side surface decay and corrosion of iron beams

The above-described analysis was also carried out for different typologies of staircases, as summarised in Table 18. First, it should be mentioned that some pathology patterns occur in all the cases. In detail, intrados and side surfaces of steps and landings extensively show decay and stains, with minor differences among the typologies. The causes are lacking protection of elements, poor chemical, mechanical and physical compatibility among different materials, aggressive environmental conditions and inappropriate use, especially in terms of maintenance of extrados surfaces (figure 166).

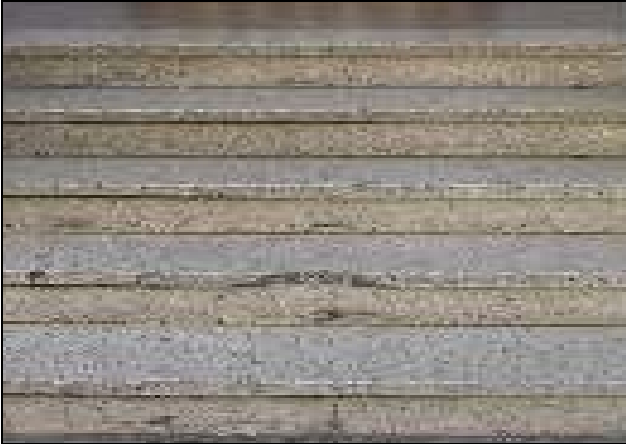
Figure 168 - Type C1 staircase. Disaggregation, decohesion and detachment of stone covering

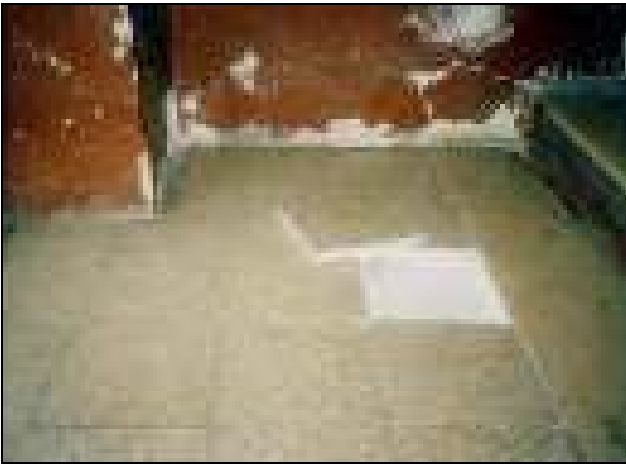
Figure 169 - Type B1a staircase. Cracking and detachment of tiles on landings

In most cases, although less common than the previously described pathology patterns, deformations of iron beams can be observed that might trigger cracking and detachment of tiles on steps and landings. In typologies B1c, such deformations can also make the brick blocks of the vault rampant to fall down. Possible causes are deficient iron beam bearing section, compared with loads and span; poor mechanical, chemical and physical compatibility between different materials - especially mechanical compatibility with tiles on steps and landings (figure 169). As far as type B1d is concerned, disaggregation, decohesion and detachment of cantilever stone steps is quite frequent, because poor dimensional and mechanical compatibility, as well as differential dilation, might be present between contiguous blocks and between blocks and iron rail. Inappropriate use might worsen such a phenomenon [De Fino et alii, 2010]

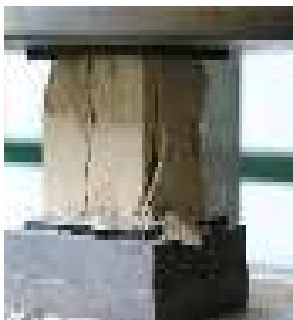
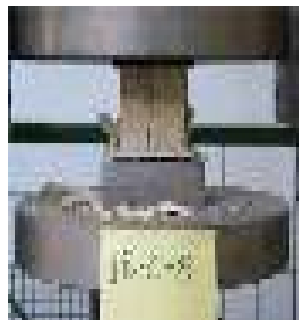
Figure 172 a)

Creep Tests

The programme of structural tests has provided the carrying out of squashing tests to settle the breaking test load and to assess the differences related to the origin, and creep tests (figure 172 a) and b)) to settle the breaking test load for a material subdued to a steady load.

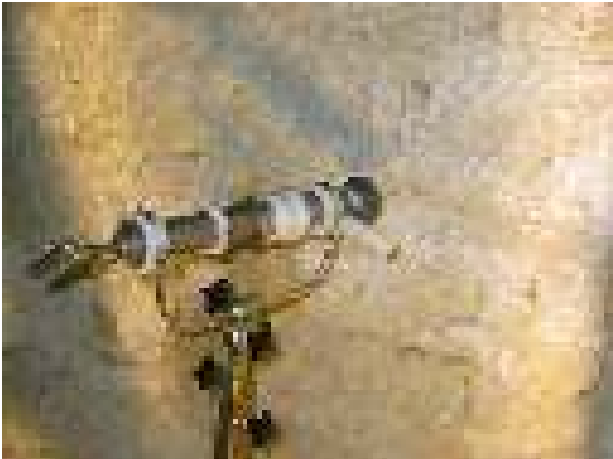
Figure 173 – Penetration meter test

The tests on mortar (Penetration meter test) have been carried out on site (figure 173 and 174) by means of an instrument, planned and produced by the University of the Basilicata Material Tests and Structures Laboratory of the Di.S.G.G (Structures, Geotechniques and Geology applied to Engineering Department). This instrument settles the mechanical features, the angle of friction and the screen curve of the traditional and modern mortars, which have been used as a result of a reinforcement intervention carried out on several monuments in the sample area: and therefore it is possible to check the carried out intervention's efficiency. The aim of the tests is to correlate the numbers of strokes per a penetration millimetre (Stokes per Penetration Unit) with the

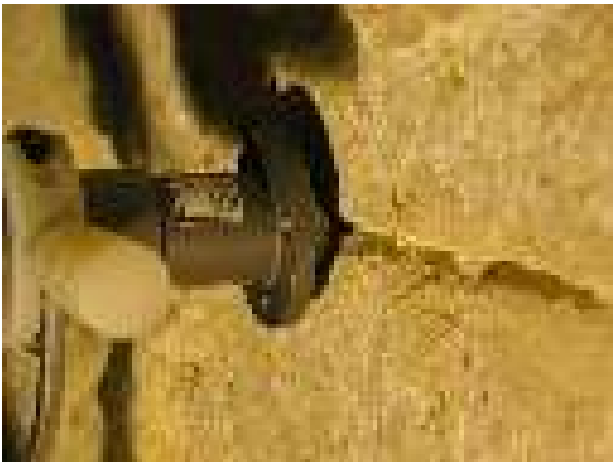
Figure 174 – Penetration meter test
