# REHABEND 2022

CONSTRUCTION  
PATHOLOGY,  
REHABILITATION  
TECHNOLOGY AND  
HERITAGE MANAGEMENT

Granada (Spain) - September 13<sup>th</sup>-16<sup>th</sup>, 2022

29	BUILDING CONSTRUCTION AVANT-GARDE IN ITALIAN IMPERIALISM: AN ARCHITECTURE AND TECHNICAL LABORATORY <i>Pagliuca, Antonello; Trausi, Pier Pasquale; Gallo, Donato</i>	1291
43	DECIMONONIC WOODEN BRIDGES IN THE CENTRAL REGION OF COLOMBIAN ANDES <i>Galindo-Díaz, Jorge; Escobar-García, Diego; Flórez, Gilberto</i>	1299
94	EXPERIMENTAL STUDY OF THERMAL AND ACOUSTIC PERFORMANCE OF RAMMED EARTH PANELS LIGHTENED WITH ANGUSTIFOLIA KUNTH BAMBOO TUBES <i>Aguirre-Maldonado, Eduardo; Guzmán Rojas, Jonathan; Balcázar-Arciniega, Cristian</i>	1307
105	USE OF CHALCEDONITE POWDER AS A SUPPLEMENTARY MATERIAL IN LIME MORTARS <i>Vyšvařil, Martin; Krebs, Martin; Bayer, Patrik</i>	1314
112	USE OF FINE-GROUND LAVA SAND AS A POZZOLANIC ADDITIVE IN AERIAL LIME-BASED MORTARS <i>Žižlavský, Tomáš; Vyšvařil, Martin</i>	1321
123	CONSTRUCTIVE TYPOLOGIES ON PREHISPANIC STONE WALLS IN THE REGION OF PUNO, PERU <i>Tarque, Nicola; Lipa Cusi, Leonel</i>	1327

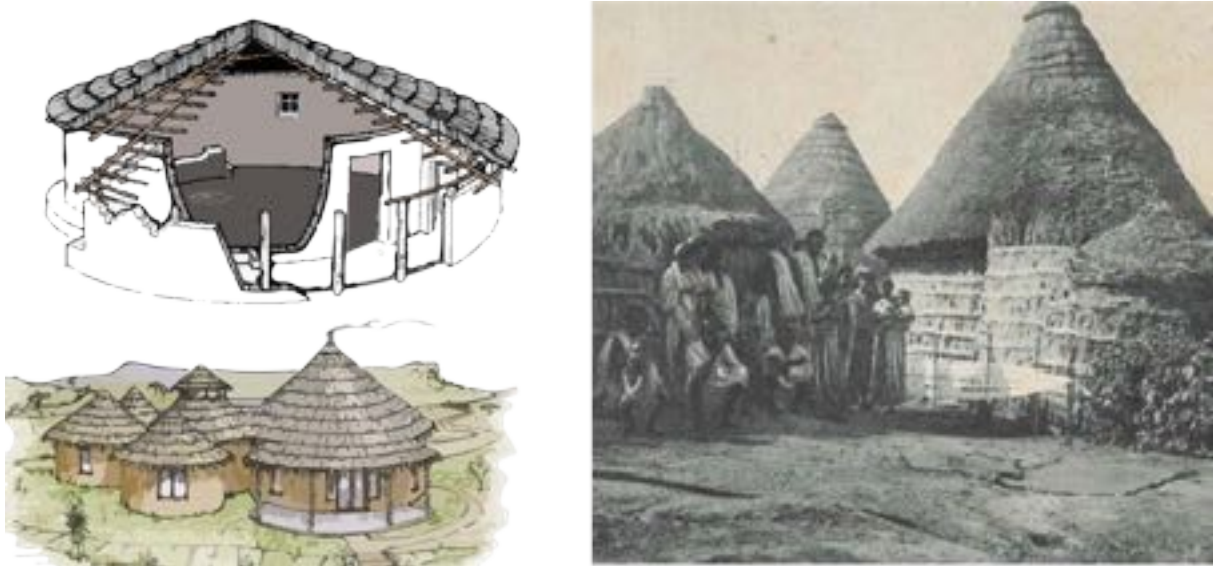
Figura 1: A sinistra: elaborazione grafica, a cura degli autori, di una abitazione tipo “Tukul”. A destra: immagine storica di un villaggio “Tukul” in Eritrea, 1936 (rif. Giovanni Carbonara, Antonello Pagliuca e Pier Pasquale Trausi, “L’Architettura delle colonie d’Oltremare. Un riflesso della «Modernità» fra sperimentalismo e identità nazionale”. Roma: Gangemi Editore spa, 2021, pag.170.)

architettoniche e bio-climatiche essenziali per i climi desertici dell’Africa: avevano spessori murari superiori a 50 cm (con una inerzia termica che consentiva di mantenere quasi stabile la temperatura interna, anche a fronte delle ben note escursioni termiche giornaliere), tetti di paglia fortemente spioventi (quasi 40°, consentendo un rapido smaltimento delle acque meteoriche, la ventilazione, il ricambio d’aria nonché una ottima impermeabilità) e un canale perimetrale all’edificio che consentiva di allontanare l’umidità dall’interno dell’abitazione. [5] Figura 1.

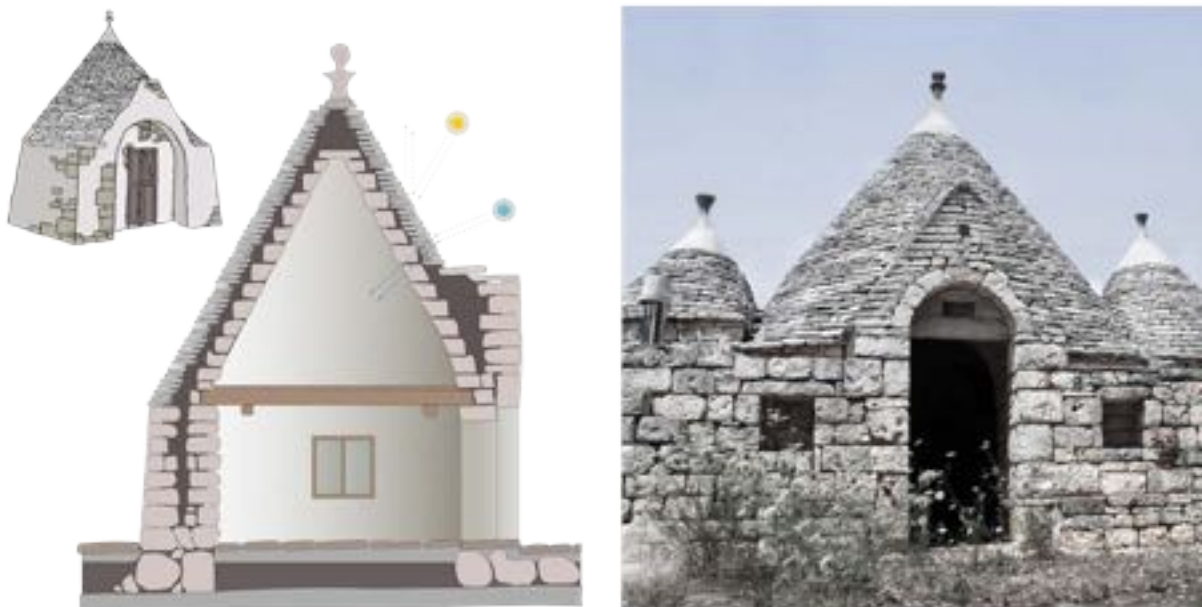
Figura 2: A sinistra: elaborazione grafica, a cura degli autori, di un “trullo” pugliese. A destra: fotografia attuale di un complesso di trulli nel comune di Alberobello (BA).

In prima istanza, i progetti proposti dagli architetti italiani per la realizzazione delle abitazioni rurali prendevano spunto dalle costruzioni tipiche dell’Africa Orientale e, in particolare, alcuni ravvedevano somiglianze tipologiche fra i “tukul” e i famosi “trulli” pugliesi. Pertanto, sulla scorta della tradizione costruttiva italiana venivano riproposte opere analoghe per la realizzazione di due aziende agricole in Africa, ispirate al trullo pugliese. Benché questa tipologia abitativa risolvesse le questioni bio-climatiche (grazie all’inerzia termica delle murature) e garantisse anche una grande facilità costruttiva (soprattutto nel reperimento dell’unico materiale che la costituiva, ovvero la pietra), l’aspetto tipologico e architettonico risultava ancora non risolto. Dopo questo primo risultato insoddisfacente gli architetti italiani dovettero industriarsi per progettare altre tipologie di case coloniche, più articolate ma sempre costruite con materiali locali (tali da garantire un comodo approvvigionamento), facilmente realizzabili (senza bisogno di operai specializzati) e soprattutto tenendo conto della rapidità costruttiva (data l’estrema esigenza di abitazioni) [6] Figura 2.

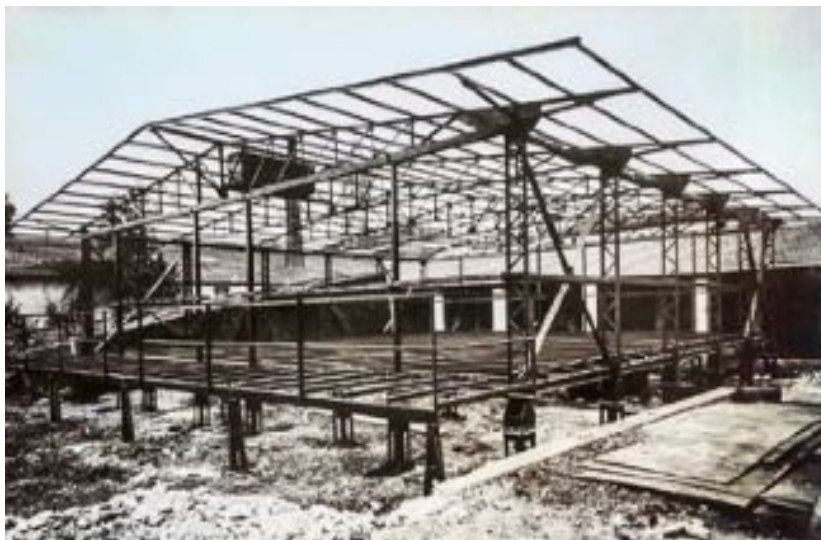
Figura 5: Cartolina storica del montaggio di un padiglione dell'Invulnerabile" (rif. Giovanni Carbonara, Antonello Pagliuca e Pier Pasquale Trausi, "L'Architettura delle colonie d'Oltremare. Un riflesso della «Modernità» fra sperimentalismo e identità nazionale". Roma: Gangemi Editore spa, 2021, pagg.204.)

Il primo, in particolare, era composto da elementi metallici laminati e trafilati a freddo tipo IPE ancorati su una fondazione lineare in calcestruzzo debolmente armato; al sistema di telaio erano applicati (con semplice incastro, esternamente e internamente) pannelli di Eraclit di spessore variabile in base alle esigenze termiche e prestazionali (generalmente 2,5 cm).
