Geotechnical characterisation and back analysis of a landslide in marl deposit: A case study of Algiers Sahel (coast), Algeria

M Filali, A Nechnech, J de Rosa, H Gadouri, B Meziani

The purpose of this study is to present the results of geotechnical investigations and landslide analysis in a marl deposit at the Sahel (coast) of Algiers in northern Algeria, where many landslides take place in the Plaisancian marls, particularly following rainfall periods each year, causing severe damage to infrastructures and buildings. The physico-mechanical characteristics of the soils obtained from three different sites (El-Achour, Daly-Brahim and Ouled-Fayet) were analysed to identify the mechanism of these landslides. In the study, the laboratory test results providing grain-size distribution, Atterberg limits, water content, shear strength, and compressibility were analysed. The findings showed that, although the soils were characterised by slightly higher plasticity at Ouled-Fayet, they were generally homogeneous in the studied sites. The upper soils, generally weathered, exhibited low shear strength parameters, which are lower than the undisturbed formation beneath. The stability analysis b

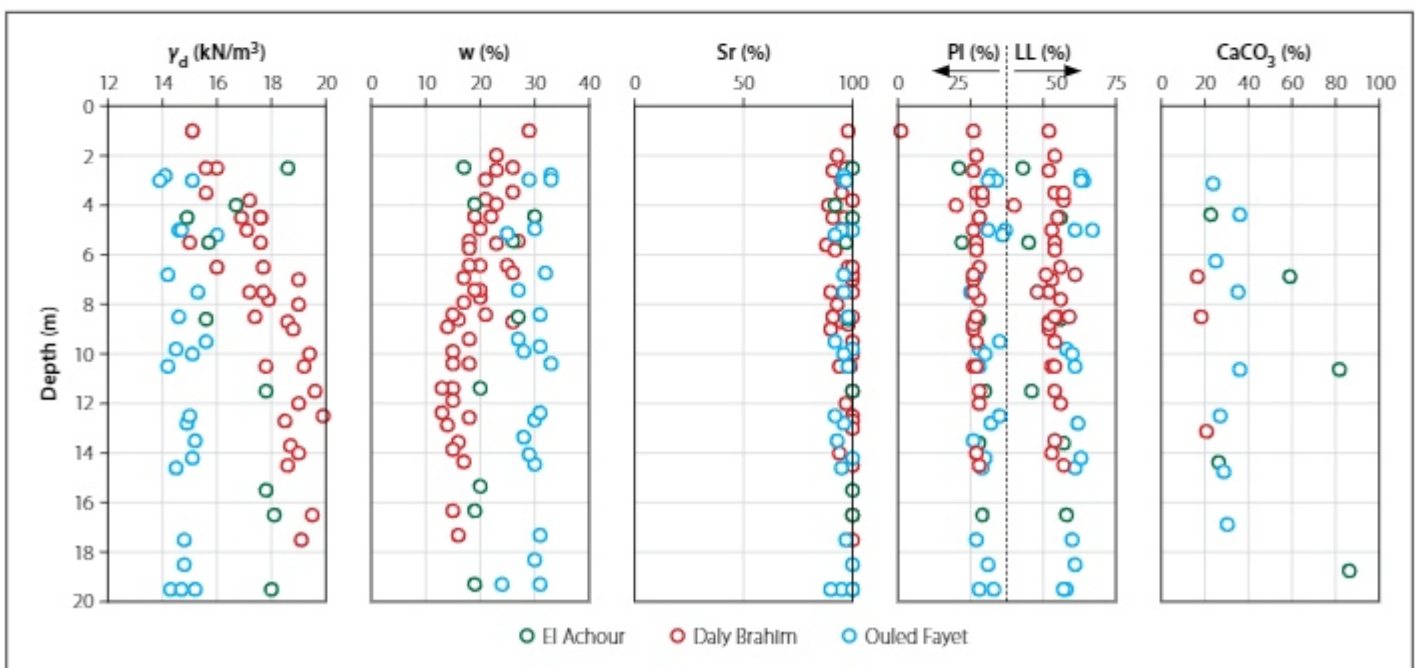
Figure 5 Profiles of γ_d , w , S_r , LL, PI and CaCO_3 content for El Achour (Site A), Daly Brahim (Site B) and Ouled Fayet (Site C)

Figure 5 depicts the results of the variation in dry unit weight (γ_d), water content (w), saturation degree (S_r), liquid limit (LL),

plasticity index (PI), and calcium carbonate content (CaCO_3) with depth. As Figure 5 depicts, the dry unit weight of the weathered layer of sites A and B increases from about 14 kN/m^3 close to the ground surface to about 19 kN/m^3 at a depth of about 8 m, below which, in the underlying undisturbed formation, it is almost constant. It is worth noting that some samples were extracted in May, and others between October and March of the following year. Irrespective of the month of sampling, the weathered marls were saturated ($S_r = 100\%$) or almost saturated at the investigated depths. This result has important consequences for the response of pore water to rain, as shown in

the section of slope stability analysis. The water content decreases from about 30% close the ground surface to an average of about 15% in the undisturbed formation. Site C, in contrast, has a dry unit weight and water content almost constant along the verticals, and close to the minimum and maximum values, respectively, of the corresponding parameters of the other two sites. The higher water content and lower dry unit weight of site C are probably due to the presence of more expansive clay minerals. In fact, the Atterberg liquid limits of site C are generally higher than the other two sites (Figures 5 and 6), whereas the clay fractions are similar. This site is actually known for its high swelling potential (Medjnoun 2014), associated with the predominance of illite-montmorillonite minerals (Bougdal 2007).

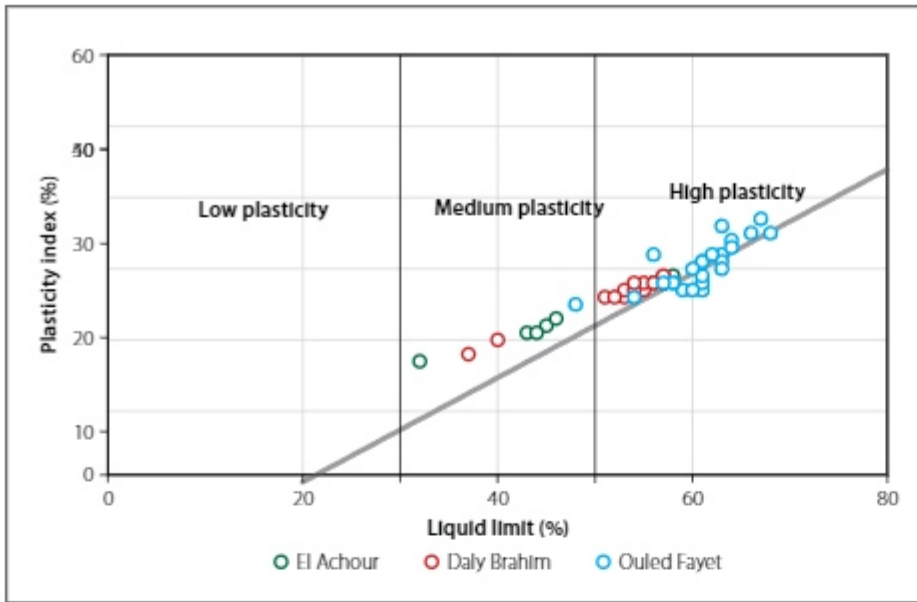
Figure 6 Plasticity chart of the studied soils

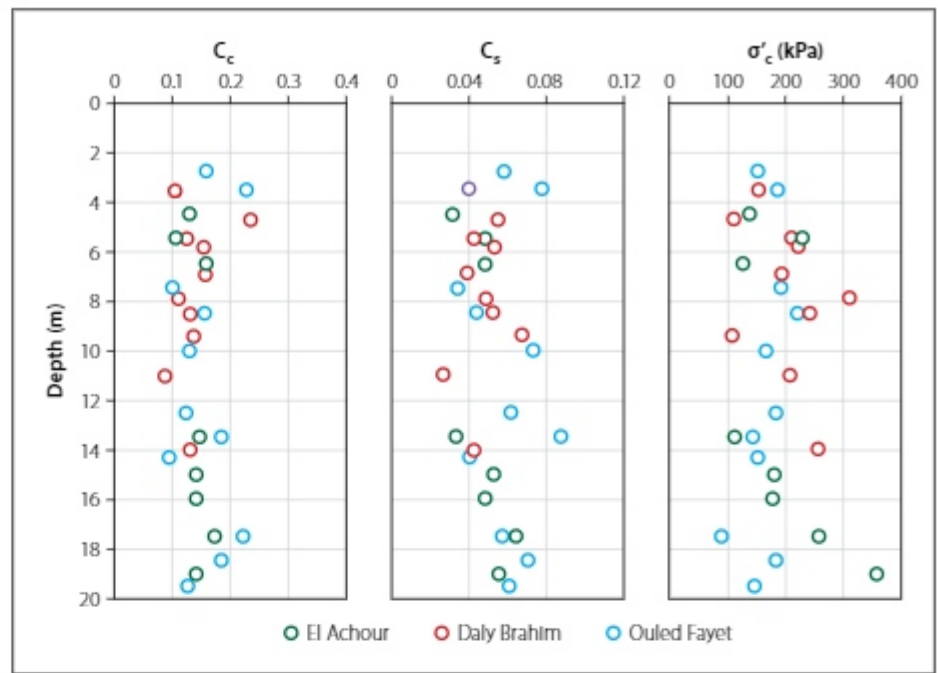
Figure 8 Profiles of the C_c and C_s indices and over-consolidation pressure σ'_c

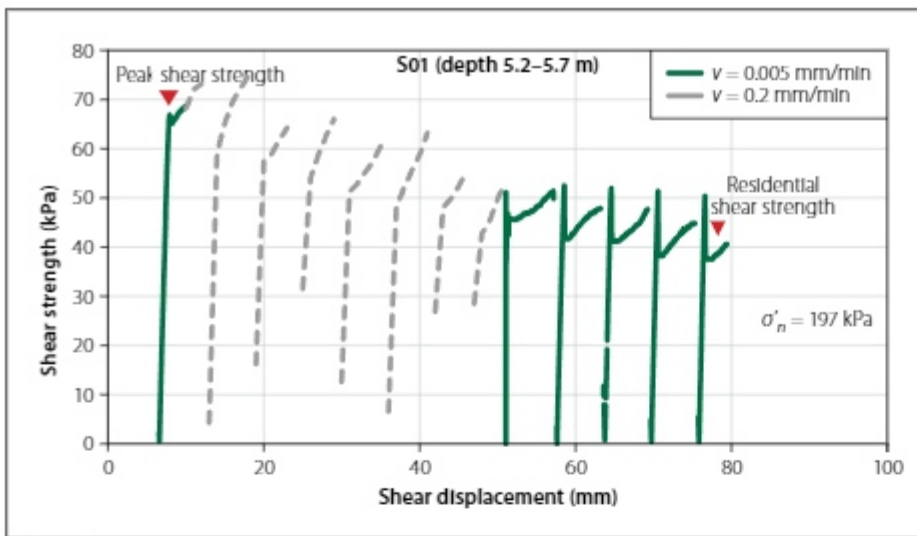
Figure 10 Shear strength versus shear displacements for a specimen of weathered marls (S01)

from about 12 m (S04) in unweathered marls, respectively. Sample S01 was consolidated under a normal stress of 197 kPa, and was then sheared (Figure 10). The first two cycles were performed at low displacement rates ($v = 5 \mu\text{m}/\text{min}$). The following cycles were performed faster in order to obtain a complete alignment of the clay particles within a few days. At a displacement of about 40 mm, the rate was lowered to $5 \mu\text{m}/\text{min}$ again, after which additional cycles were performed to obtain the drained residual shear strength parameters, residual friction angle ϕ'_r and residual cohesion c'_r (Figure 12). The same

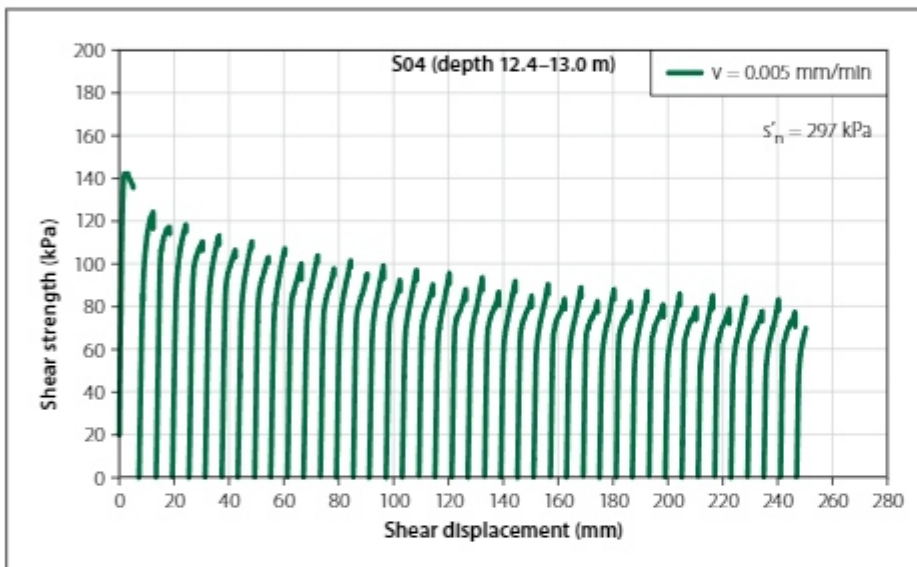
Figure 11 Shear strength versus shear displacements for the undisturbed material taken from unweathered marls (S04)

specimen was subsequently consolidated under a higher normal stress at 297 kPa and sheared again to the residual conditions. Figure 11 presents the results obtained for a specimen of sample S04 extracted from the unweathered formation. The specimen was consolidated and then sheared to the residual conditions at a rate of $5 \mu\text{m}/\text{min}$. Figure 12 shows that the residual friction angle of weathered marls is $\phi'_r = 11^\circ$. Under the reasonable hypothesis that c'_r is null, ϕ'_r of the sample of unweathered marls is 13° , a little bit higher, probably because of the difference in grain size distribution and c.f. (Figure 4).

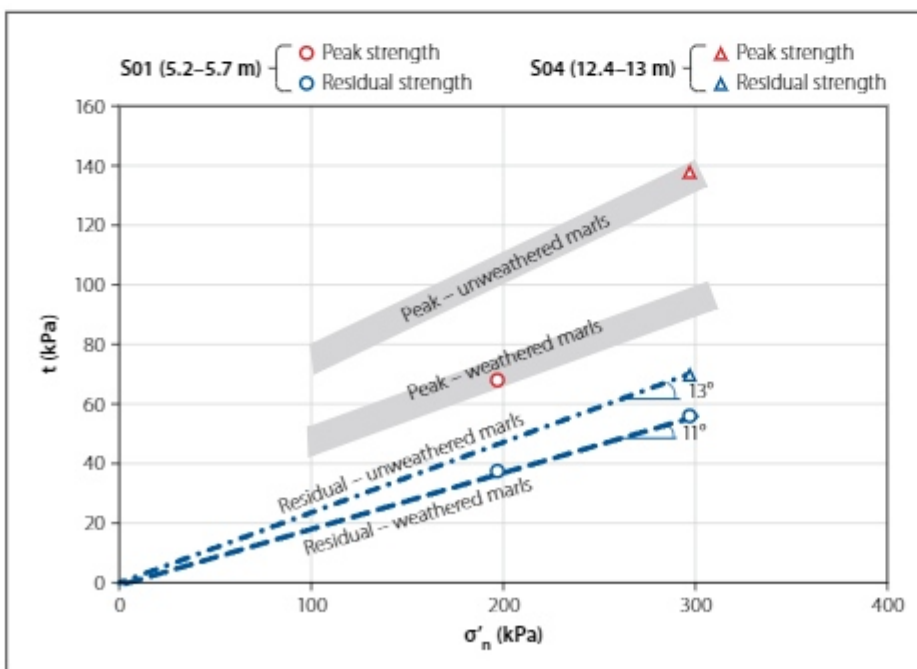
Figure 12 Peak and residual shear strengths versus shear displacements for specimens of weathered (S01) and unweathered marls (S04)

Both values are consistent with the presence of important percentages of clay minerals (Lupini *et al* 1981). The comparison between the peak strength lines and the residual ones shows the dramatic drop in strength from peak to residual, indicating the susceptibility of the soil to progressive failure.

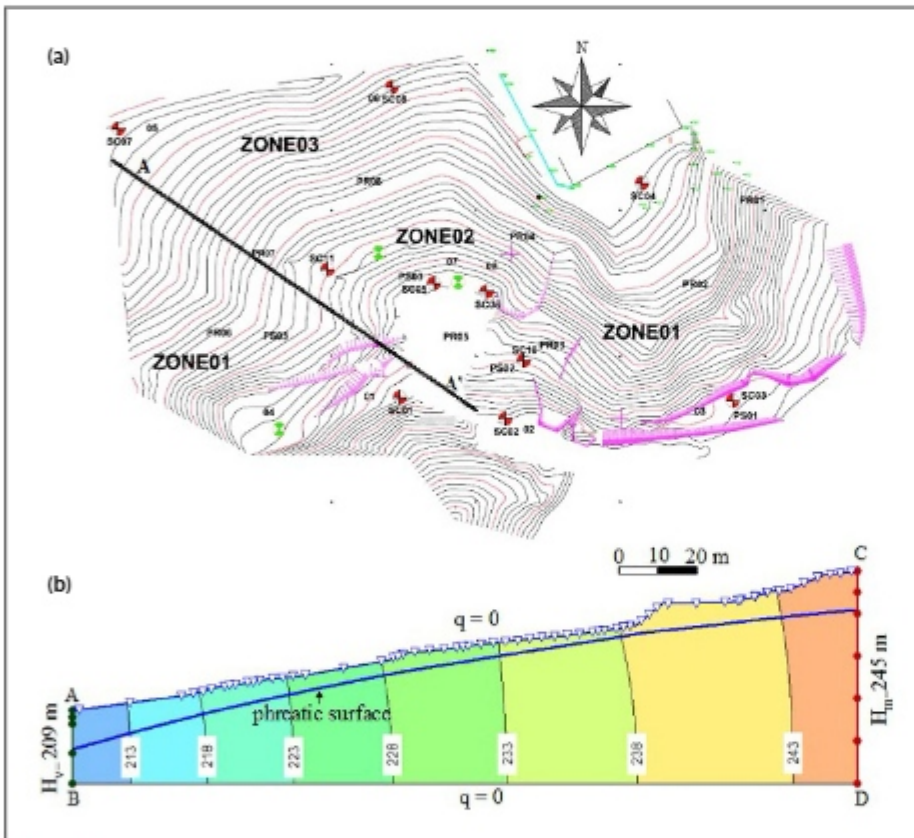
Figure 14 (a) Map of Dounia Park at Daly Brahim and a trace of the section AA' considered for the stability analysis; (b) section AA': hydraulic head distribution relative to the third condition ($H_m=245$ m, $H_v=209$ m, and unit flux $q = 0$ on the ground surface)

The calculations were performed with reference to the section A-A' (Figure 14a). The pore-water pressure distributions for the analyses in 2D and drained conditions were evaluated by the code SEEP/W for the domain represented in Figure 14b. Since the soils have high values of the degree of saturation and the water level recorded in some piezometers ranges from 0.3 m to 10 m depths, the soil was always studied saturated so that three different hydraulic boundary conditions were considered:

1. hydraulic head equal to the elevation of the ground points on the two vertical boundaries AB and CD, and water pressure $u = 0$ on the ground surface
2. hydraulic head 5 m lower than in the first case on the two vertical boundaries and null unit flux ($q = 0$) on the ground
3. hydraulic head 10 m lower than in the first case on the two vertical boundaries and null unit flux on the ground.

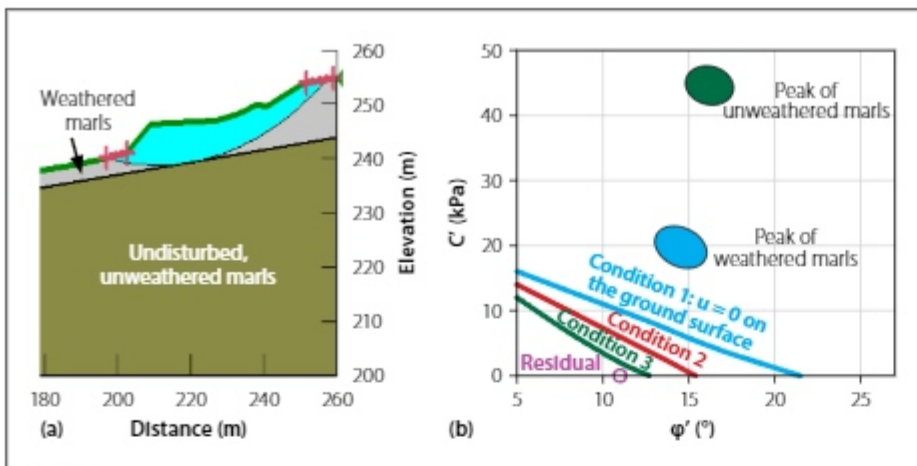
Figure 15 (a) Model for the LEM stability analysis and critical slip surface; (b) limit curves of the couples of c' and ϕ' values providing SF = 1 for the three different hydraulic boundary conditions, areas of c' and ϕ' couples and point of ϕ'_r obtained experimentally for the considered soils

The first condition on the ground ($u = 0$) corresponds to continuous rain with intensity higher than the soil hydraulic conductivity, while the second condition ($q = 0$) corresponds to dry weather. The results of the stability analyses performed using SLOPE/W for the worst slip surface are illustrated in Figure 15a, and for the three water pressure distributions are shown in Figure 15b in terms of $c' - \phi'$ couples which provide a safety factor $SF = 1$. The figure shows that the strength parameters characterising the peak strength of the undisturbed, not weathered, formation are much higher than those corresponding to failure along the considered slip surface, even in the case of $u = 0$. In contrast, the parameters of the weathered formation are closer to those corresponding to failure, for the case of $u = 0$ on the ground surface (condition 1) corresponding to continuous rain with intensity higher than the vertical permeability. The values of residual friction angle ϕ'_r ($11^\circ - 13^\circ$) are equal to or even lower than the parameter that brings the slope to

failure under the third hydraulic condition. It is thus reasonable to hypothesise that the real available strength parameters are intermediate between the peak and the residual ones.
