Geological and geophysical characterization of the Brindisi di Montagna Scalo landslide (Basilicata, Southern Italy)

The Brindisi di Montagna Scalo Landslide in Southern Italy is an active complex mass movement, which affects the left slope of the Basento River. In the last few decades, this landslide has been continuously monitored, as it directly threatened some of the most important communication routes in the Basilicata Region. Nevertheless, little progress has been made to prevent further landslide advancement, and continuous maintenance is required. With the aims of better understanding, the main factors controlling the evolution of this landslide, and suggesting the most appropriate countermeasures, a multidisciplinary study, based on the integration of direct and indirect techniques, was carried out. Direct techniques included multi-temporal geomorphological analysis of the slope, alongside geological and structural field observations. Indirect techniques consisted of electrical resistivity tomography acquisition. The combined analyses of the geological and geophysical data showed that Quaternary tectonic processes played a fundamental role as a predisposing factor, wherea

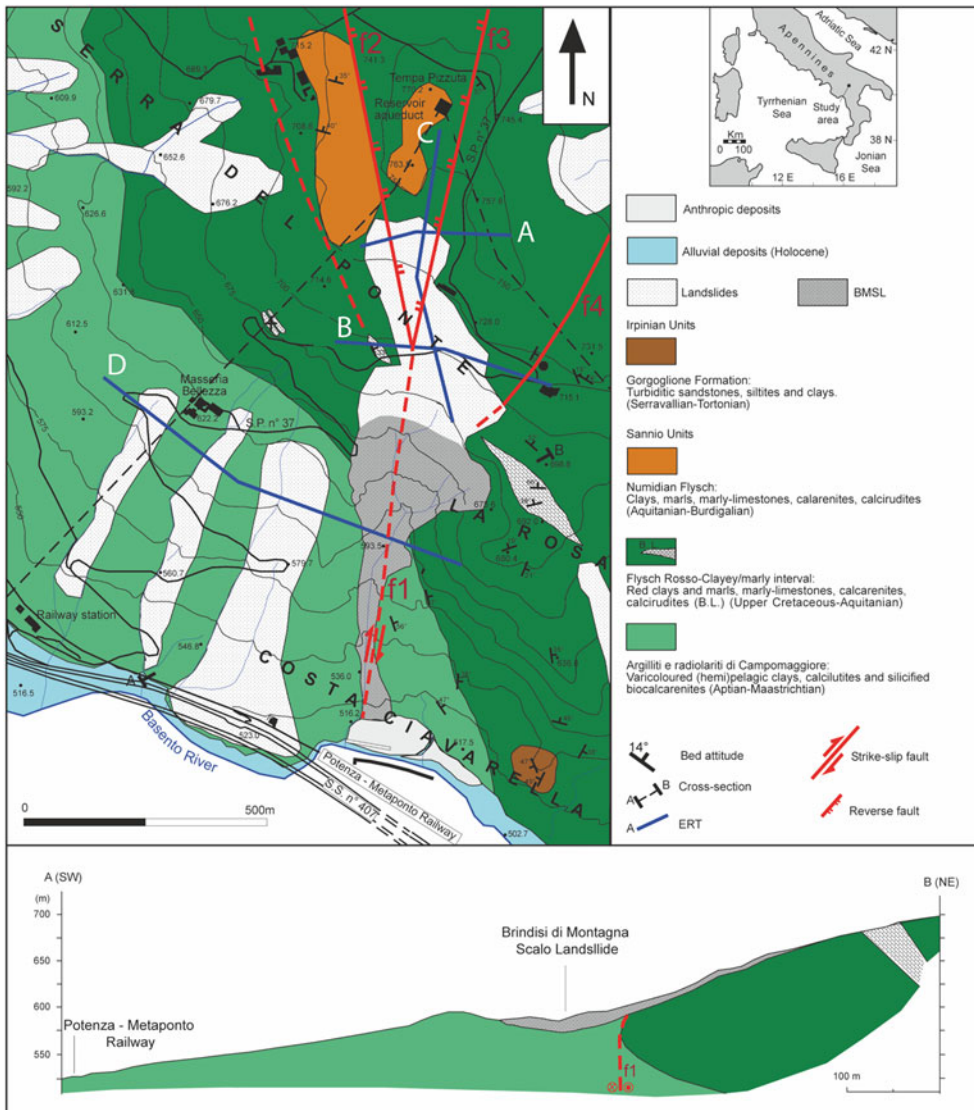
Figure 1. Geological map and cross-section of the BMSL area. The study landslide represented by the grey area. The mapped tectonic structures have been positioned based on both outcrop observations and geophysical data. Electrical Resistivity Tomography profiles are included. Source: Author

geomorphological maps (Figures 1 and 3) were obtained from a combination of all the different techniques used.

ERT A, B and C (Figures 1 and 8) form a grid, meant to investigate the subsurface characters of the area located between Tempa Pizzuta and the BMSL crown zone, where all the splays, converging towards the BMSL, would be expected. This area is prevalently characterized by dormant rotational slides, which are hardly recognizable in the field or on aerial photographs. The ERT A (Figure 8) shows a concave resistivity contrast (C1), between the topographic surface and about 725 m asl, which is interpreted as the contact between the slide material and the Flysch Rosso. The major features of the ERT A are the two sharp lateral variation of electrical resistivity at about 50 and 200 m, which are interpreted as the f2 and f3 splay, respectively. ERT B (Figure 8) was carried out along one of the crowns of the dormant landslide. It shows a quite firm substrate in the Flysch Rosso, with little evidence of landslide material in the first few metres. The Flysch Rosso/Argilliti e radiolariti di Campomaggiore transition is visible at a depth of about 650 m asl. Abrupt lateral variation of electrical resistivity at about 170 and 400 m are interpreted as the f2 and f4 splay. ERT C (Figure 8) extends longitudinally between the Tempa Pizzuta hilltop and the

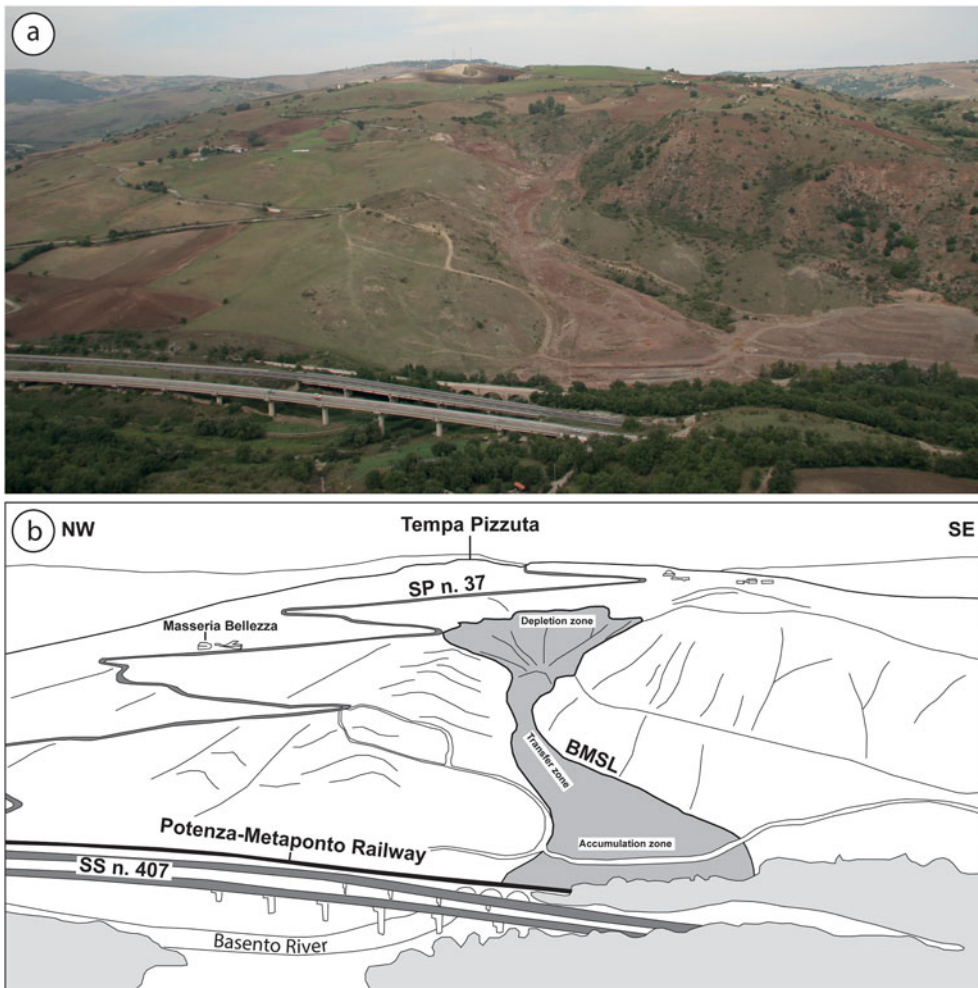
Figure 2. a) Frontal view from the south of the left slope of the Basento River which includes the BMSL; b) interpretation. The main infrastructures involved in the mass movement are included. Source: Author

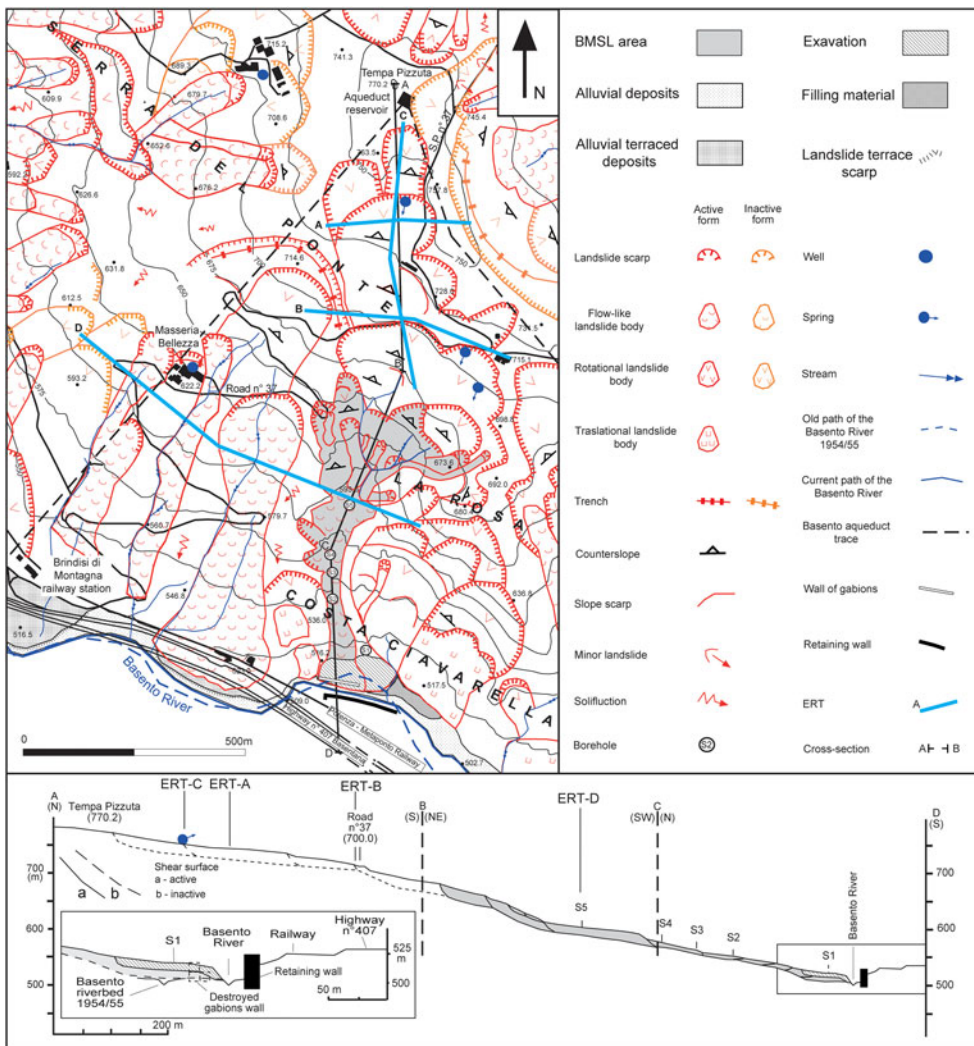
Figure 3. Geomorphological map and cross-section of the study area. The grey colour indicates the area where the BMSL resides. Source: Author

The depletion zone of the BMSL (Figures 3 and 4b), where the rotational to translational mechanisms mainly occur, developed between two stable areas, represented by the Serra del Ponte and La Rosa localities. This area mainly consists of three strongly deformed source zones, respectively named the western, central and eastern sources, characterized by active erosion, a large occurrence of trenches, open fractures, water-filled depressions and upslope-tilted blocks. Here, the measured terrain gradient averages 23° . Along the steeply-dipping crown, the main mass movement is often accomplished by falling and toppling mechanisms. In this part of the landslide, a retrogressive evolution has been identified.

Data concerning the depth of the sliding surface of the BMSL are provided from borehole logs (Cotecchia et al. 1986) (Figure 3). The thickness of the displaced

The BMSL is a rotational slide evolving downhill into an earthflow (Figure 3). It mainly developed in a structurally-complex succession of alternating clay and turbiditic limestones ascribed to the Argilliti e radiolariti di Campomaggiore and Flysch Rosso formations. The depletion area mainly resides in the Flysch Rosso, where turbiditic limestones are predominant. The transfer and accumulation zones occur in the Argilliti e radiolariti di Campomaggiore, which is a predominantly clay-rich unit. Multi-temporal analysis of aerial photos and ERT investigations revealed that two main critical factors controlled, and still strongly influence, the evolution of the Brindisi di Montagna Scalo Landslide: (i) the BMSL is particularly susceptible to seasonal rainfall, which is considered the main triggering factor; (ii) the BMSL mainly formed in association with an intensely-deformed Quaternary fault zone. The recognized faults greatly contributed to the weakening of the substrate, presenting a preferential route for groundwater infiltration and migration. We consider these to be a fundamental predisposing factor.

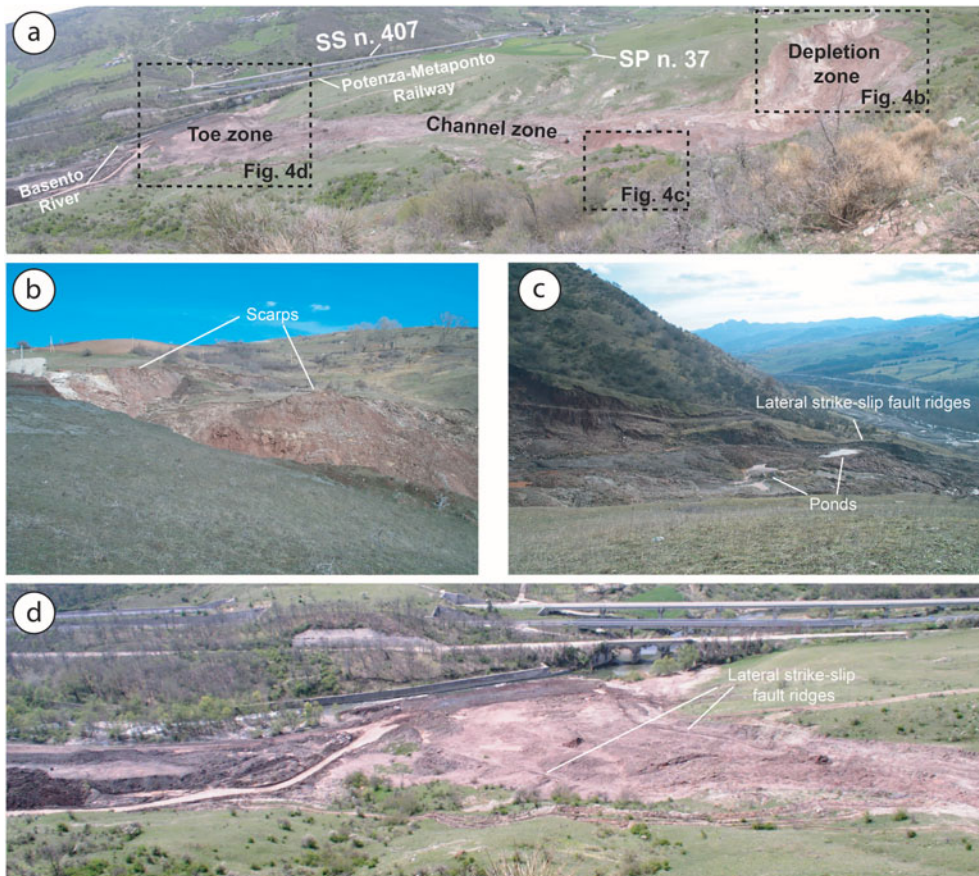
Figure 4. a) Panorama view of the BMSL taken from La Rosa. From this position all the main landslide elements forming the study landslide as well as the depletion, transfer and accumulation zones are visible; b) view of the BMSL crown zone from SW. Note the occurrence of different landslide scarps; c) particular of the BMSL channel zone showing well-defined lateral strike-slip fault ridges and water ponds located within ephemeral topographic depressions; d) view of the BMSL toe zone from NE. Note the reduced section of the Basento River and the occurrence of fresh lateral strike-slip fault ridges bounding the active toe. Source: Author

The transport zone of the BMSL consists of an elongated channel through which the material, produced in the depletion area, is transferred downward to the deposition zone (Figure 4c). The channel is confined between marked incisions, the activity of which is testified by the presence of well-preserved striated shear planes. Along this tract, the landslide is characterized by an evident hummocky morphology, produced by extensional cracks and contractional corrugation. In this portion, the terrain, the gradient may reach 11° .

The deposition zone of the BMSL (Figure 4d), corresponding to the Basento River valley bottom, consists of a fan-shaped toe that deflects, and periodically interrupts, the watercourse. Here, diffuse cracking and soil corrugation are the most easily recognized features. In this sector, the terrain gradient averages 7° .

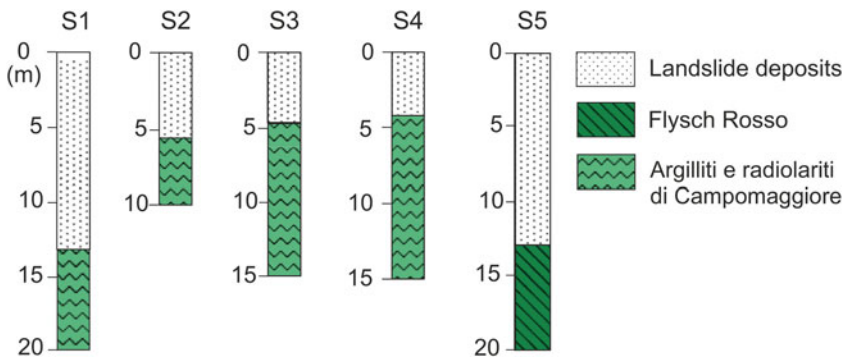
Figure 5. Borehole stratigraphic logs made along the BMSL channel zone (modified by Cotecchia et al.1986).

material ranges from about 5 m in the channel zone to 13–14 m measured in the upper part of the channel, and in the toe zone (Figure 5).

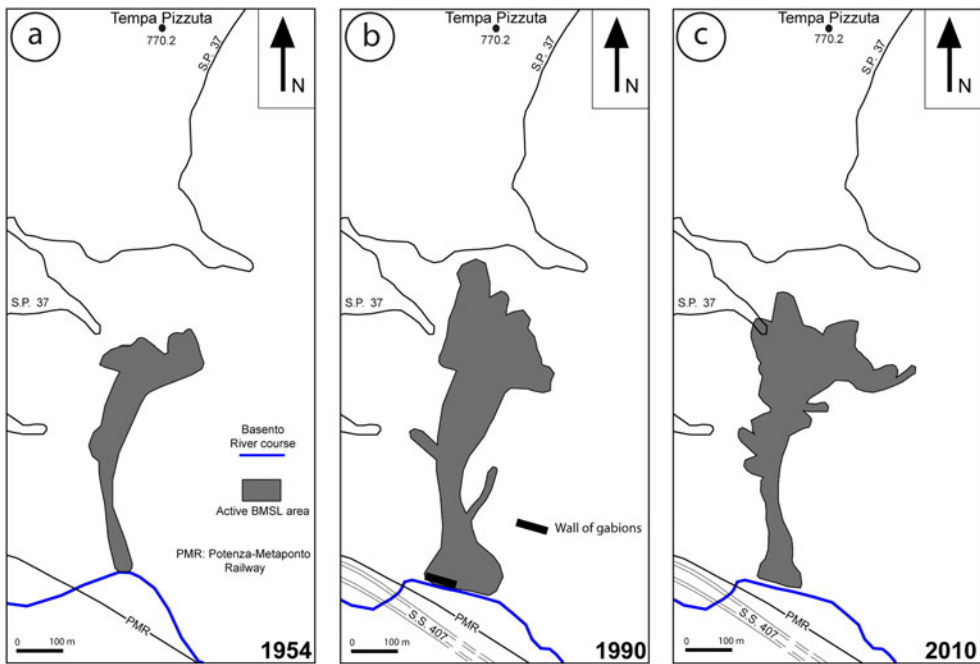
Figure 6. Long-term multi-temporal landslide maps for the BMSL. Note the progressive increase of the area involved in the landslide movement through the years a) 1954, b) 1990 and c) 2010. Note also the change in Basento River course due to growing of the BMSL toe. Source: Author

The first stereoscopic aerial photographs available for the study area date back to 1954 (Figure 6a). In these photographs, the BMSL was about 640 m long, and ranged in elevation from about 675 to 516 m. When compared to the present-day landslide geometry, the BMSL shows a narrower depletion zone and a smaller accumulation zone. The depletion zone consisted of two main source areas, feeding the main earthflow body. Steep morphologies and back-tilted surfaces were common in this part of the landslide. Extensional cracks characterized the transition between the depletion zone and the channel. The channel was also narrower, with an evident neck at about 650 m. Corrugations, related to contractional deformation, have been previously documented (Del Prete 1992). At the toe, the Basento River formed a wide curve, which shows no evidence of any involvement in the mass movement. Infrastructure

Aerial photographs for the year 1990 (Figure 6b) show that significant geomorphological change occurred over the course of 36 years. The active zone of the whole landslide noticeably lengthened, and the depletion and accumulation zones cumulatively enlarged. At this time, the BMSL was about 800 m long, and ranged in elevation from about 690 to 520 m. Significant retrogressive processes markedly had changed the position and geometry of the landslide head scarp, and the western, central and eastern sources had developed. Ponds, ephemeral springs and deeply-incised gullies are visible, especially around the boundary between the Argilliti e radiolariti di Campomaggiore and Flysch Rosso, along the eastern side of the landslide. In the channel zone area, secondary earthflows had joined the main body on both sides; however, the most striking feature is represented by a wide fan-shaped toe, which had invaded the valley bottom, and deflected the course of the Basento River. The necking of the river section gave rise to a landslide lake upstream (Cotecchia et al. 1986). Gabions, aimed at protecting the adjacent Potenza-Metaponto National Railway, are clearly visible in the aerial photographs (Figures 3 and 6).

In 2010 (Figure 6c), the geometry of the BMSL had further changed. The BMSL was about 850 m long, and ranged in elevation from about 695 to 520 m. The depletion zone was significantly enlarged. Obvious activity seems to have been on the eastern side, where new rotational slides and secondary earthflows had joined the main body. On the western side, retrogressive evolution of the head scarp had caused the involvement of the SP n. 37 road. The transfer zone geometry also appears to have

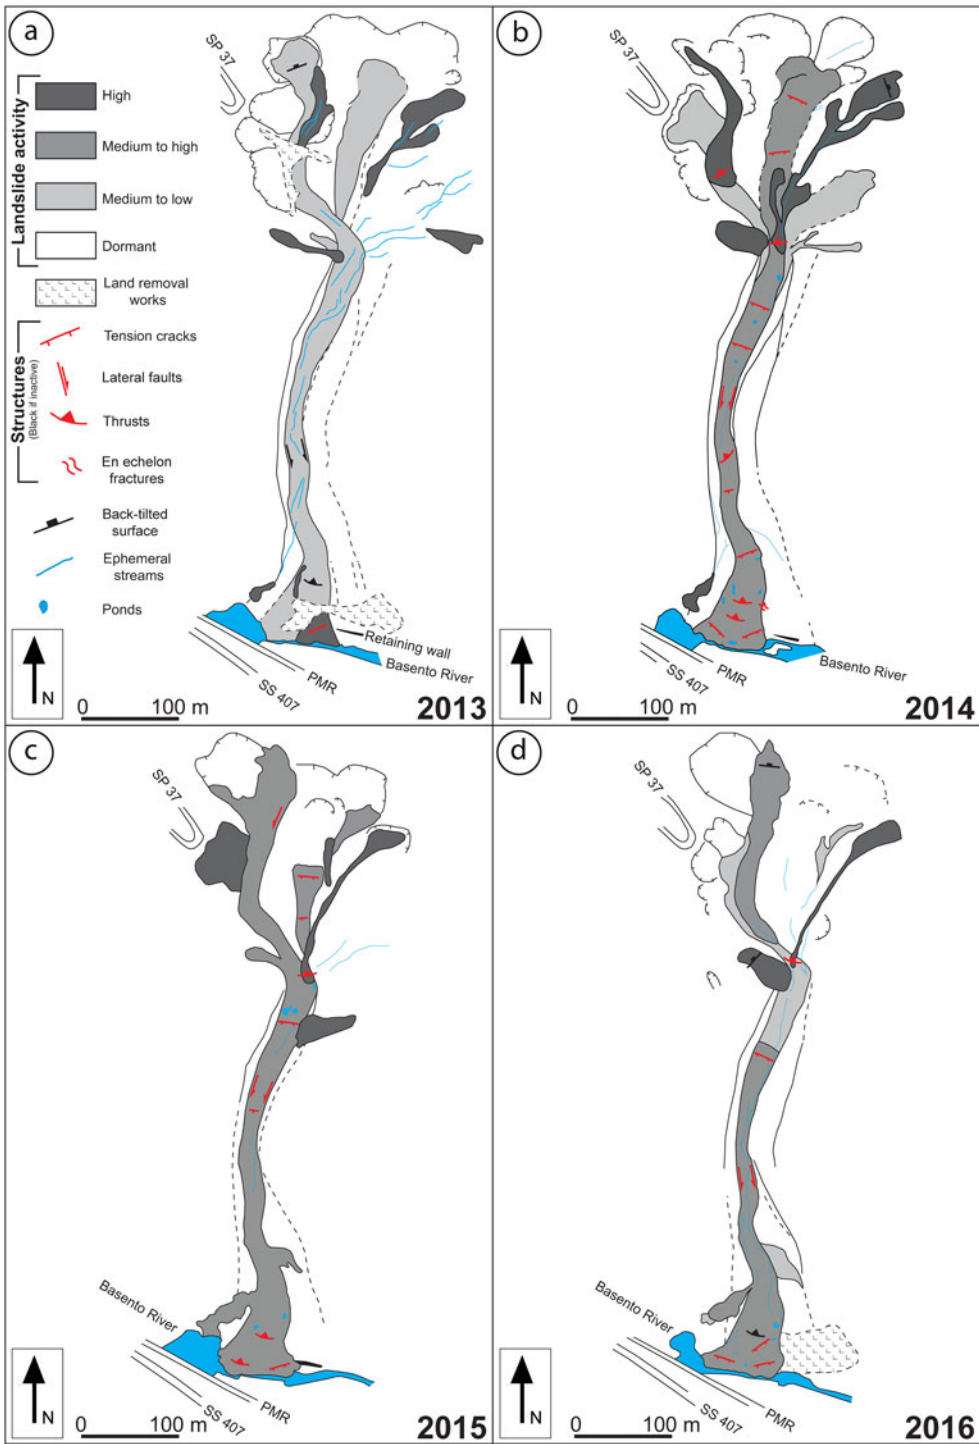
Figure 7. Short-term multi-temporal landslide maps for the BMSL. In all maps, landslide activities and the main landslide features for the years a) 2013, b) 2014, c) 2015, d) 2016 are showed. The landslide activity was detected by direct observation in the field. Source: Author

A view of the short-term evolution of the BMSL was obtained through serial visual analysis of Google Earth imagery, from 2013 to 2016 (Figure 7). During this period, the earthflow showed repeated geomorphological change, most occurring in the catchment area and at the active toe. Along the transfer zone, the landslide showed different generations of flank ridges and lateral trenches, with the narrowest corresponding to the current active sector of mass movement.

The BMSL Google Earth image from 2013 goes back to September 25th (Figure 7a). At that time, land removal works were underway in different sectors of the landslide, and numerous dirt roads, allowing access to the most deformed areas, crossed the mass movement at different topographic highs. Landslide activity was mostly concentrated in the source area, where, however, it was represented by a few scattered, shallow earthflows, converging on the transfer channel. In the middle sector, the landslide was characterized by low activity. Here, predominantly erosional processes took place, as testified to by numerous longitudinal deeply-incised streams, which, in many cases, formed at the junctions of the flank ridges. Gullies largely overprinted previous morphologies consisting of tension cracks and thrusts. In the accumulation zone, activity was generally low. The Basento River was narrowed in some parts, and a neck formed in the proximity of the Potenza-Metaponto National Railway led to the formation of a lake upstream. A retaining wall, built at the toe, appears partially disrupted and buried under landslide deposits. Active tension cracks, visible on the eastern side of the toe, in the proximity of the Basento River, were the result of continuous erosive action of the river course.

The BMSL Google Earth image from 2014 was taken on October 10th (Figure 7b). Different from the previous year, the earthflow indicates a high level of activity. In the catchment area, dirt roads observable in the previous year's image had been almost completely removed by landslide activity. The main body was mainly fed by the central and eastern sources. Other isolated lateral sources also contributed. Landslide activity in the catchment area was mainly inferred from the occurrence of visible extensional cracks and the freshness of the sliding surfaces. The transfer zone was very active in 2014. High activity is illustrated by the large frequency of fresh extensional cracks, alternating with local contractional zones. Ponds and ephemeral streams are also visible, especially in the upper portion of the channel; however, the most striking evidence is represented by rejuvenated lateral strike-slip faults and, at the boundary with the toe zone, by en echelon fractures. In the accumulation zone,

The BMSL Google Earth image from 2015 was taken on May 30th (Figure 7c). Although the landslide was highly active, as in the previous year, significant changes are visible, both in the source and accumulation zone. In the feeding area, the major activity is visible in the correspondence of the western source. Here, new material was added to the landslide, due to the retrogressive evolution of the crowns. Unlike the previous year, the central and eastern sources were active only in providing a minor contribution, in terms of remobilized material. In the transfer zone, the landslide is still confined between marked lateral faults, and corrugation and extensional cracks occur extensively. Lateral lobes, formed from overflow material, are common. In the lower portion, the earthflow is characterized by a significant widening of the toe, which resulted in further necking of the Basento River. Similar to the transfer zone, corrugation and extensional cracks occur abundantly, although are less marked. The narrowing of the river resulted in the widening of the lake, located upstream, and in a threat to the walls in defence of the railway.

The BMSL Google Earth image from 2016 was taken on July 2th (Figure 7d). Landslide activity at this time was very low. In the depletion area, the three main source areas were, in great part, covered by vegetation. In particular, the central and eastern sectors seem to be almost in a dormant stage, whereas in the western portion, a little activity is observable in the crown area. The entire area is crossed by deeply-incised gullies, which often sit on previous structures, such as lateral faults. Similar characteristics are largely observable in the transfer zone. In fact, longitudinally-oriented deeply-incised gullies are the predominant feature of this zone. In the accumulation zone, the dimensions of the toe are considerably reduced, as a consequence of the Basento River undercutting erosional processes, which are not compensated by the arrival of new material from the depletion and transfer zones.

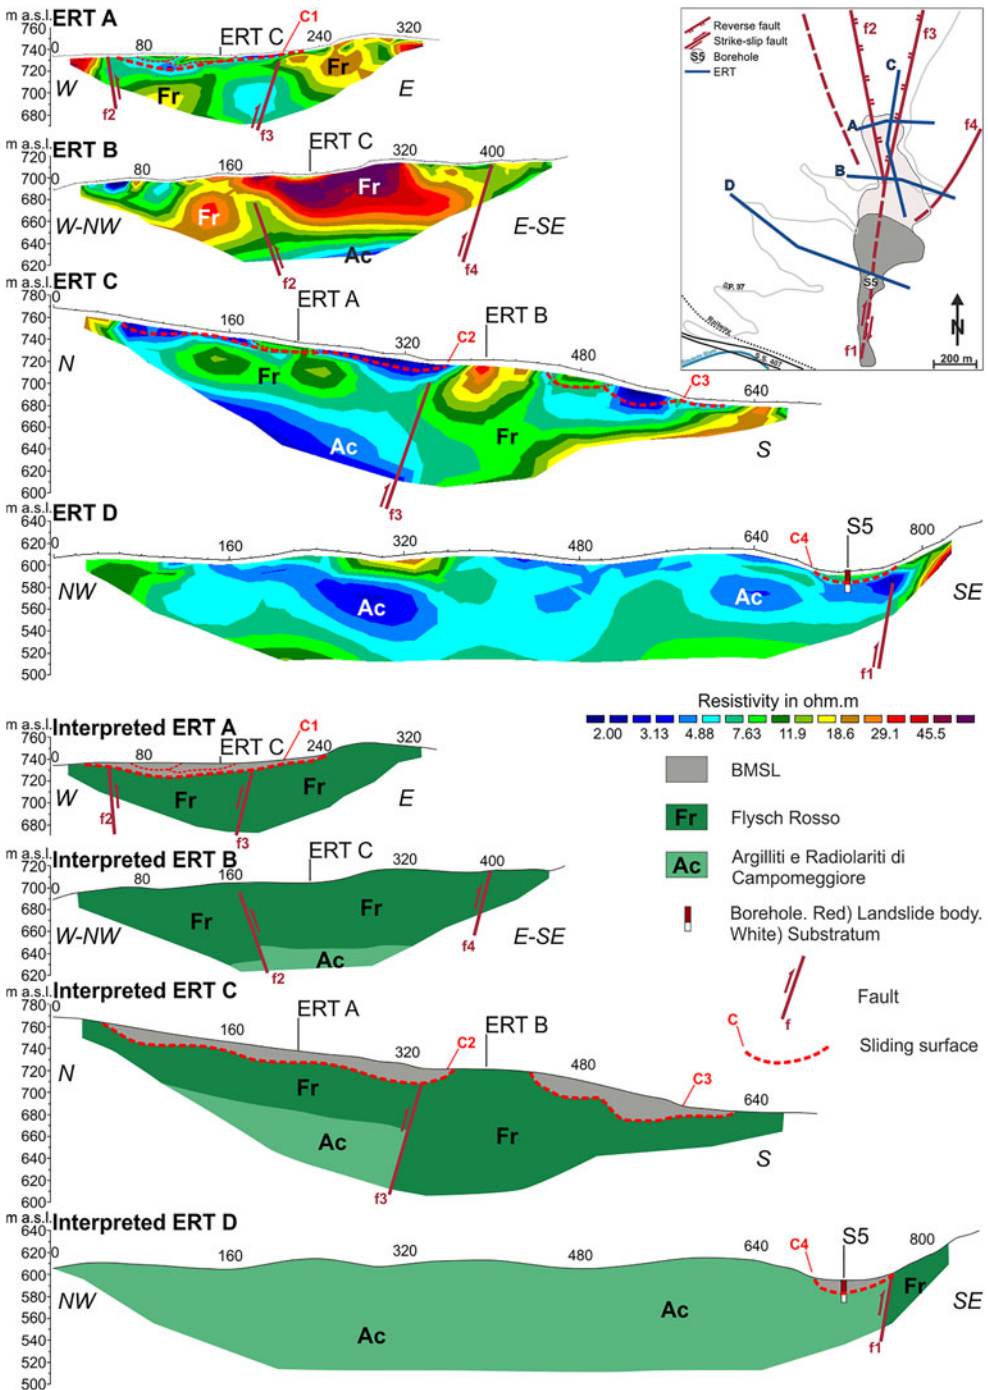
Figure 8. ERT carried out parallel and transversally to the landslide body axis and interpreted sections obtained by combining ERT and field geological and geomorphological information. See Figure 1 for the location of the ERT profiles. Source: Author

boundary between the dormant and active areas of the BMSL, intersecting ERT A and B. The main characteristic recognizable in the ERT C is the structural high in the Flysch Rosso, separating the two different sectors. It coincides with a high electrical resistivity zone ($>12 \Omega\text{m}$) where thick calciclastic limestones occur within the Flysch Rosso succession, between 360 and 440 m asl. Uphill, in the dormant sector, a shallow electrical resistivity contrast (C2) clearly marks the landslide/Flysch Rosso contact, whereas a deeper electrical resistivity contrast indicates the stratigraphic contact between the Argilliti e radiolariti di Campomaggiore and the overlying Flysch Rosso. Downhill, in the active landslide zone, the ERT shows clear concave sliding surfaces (C3) cutting into the substrate, represented by the Flysch Rosso. The transition between the dormant and active areas of the BMSL is characterized by a sharp lateral variation of electrical resistivity, interpreted as the f3 splay. In this case, the Flysch Rosso/Argilliti e radiolariti di Campomaggiore boundary is used to interpret the f3 splay as a right-lateral strike-slip fault with reverse vertical component. ERT D consists of a long profile carried out immediately south of Masseria Bellezza (Figure 1). The profile intercepts the BMSL at the transition between the depletion and channel zones. The sliding surface is clearly evidenced by a marked resistivity contrast (C4). The occurrence of a borehole (S5) helped us to better constrain this surface. The sharp lateral variation of electrical resistivity, located on the southeastern side of the landslide, is interpreted as the f1 splay.

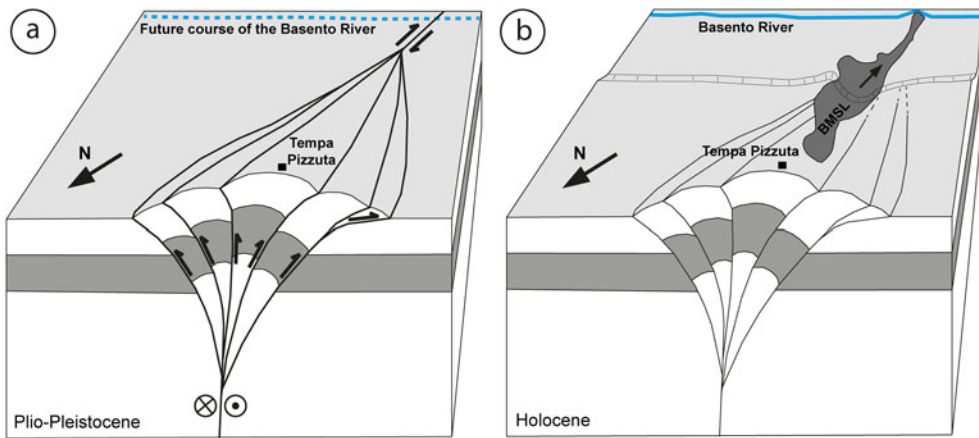
Figure 9. Schematic 3D block diagrams showing: (a) the development of a dextral transpressional fault zone in the considered sector of the southern Apennine thrust-belt during Plio-Pleistocene; (b) Present-day position of the BMSL. Not to scale. Source: Author

association with its southern termination, where the master fault, which follows the BMSL channel/toe segment, splits into several branching splay faults (Figure 9b). Uplift and faulting, related to growth of the recognized structural high, significantly predisposed the study area to landslide collapse. Faulting mainly caused weakening of the substrate and a general reduction in the shear strength. Uplift mainly contributed to gravitational disequilibrium, destabilizing the slope.
